Inspection Photos

Location Name: ROBERT MCCOY B1 & B3

API#: 05-067-07846

INSP. #: 695103014

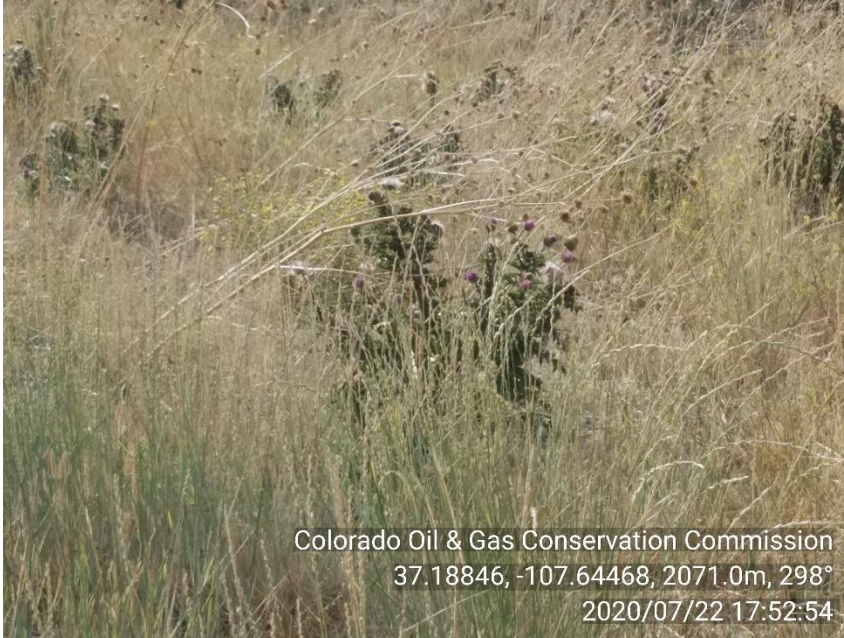
**PHOTO 3: NOXIOUS WEEDS ON INTERIM RECLAMATION
AREA ALL AROUND LOCATION. REMOVE NOXIOUS WEEDS,
COMPLY WITH RULE 1003.f. CA DATE 7-29-20.**
