Inspection Photos

Location Name: COUGAR 42-14

API#: 05-071-07320

INSP. #: 695103043

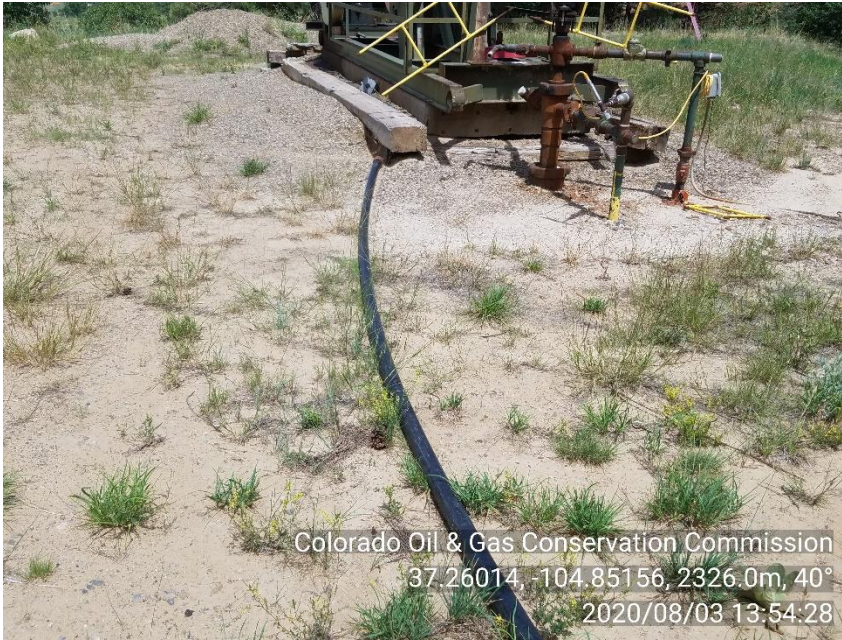
PHOTO 3: UNUSED EQUIPMENT STORED ON LOCATION (2" POLY PIPE). REMOVE UNUSED EQUIPMENT, COMPLY WITH RULE 603.f. CA DATE 11-3-20.
