Inspection Photos

API: 071-06128

Operator: TIMBER CREEK OPERATING

Inspection Date: 10/1/2020

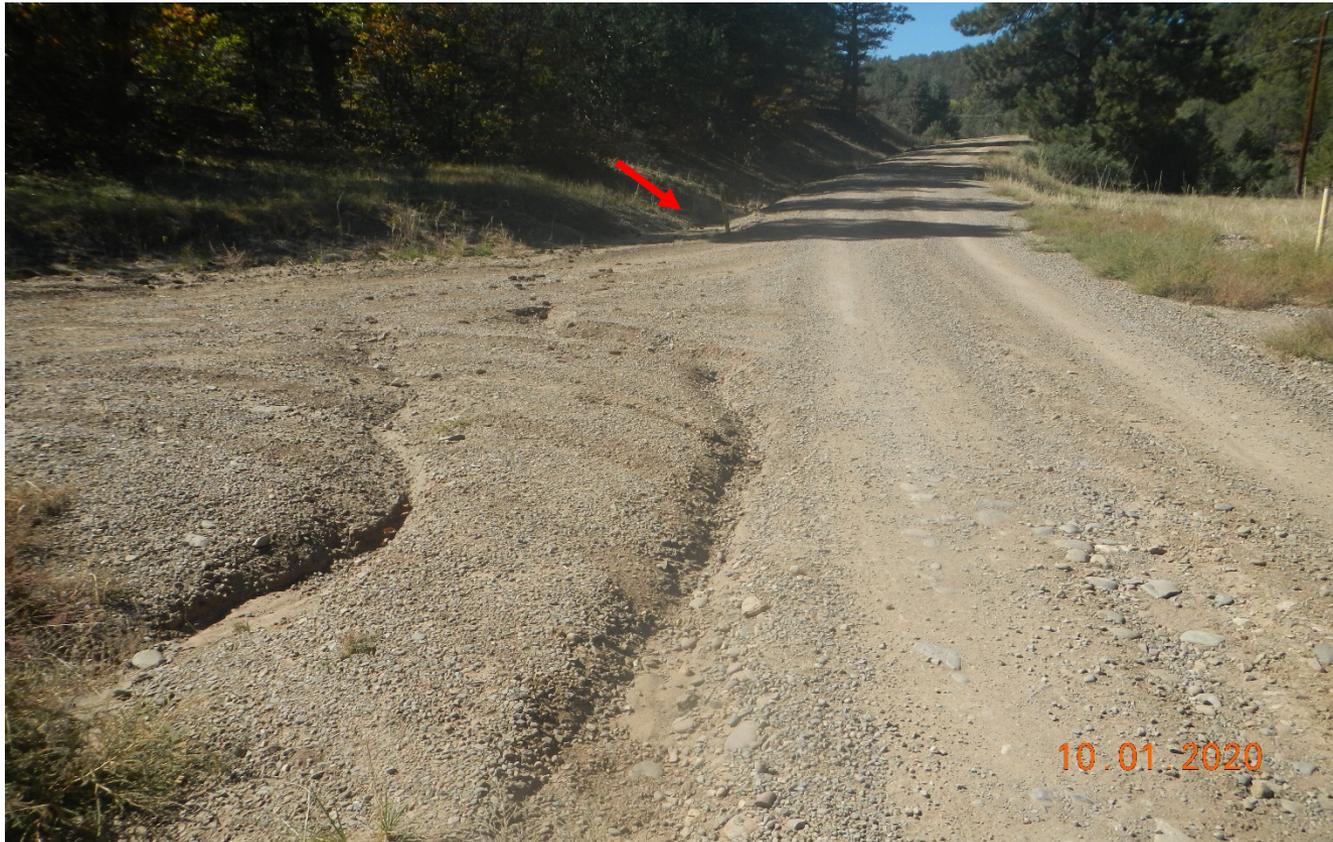
Photo 2. There is a plugged culvert along the main road (red arrow) causing stormwater to flow down the road. Lat/Long:37.09178,-104.93688. Corrective action was not completed.

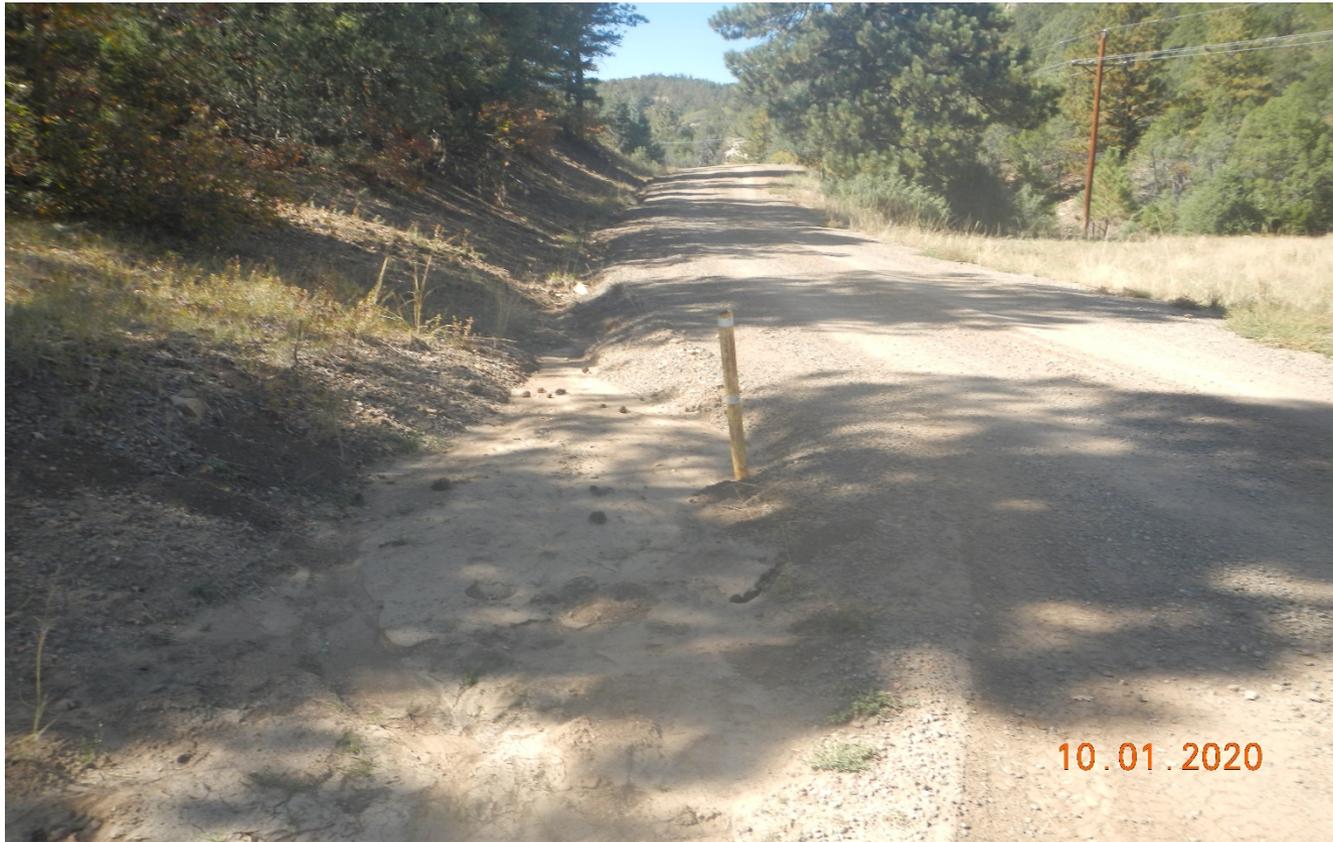
Photo 2. The culvert is filled in with sediment causing stormwater to flow down the road. All culverts need to be maintained. Previous corrective action was not performed.

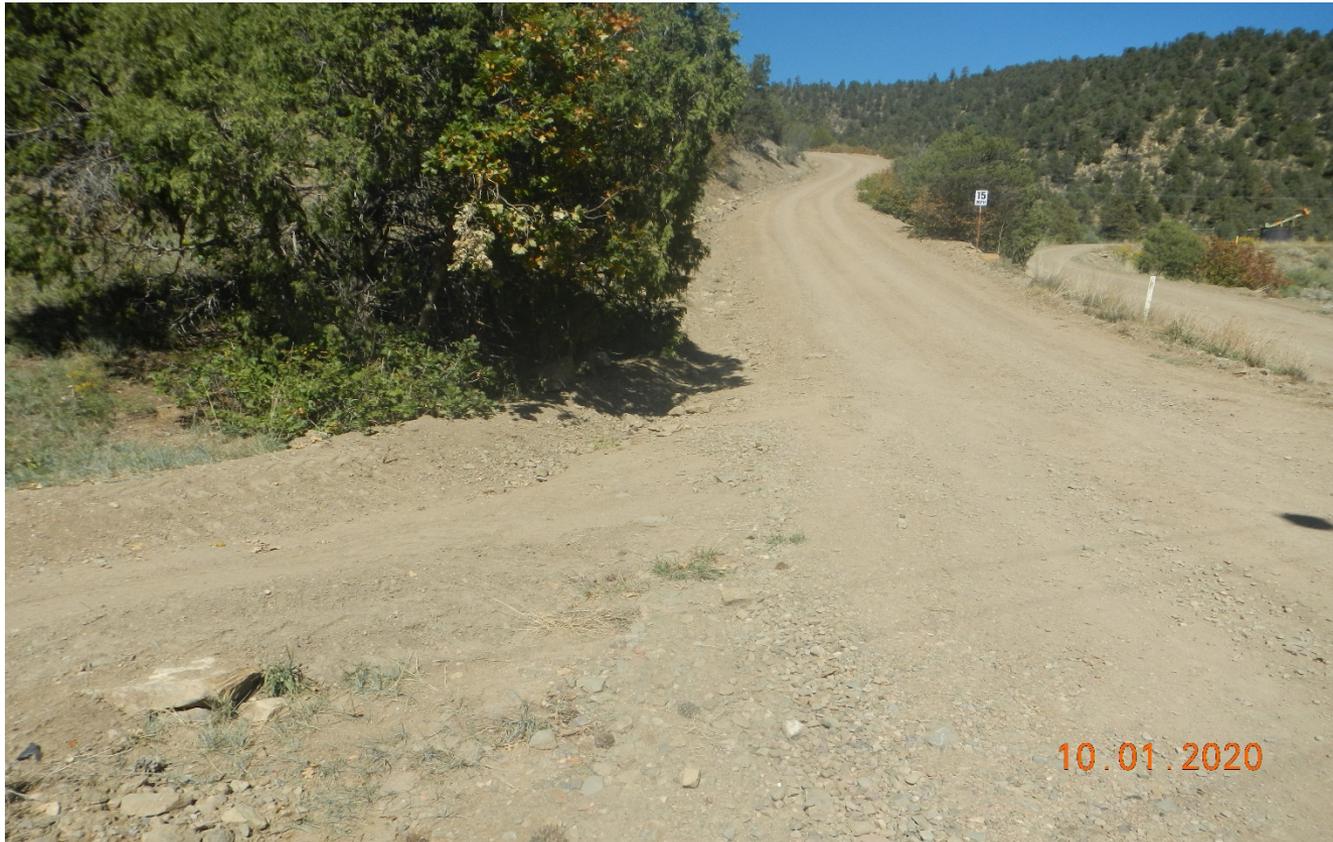
Photo 3. Facing north along the access road as it ascends the hillside. The road has been regraded since the previous inspection.

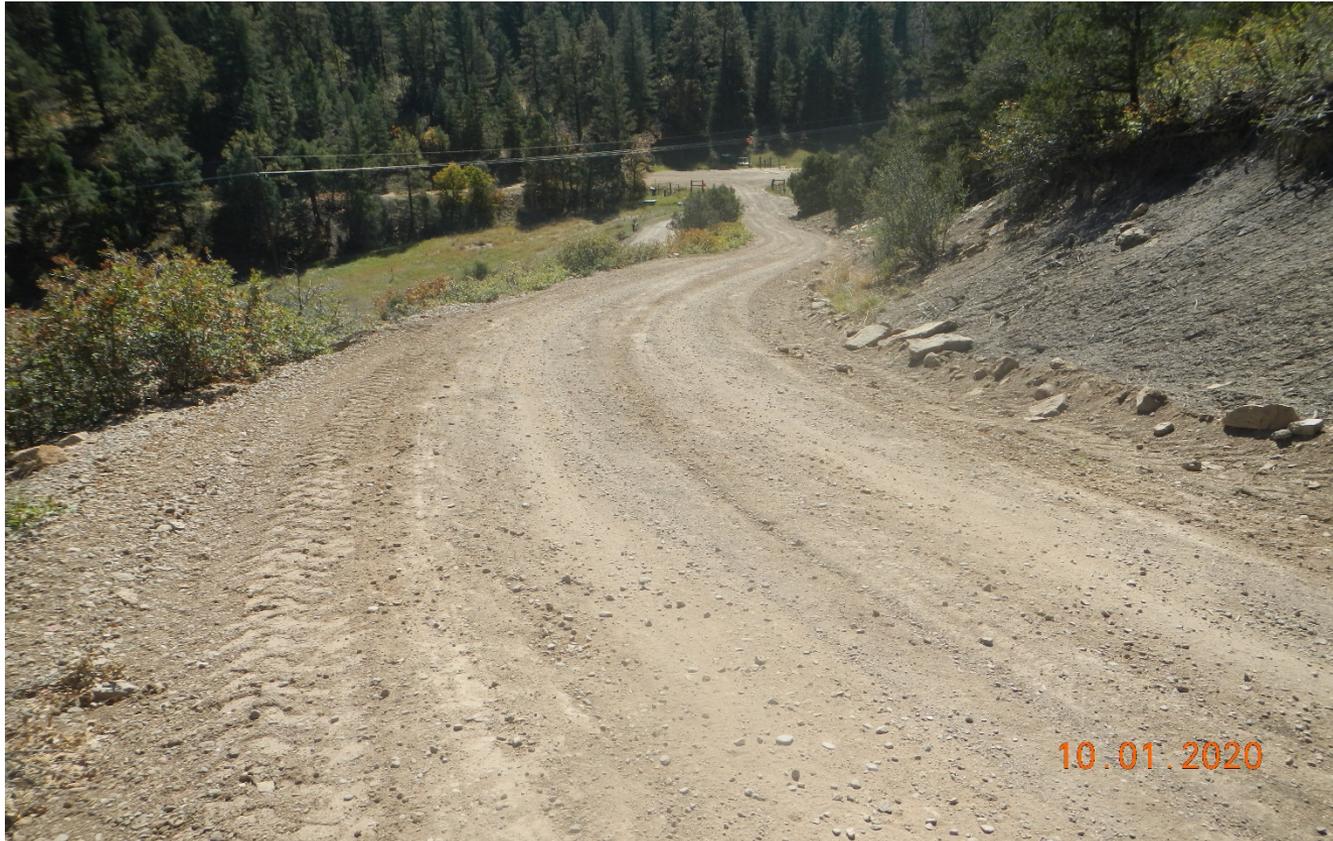
Photo 4. Facing back down the road which has been regraded. This area will need additional BMP's along the road side yo prevent erosion.

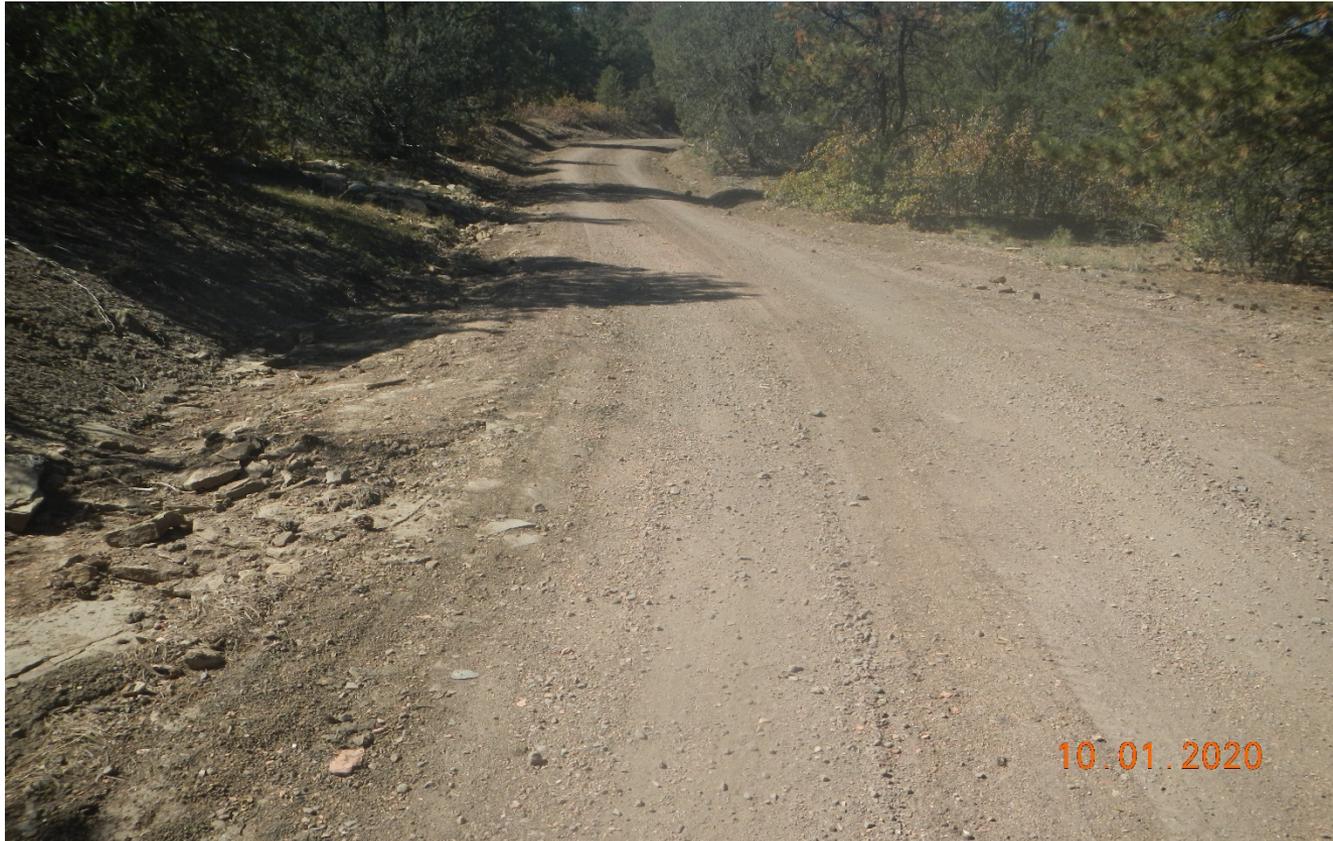
Photo 5. Facing northwest along the access road. The road has been graded and erosion along the road is repaired.

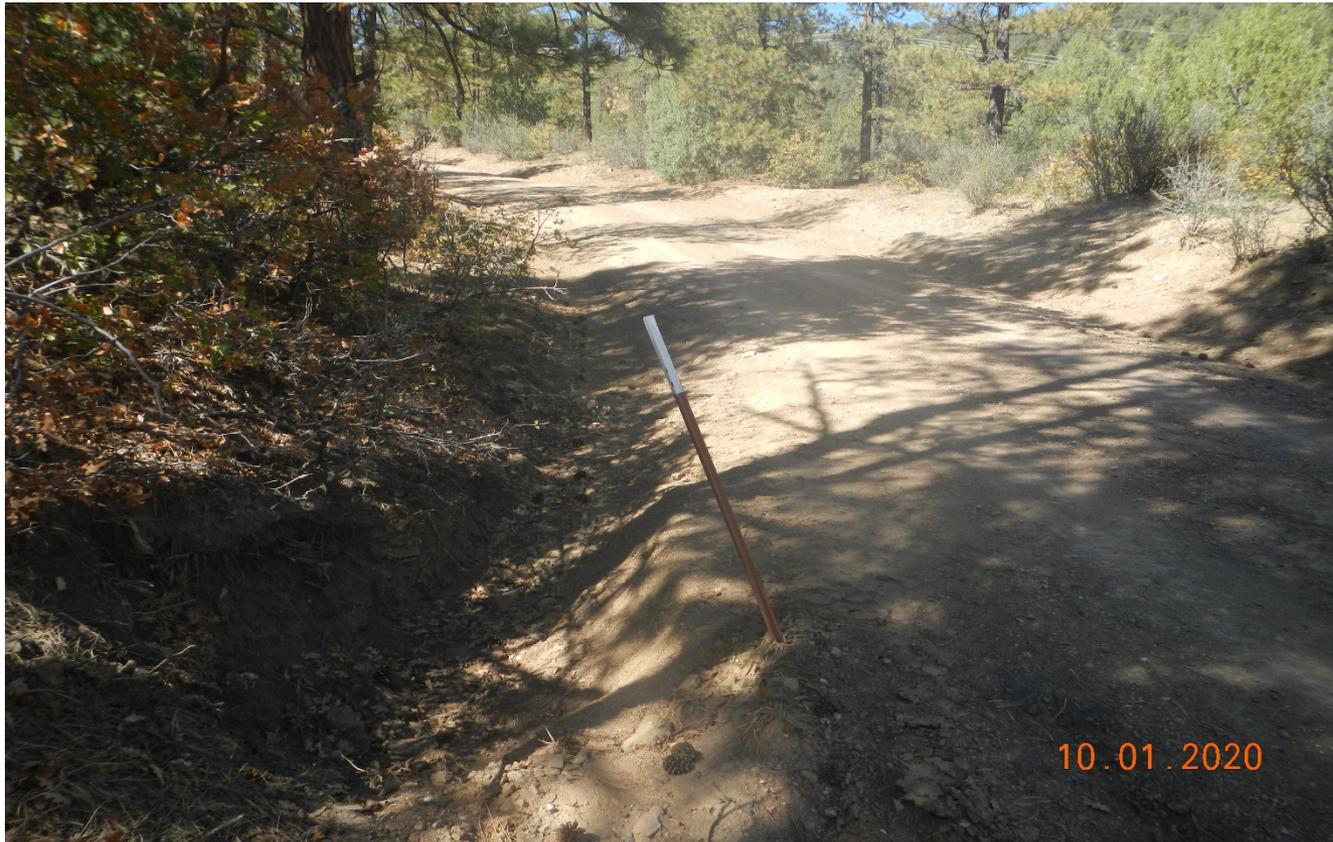
Photo 6. The culvert has been cleaned out and maintained.

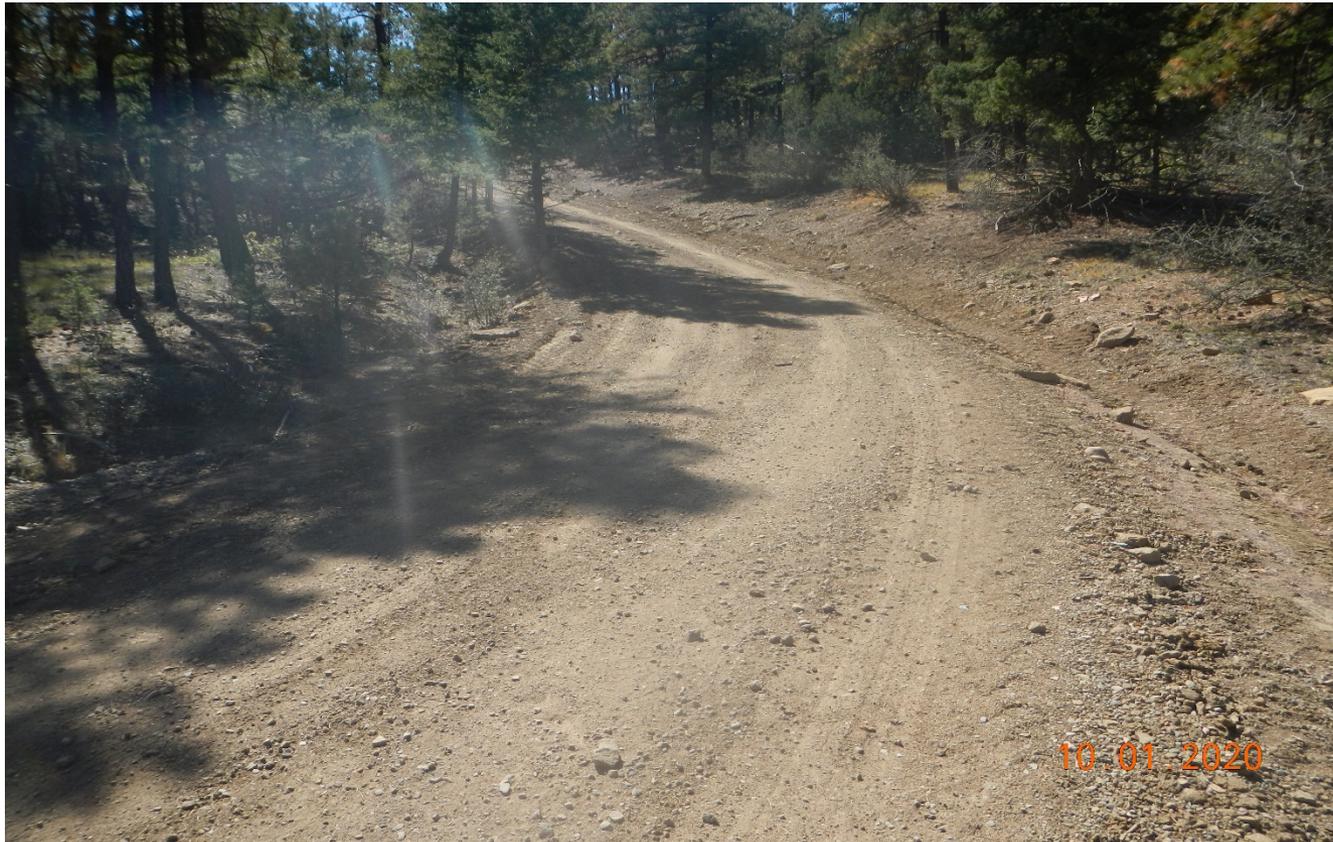
Photo 7. Facing southwest along the access road.

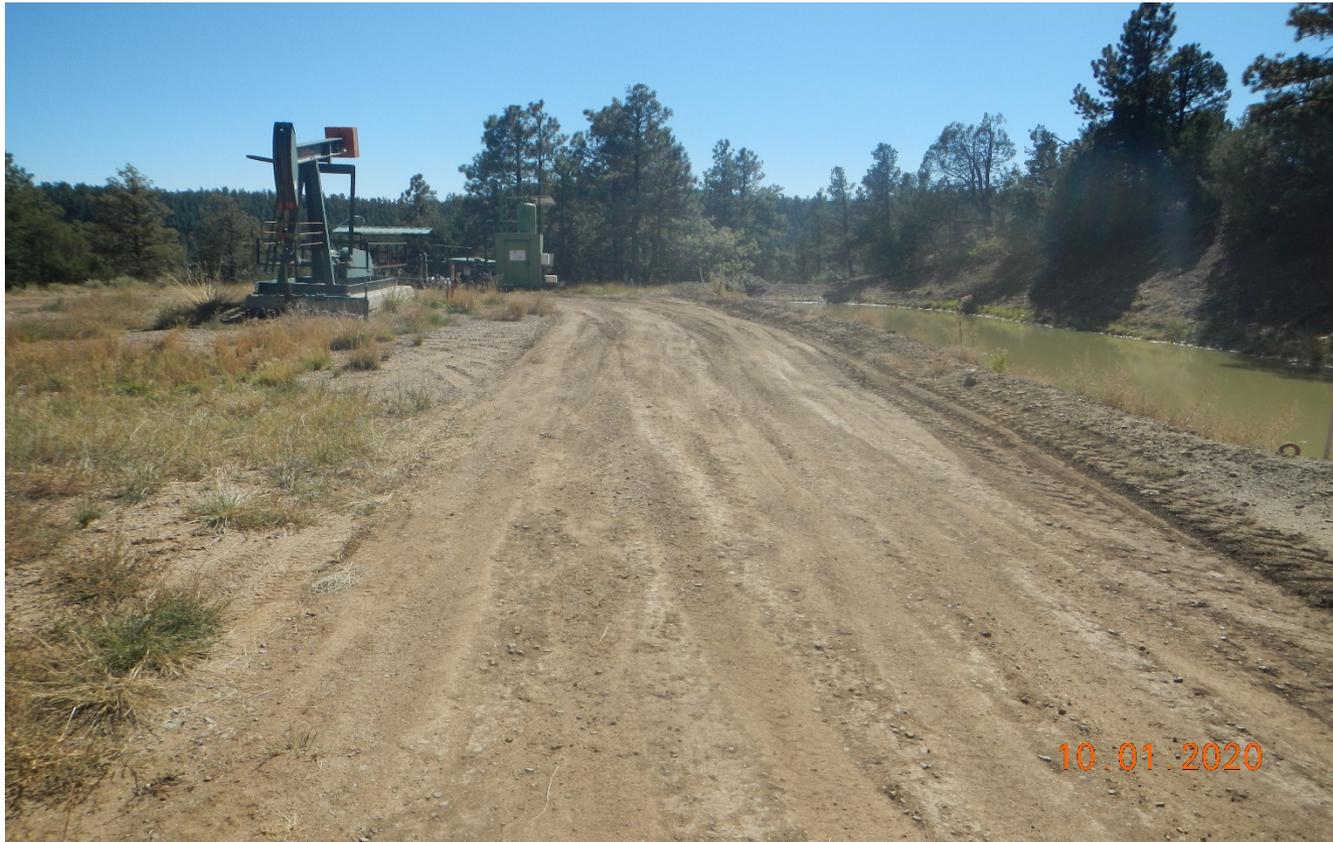
Photo 8. Facing south toward the location.
