Final Reclamation Inspection

Operator: NOBLE ENERGY INC - #100322

Location ID: 322731

Inspection Photos
Location Name: STATE #3-36
Location ID: 322731

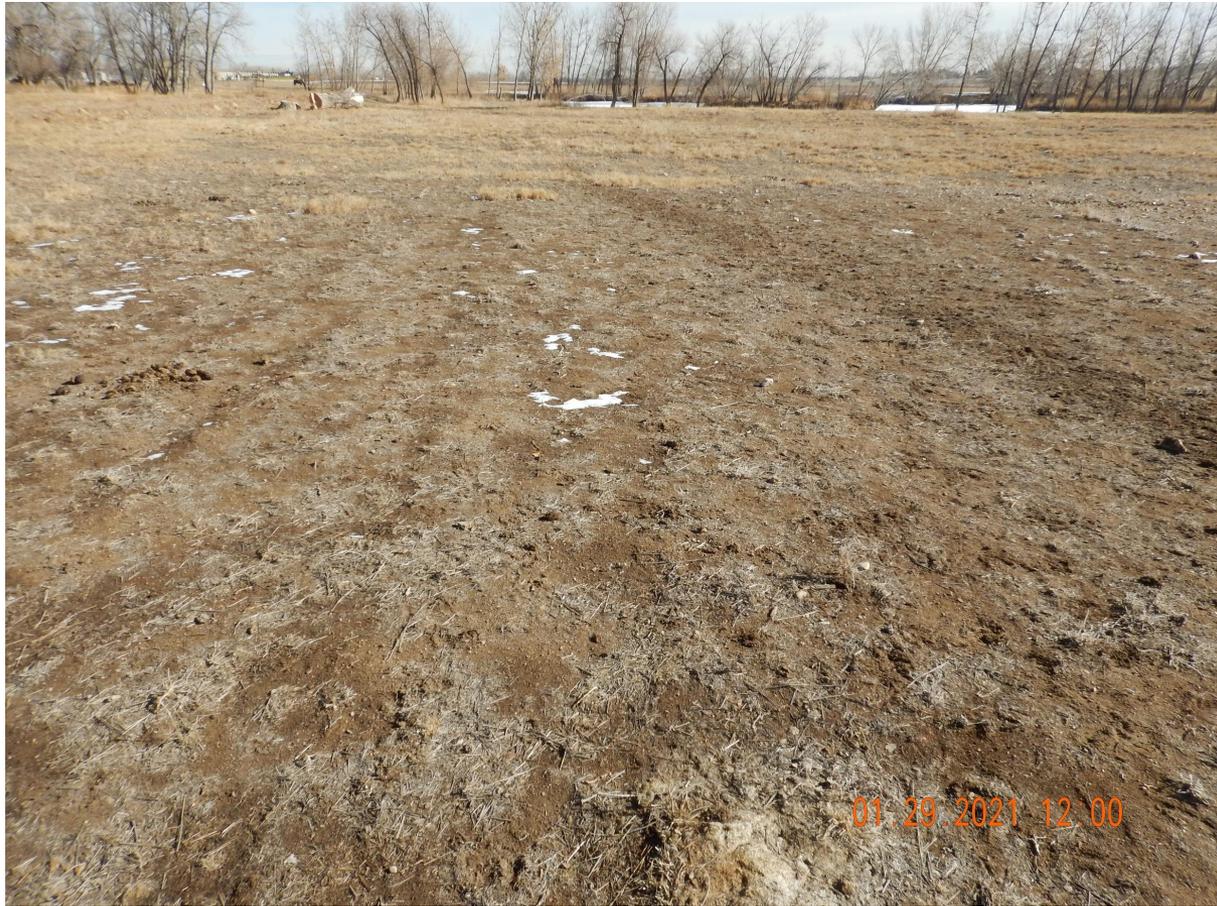
Photo 1. Photo taken from the well location, facing East. Photo illustrates the well location does not meet Rule 1004 vegetative standards and is not reflective of reference area levels.

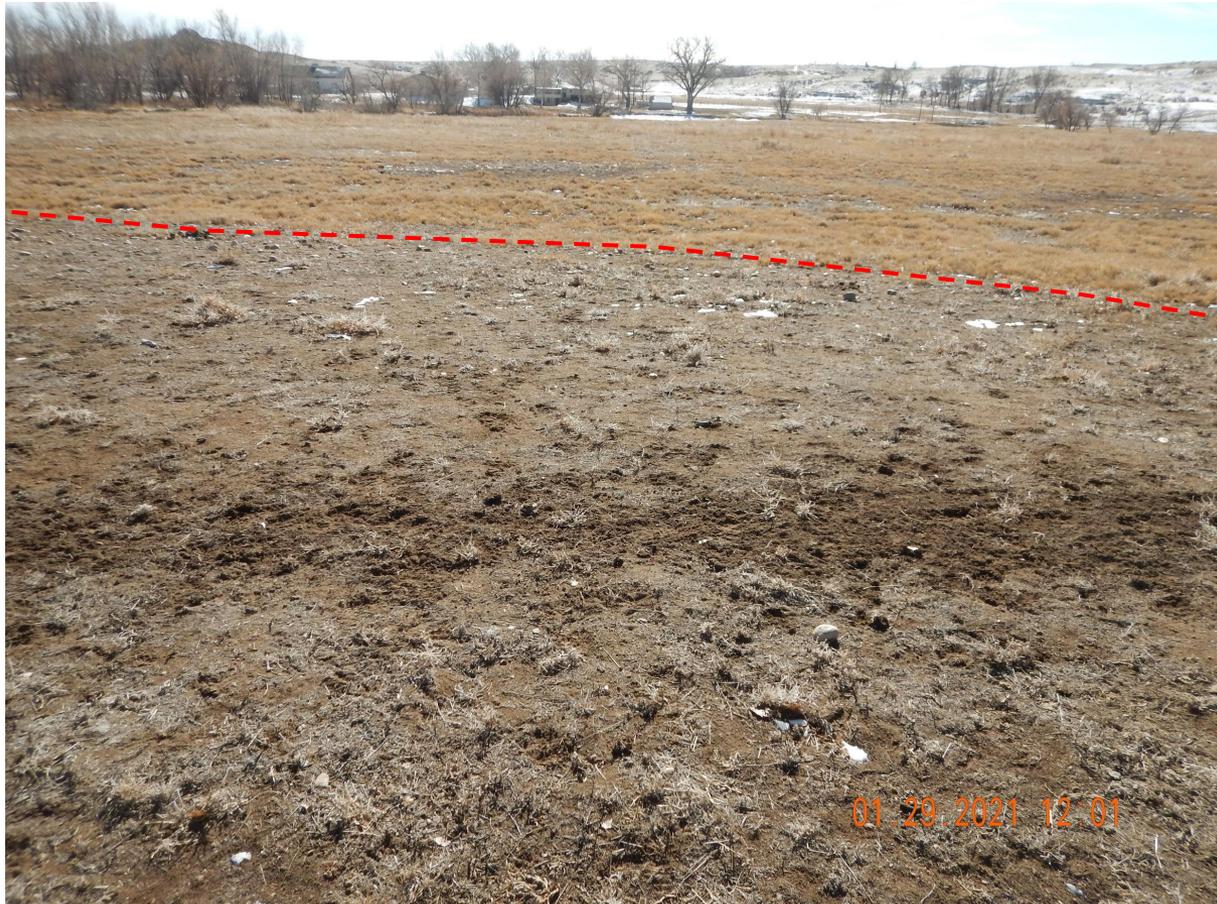
Photo 2. Photo taken from the well location, facing South. See comments under Photo 1. Reference area is above the red-dashed line and well location is below the red-dashed line.

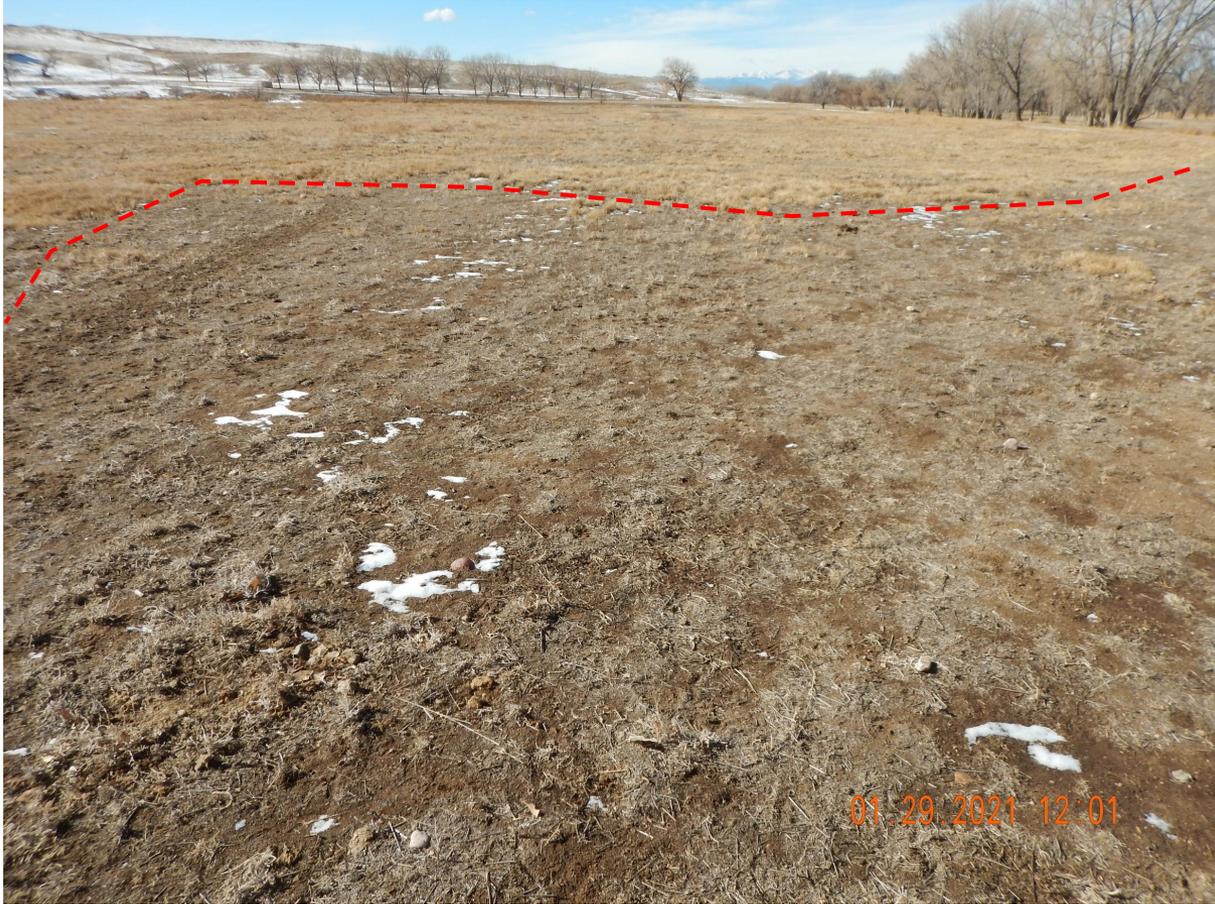
Photo 3. Photo taken from the well location, facing West. See comments under Photo 1. Reference area is above the red-dashed line and well location is below the red-dashed line.

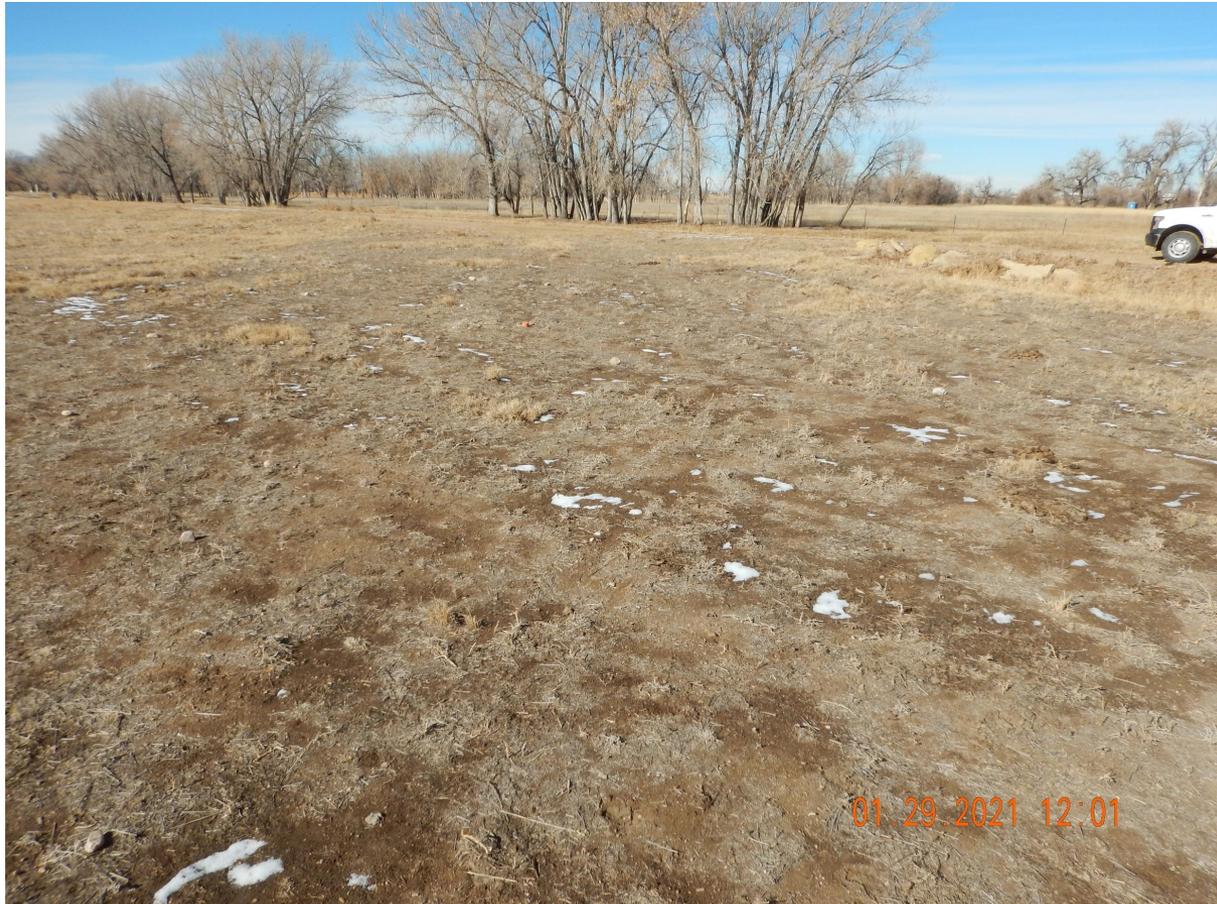
Photo 4. Photo taken from the well location, facing Northwest. See comments under Photo 1.
