Final Reclamation Inspection

Operator: FOUNDATION ENERGY MANAGEMENT LLC- #10112

Location ID: 330480

Inspection Photos
Location Name: SOONER UNIT #28-6-1
Location ID: 330480

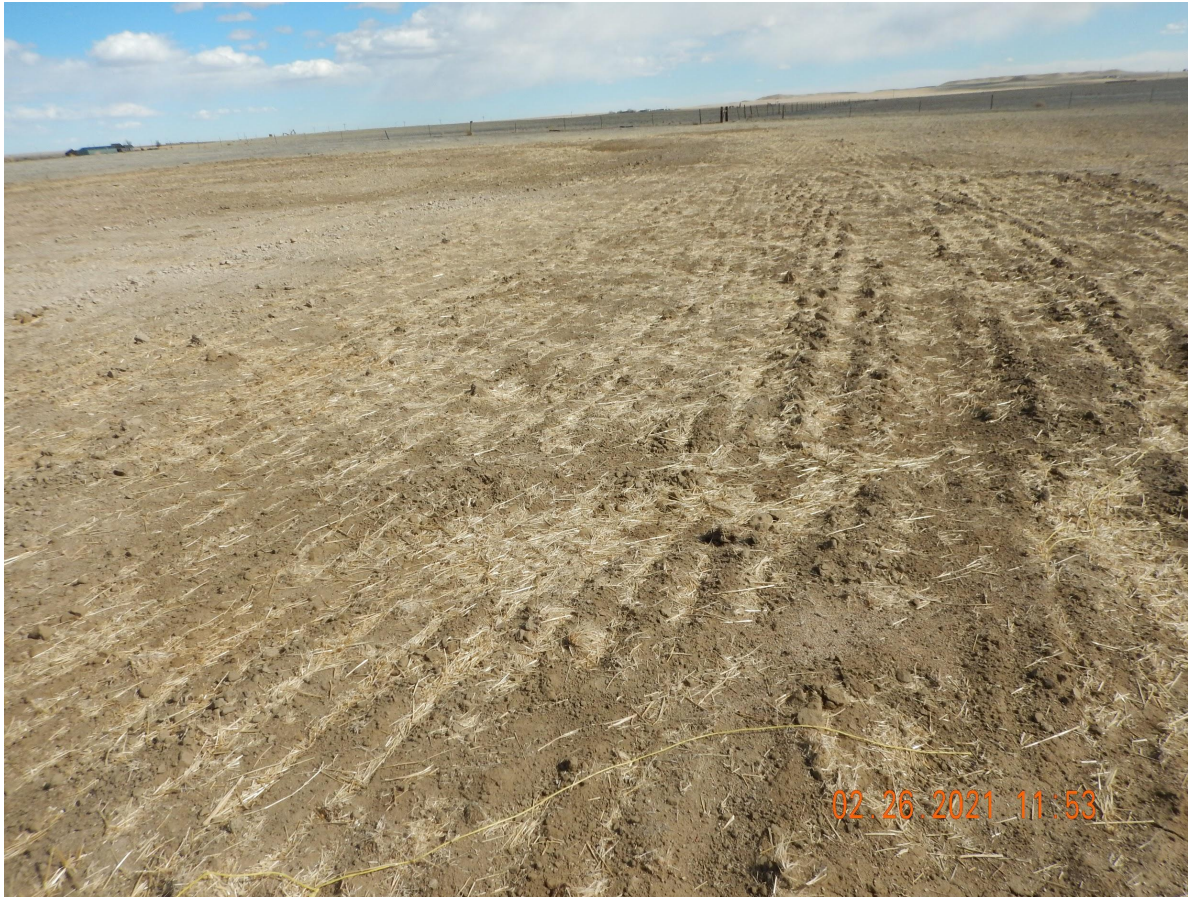
Photo 1. Photo taken from the well location, facing East. Photo illustrates the Operator has performed final reclamation activities.

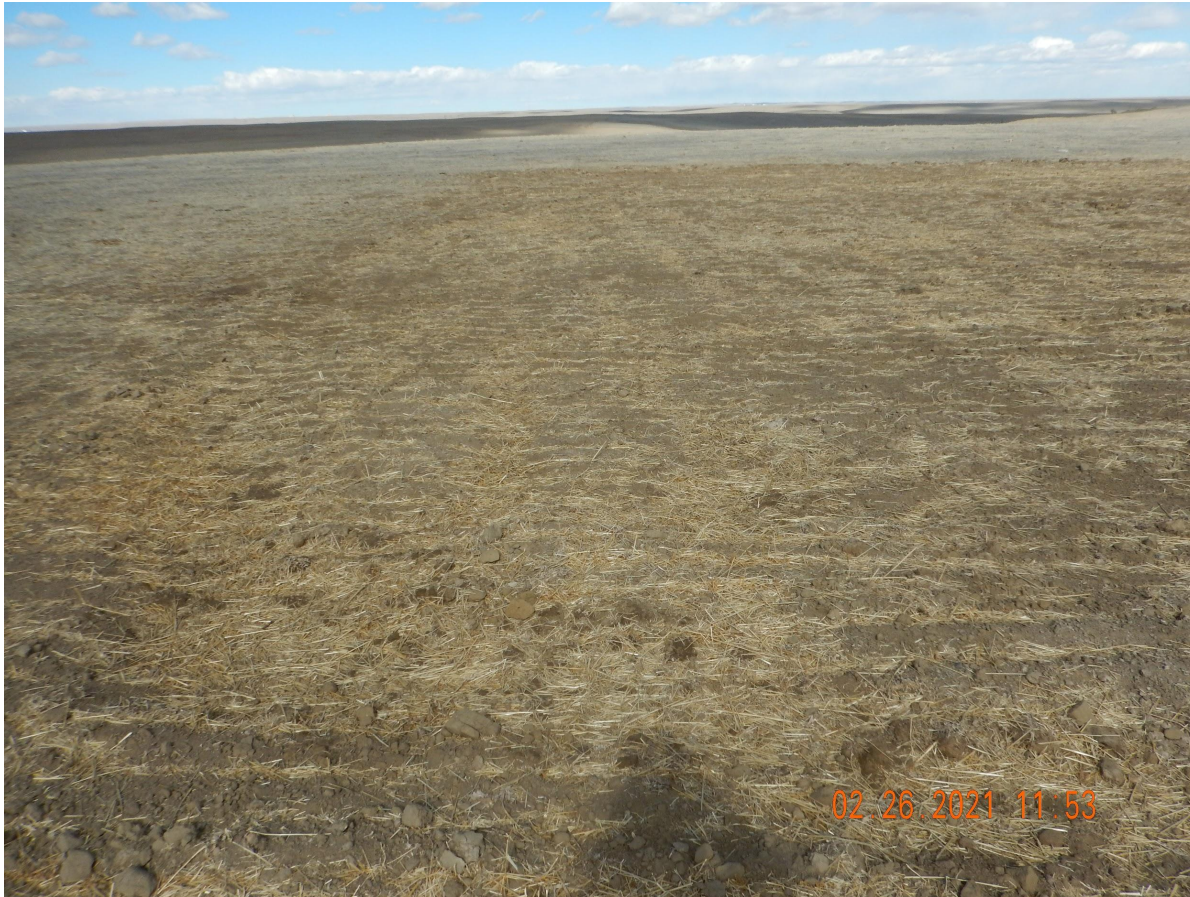
Photo 2. Photo taken from the well location, facing North. See comments under Photo 1.

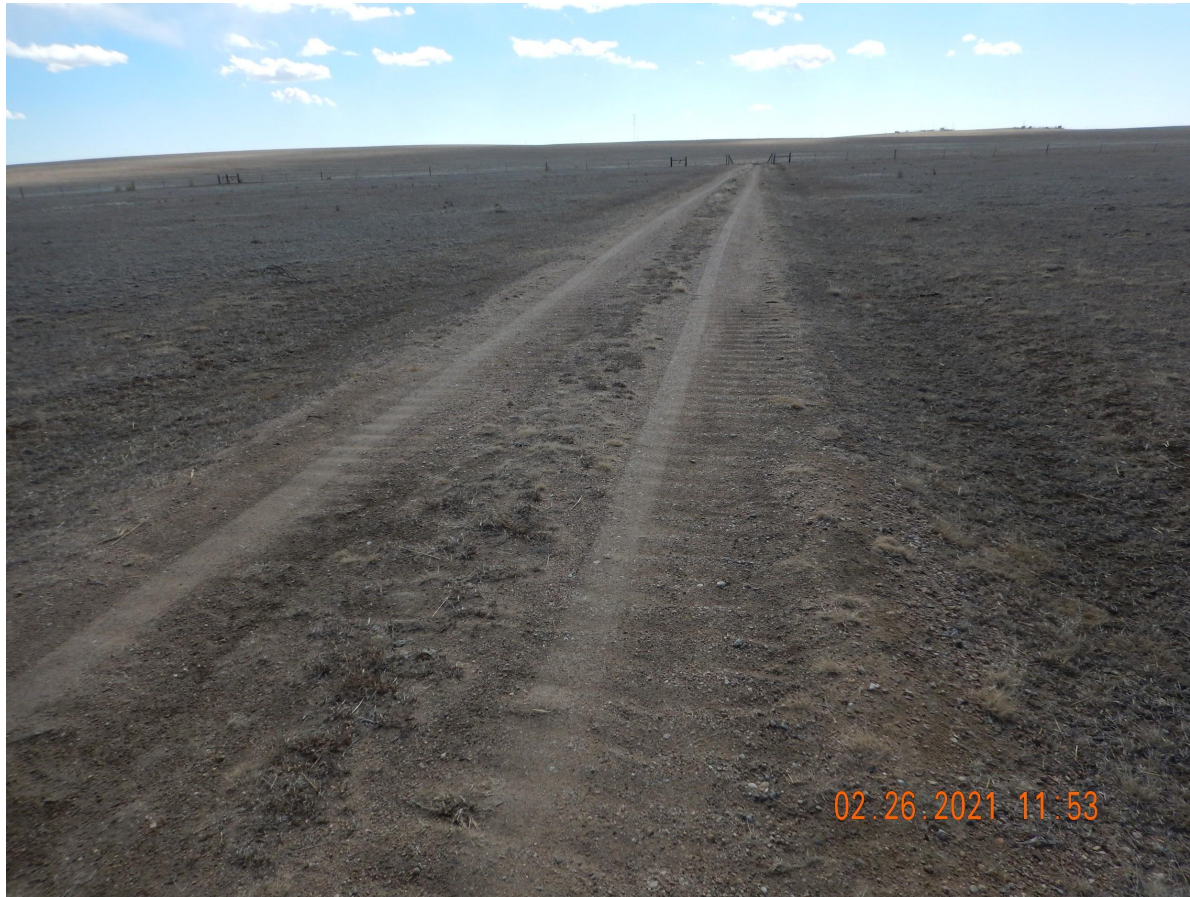
Photo 3. Photo taken from the well location, facing South. Photo illustrates Operator has failed to reclaim the access road.

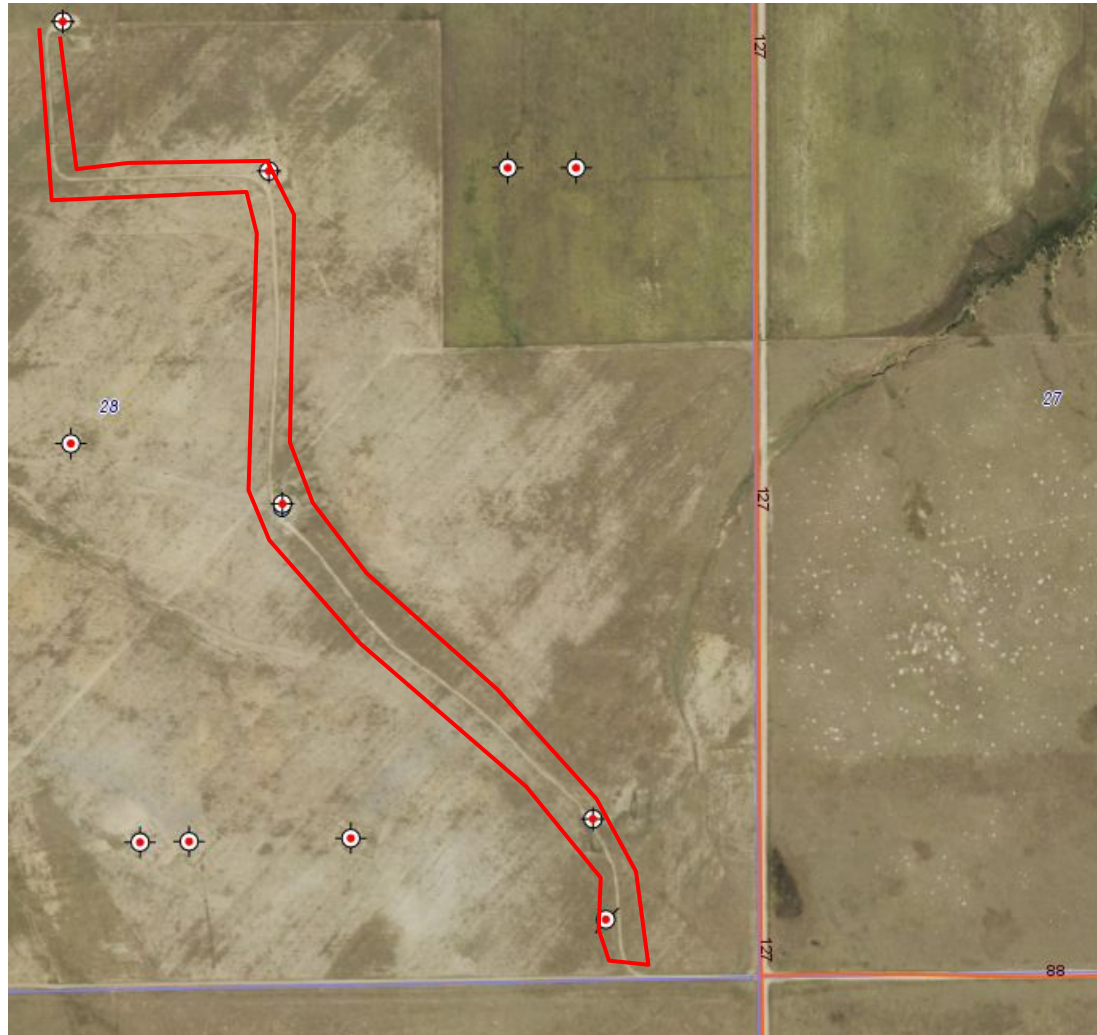
Photo 4. 2019 aerial imagery illustrates the access road that has not been reclaimed.
