Final Reclamation Inspection

Operator: FOUNDATION ENERGY MANAGEMENT LLC- #10112

Location ID: 447526

Inspection Photos
Location Name: SE SEC 21 TB
Location ID: 447526

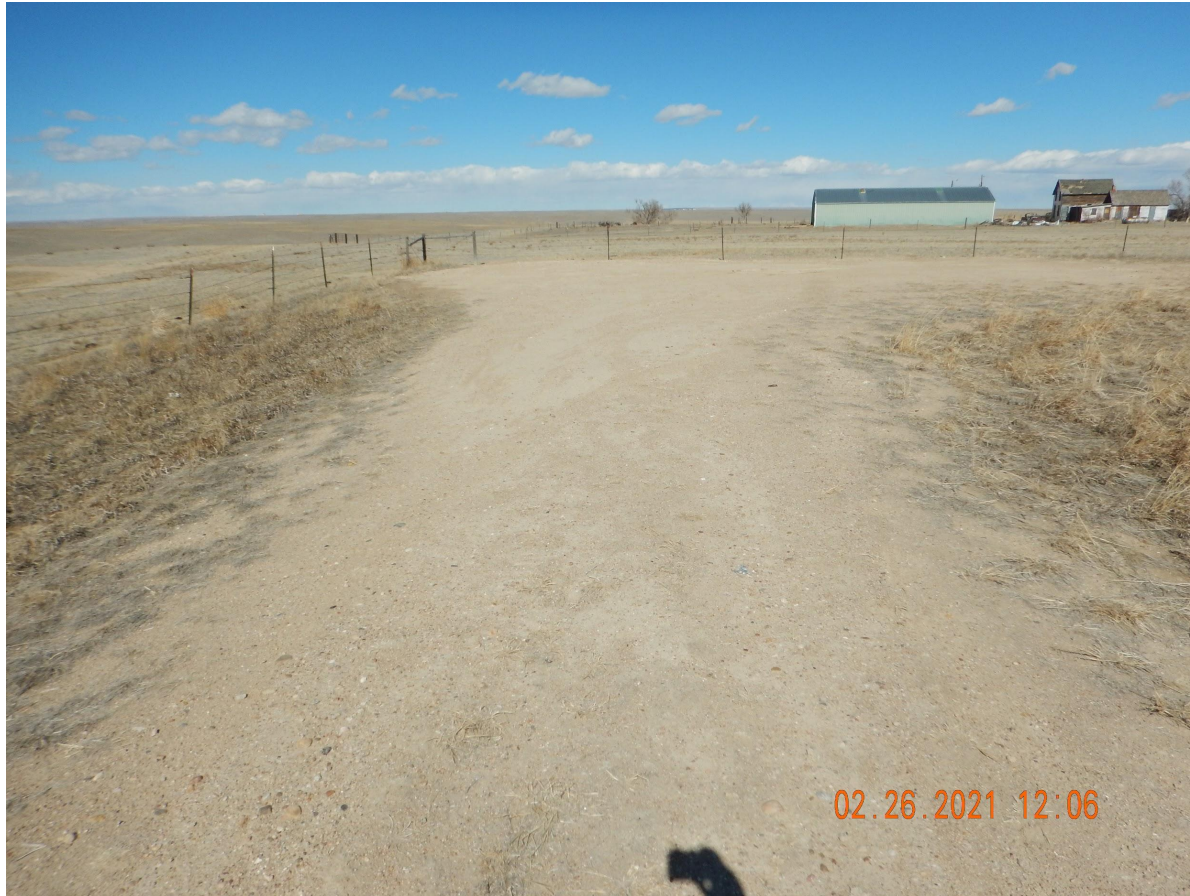
Photo 1. Photo taken from the southern tank battery location, facing North. Photo illustrates Operator has removed equipment from the northwestern corner but has failed to perform final reclamation activities.

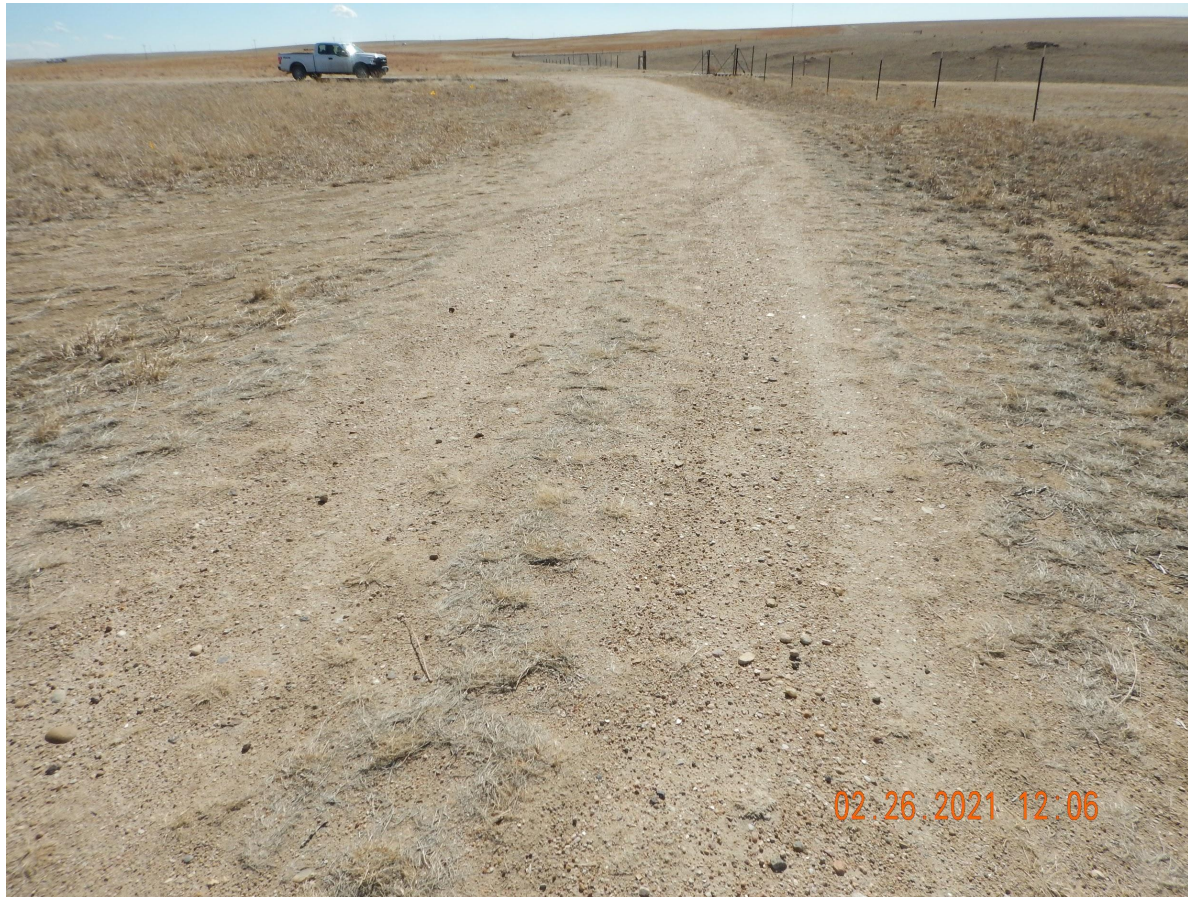
Photo 2. Photo taken from the southern tank battery location, facing South. See comments under Photo 1.

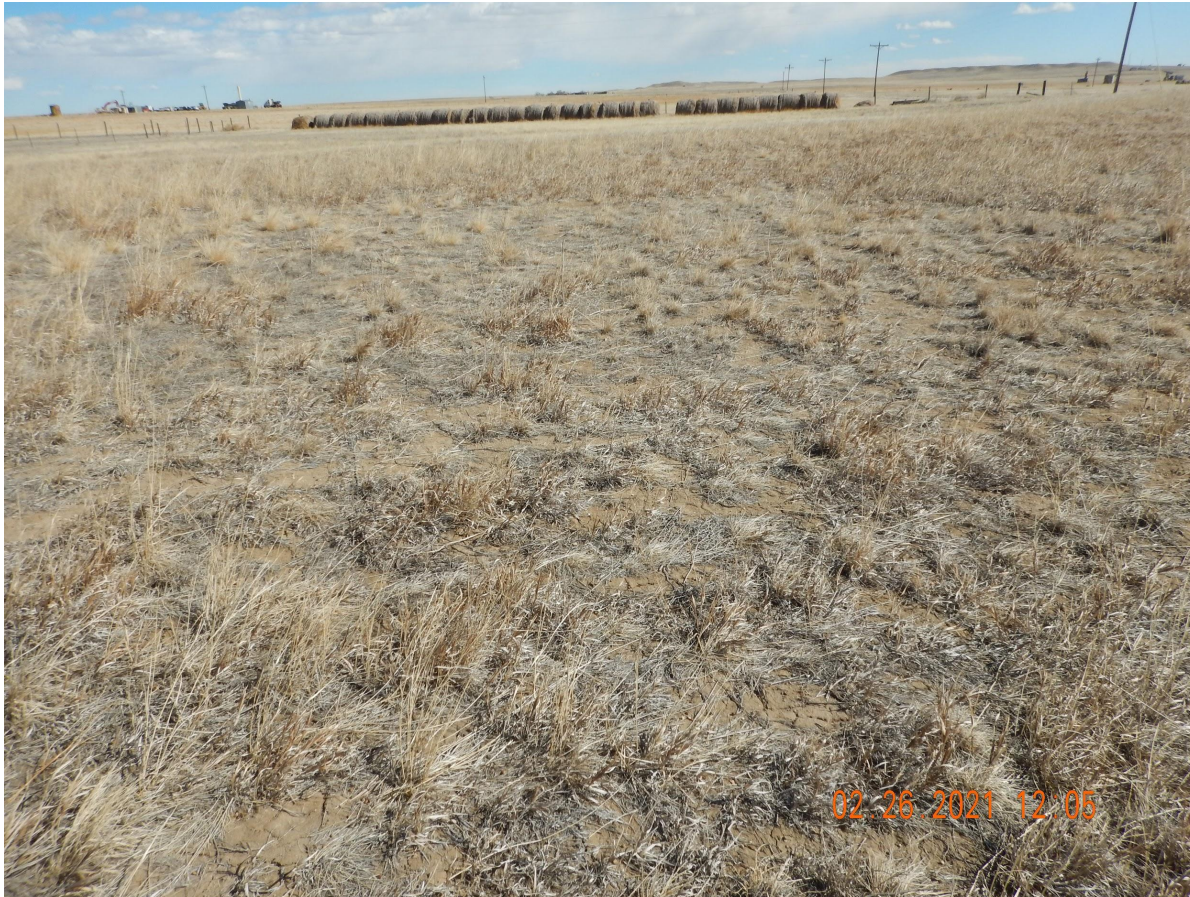
Photo 3. Photo taken from the central tank battery location, facing East. Photo illustrates the majority of the location has achieved Rule 1004 vegetative standards.
