Inspection Photos

API: 009-06627

Operator: INVESTMENT EQUIPMENT LLC

Inspection Date: 3/3/2021

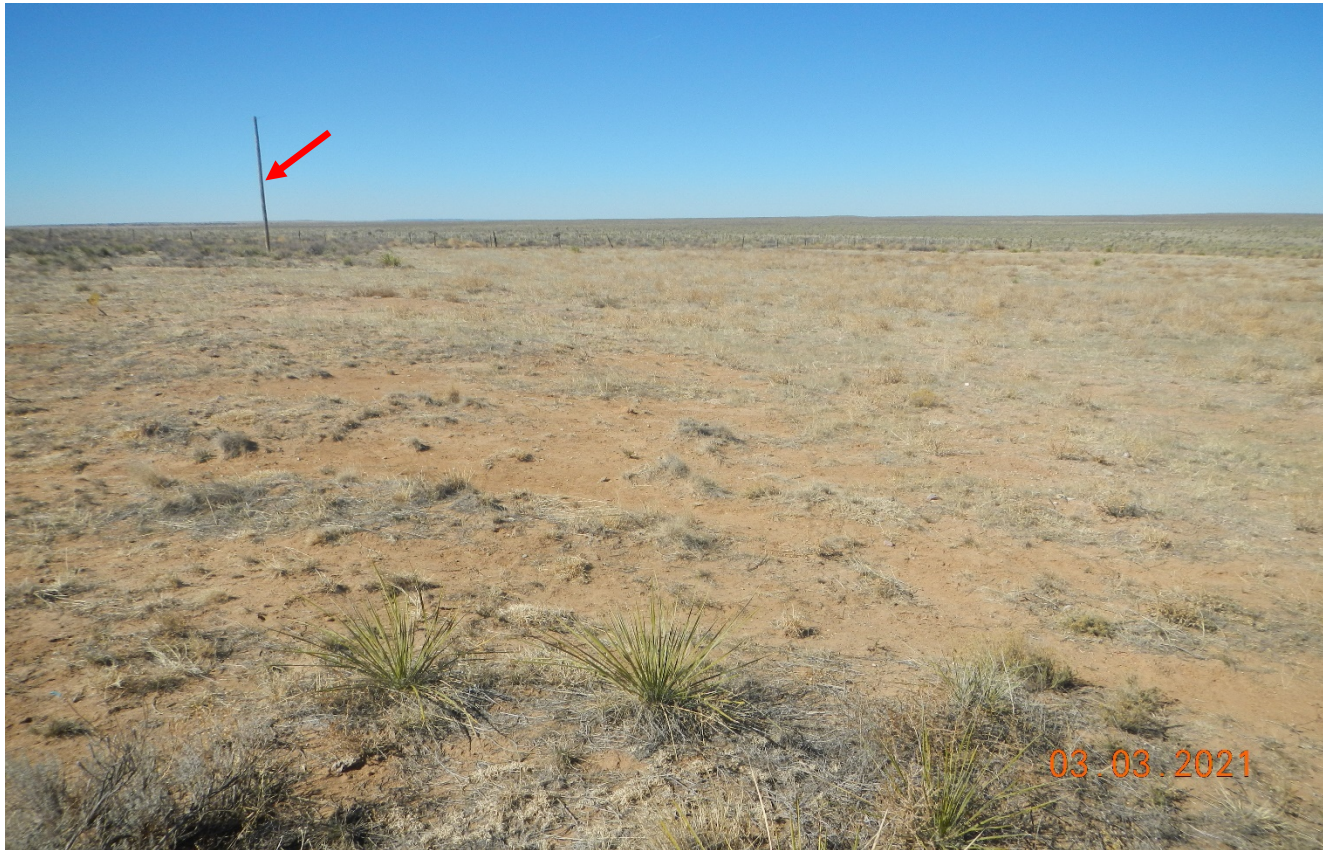
Photo 1. Facing northwest toward the location. toward the location. A power pole remains at the southwest side of the location shown at red arrow. This needs to be removed.

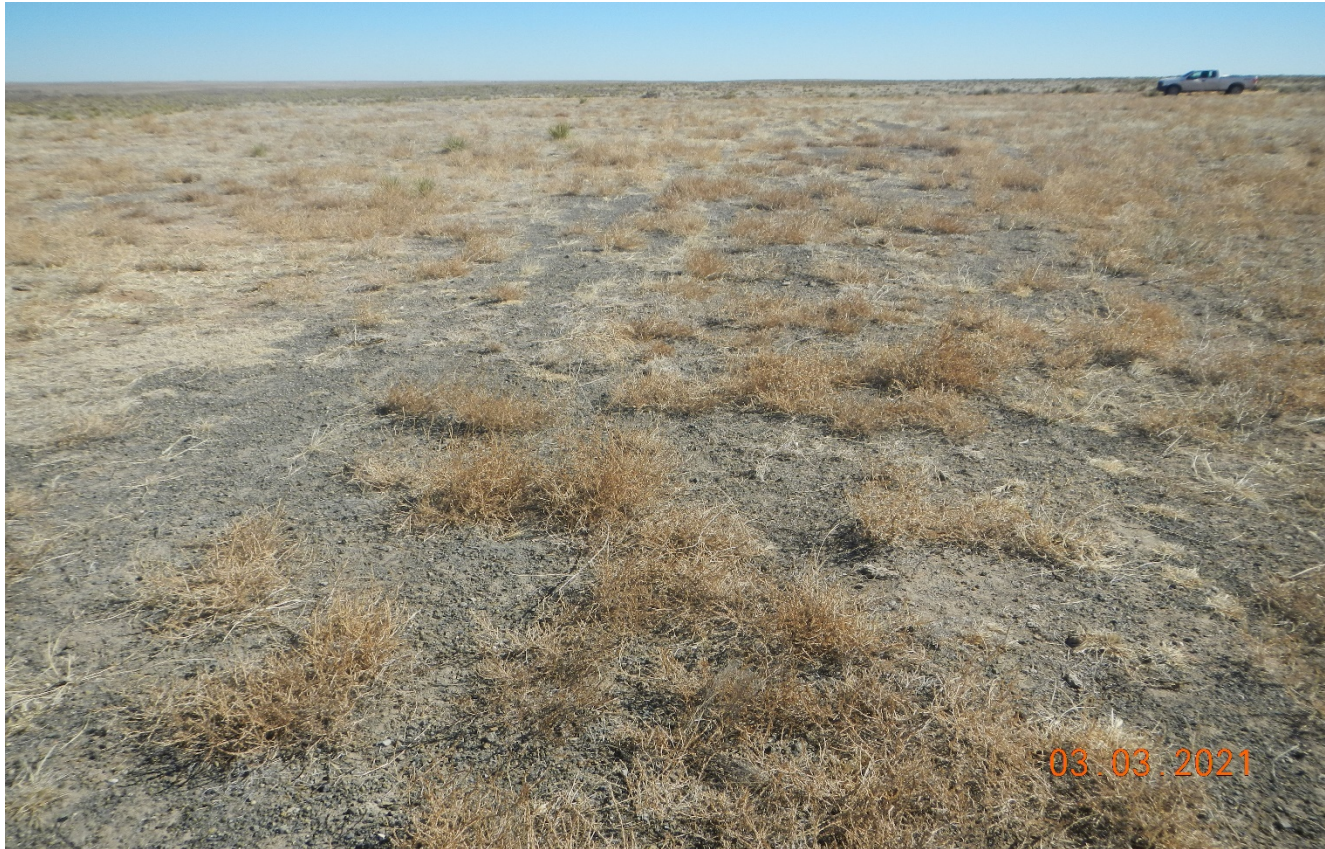
Photo 2. Facing east at the location. Vegetation has not re-established at the location. Soils appear to be compacted. There is a gravelly area that remains through the center of the location.

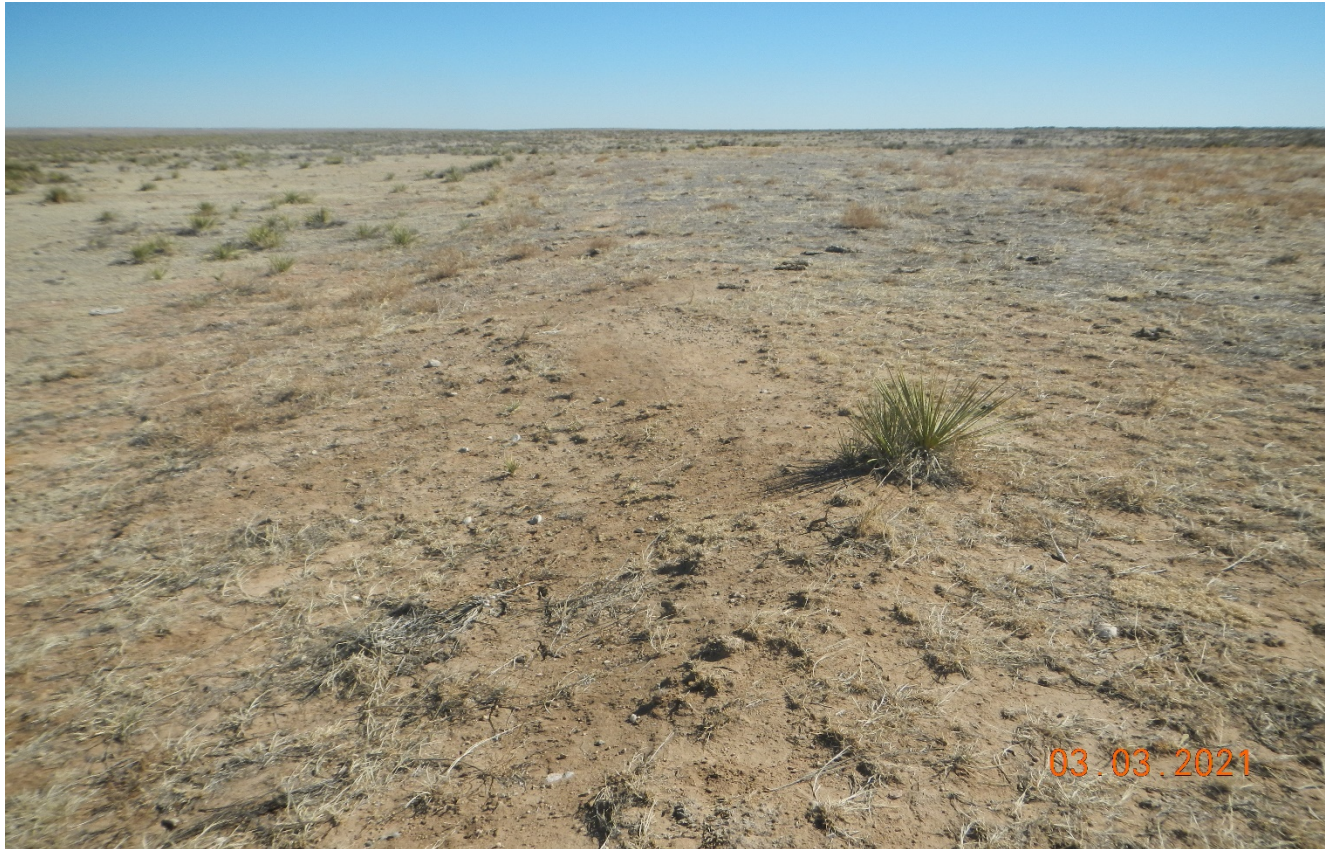
Photo 3. Facing east at the north side of the location. The area along the fill slope is compacted and should be leveled to match the contours of the terrain.

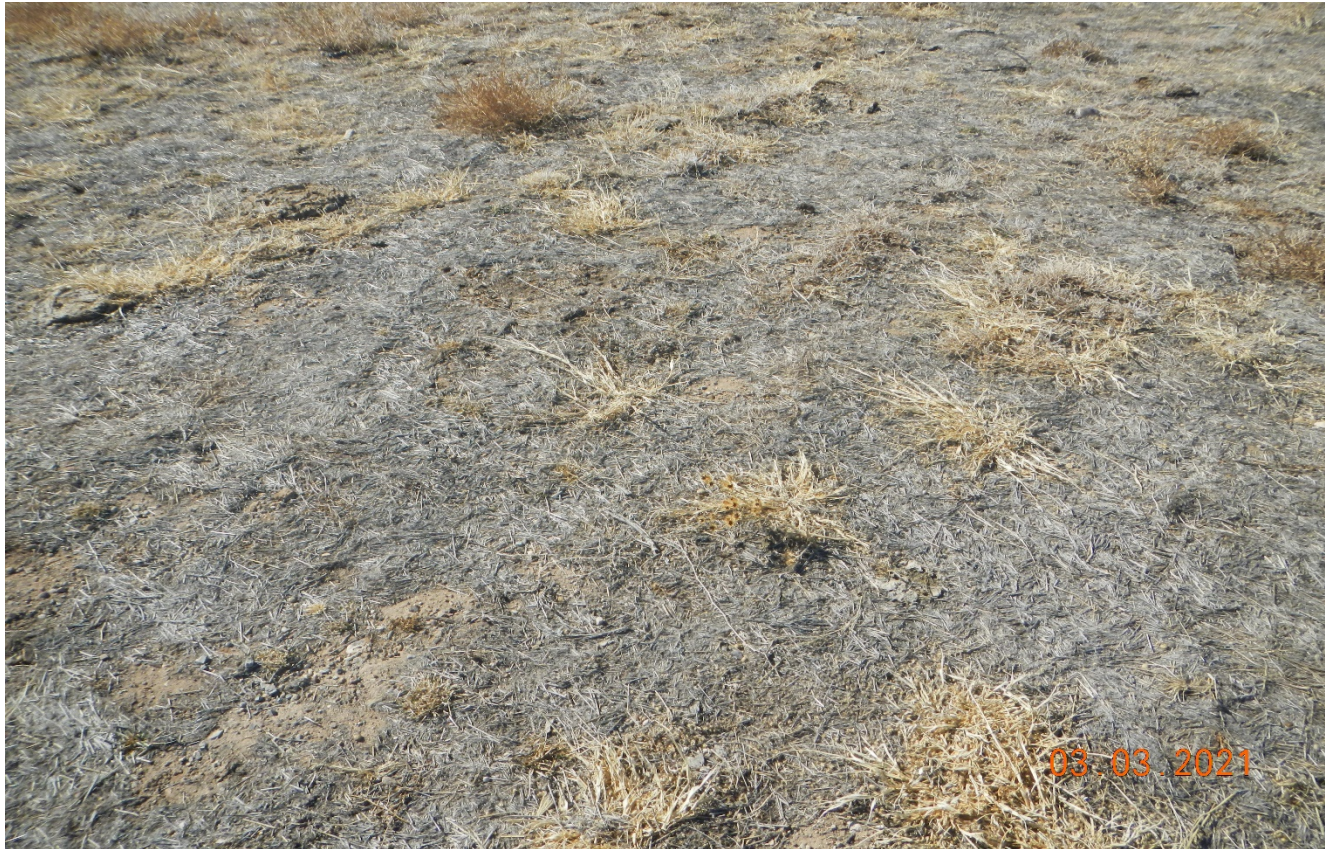
Photo 4. It appears mulch was applied to the soils. There is some Sandbur growing where mulch was applied but vegetation does not appear to be establishing due to compaction.

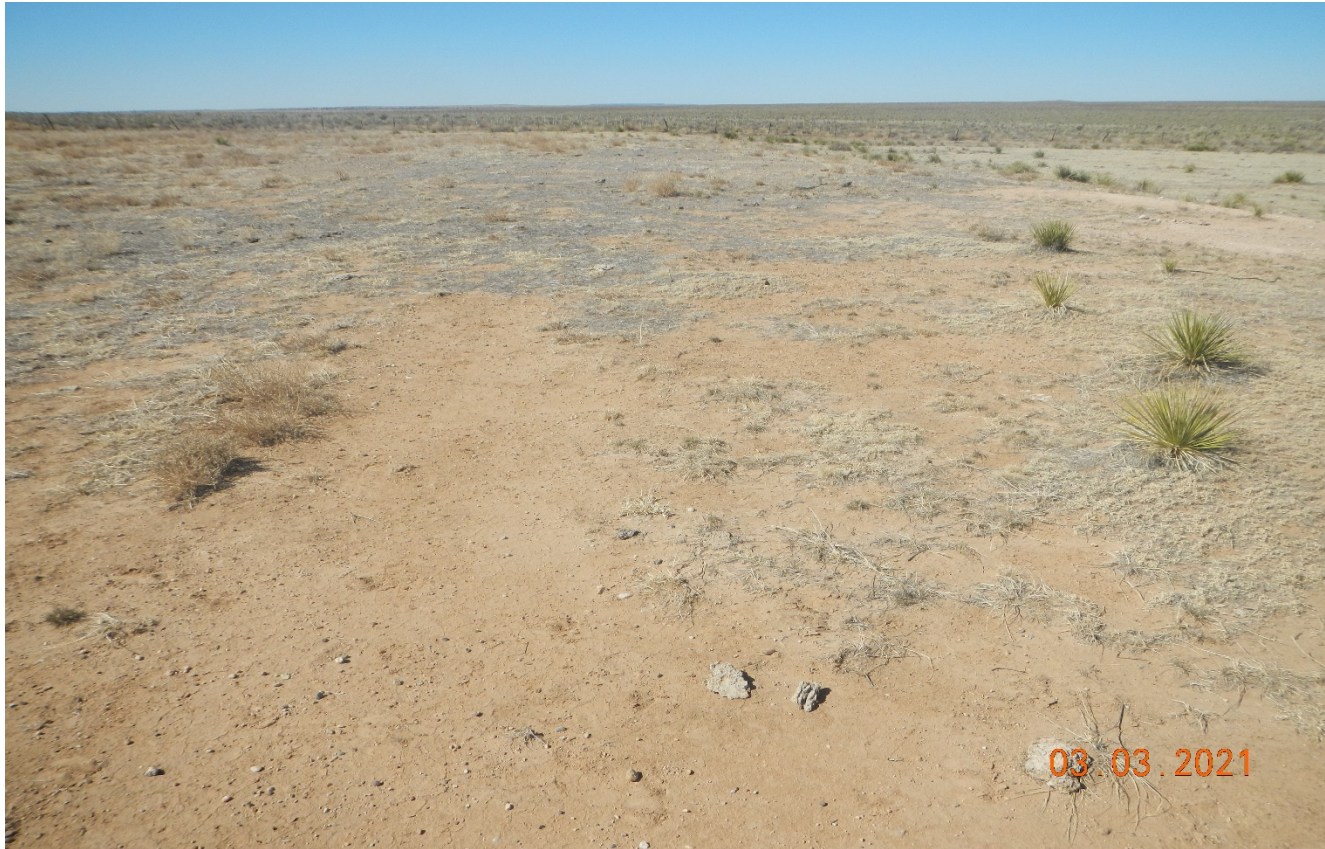
Photo 5. Facing west at the northeast side of the location. The fill slope has not been recontoured. The area along the fill slope is compacted and should be leveled to match the contours of the terrain.

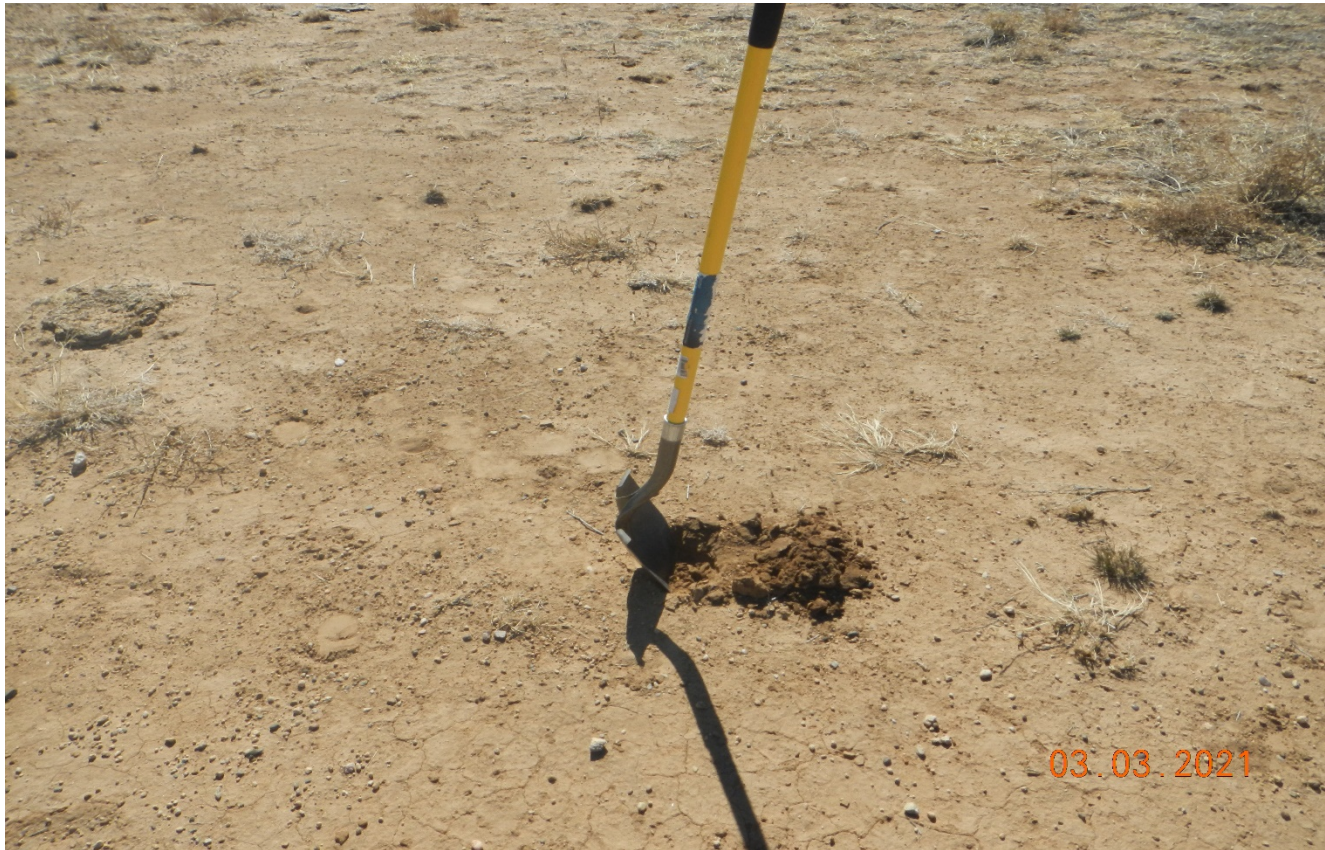
Photo 6. Soils are compacted at the location. Soils need to be decompacted by cross ripping to a depth of 18 inches. Compacted soil are preventing vegetation establishment. The shovel could not penetrate past 2-3 inches.
