APACHE CANYON 11-04 API# 05-071-06127 – TIMBER CREEK OPERATING
OGCC OPERATOR NUMBER 10672 - DATE: APRIL 14, 2021
CORRECTIVE ACTIONS COMPLETED REGARDING COGCC FIR DOCUMENT # 695103370

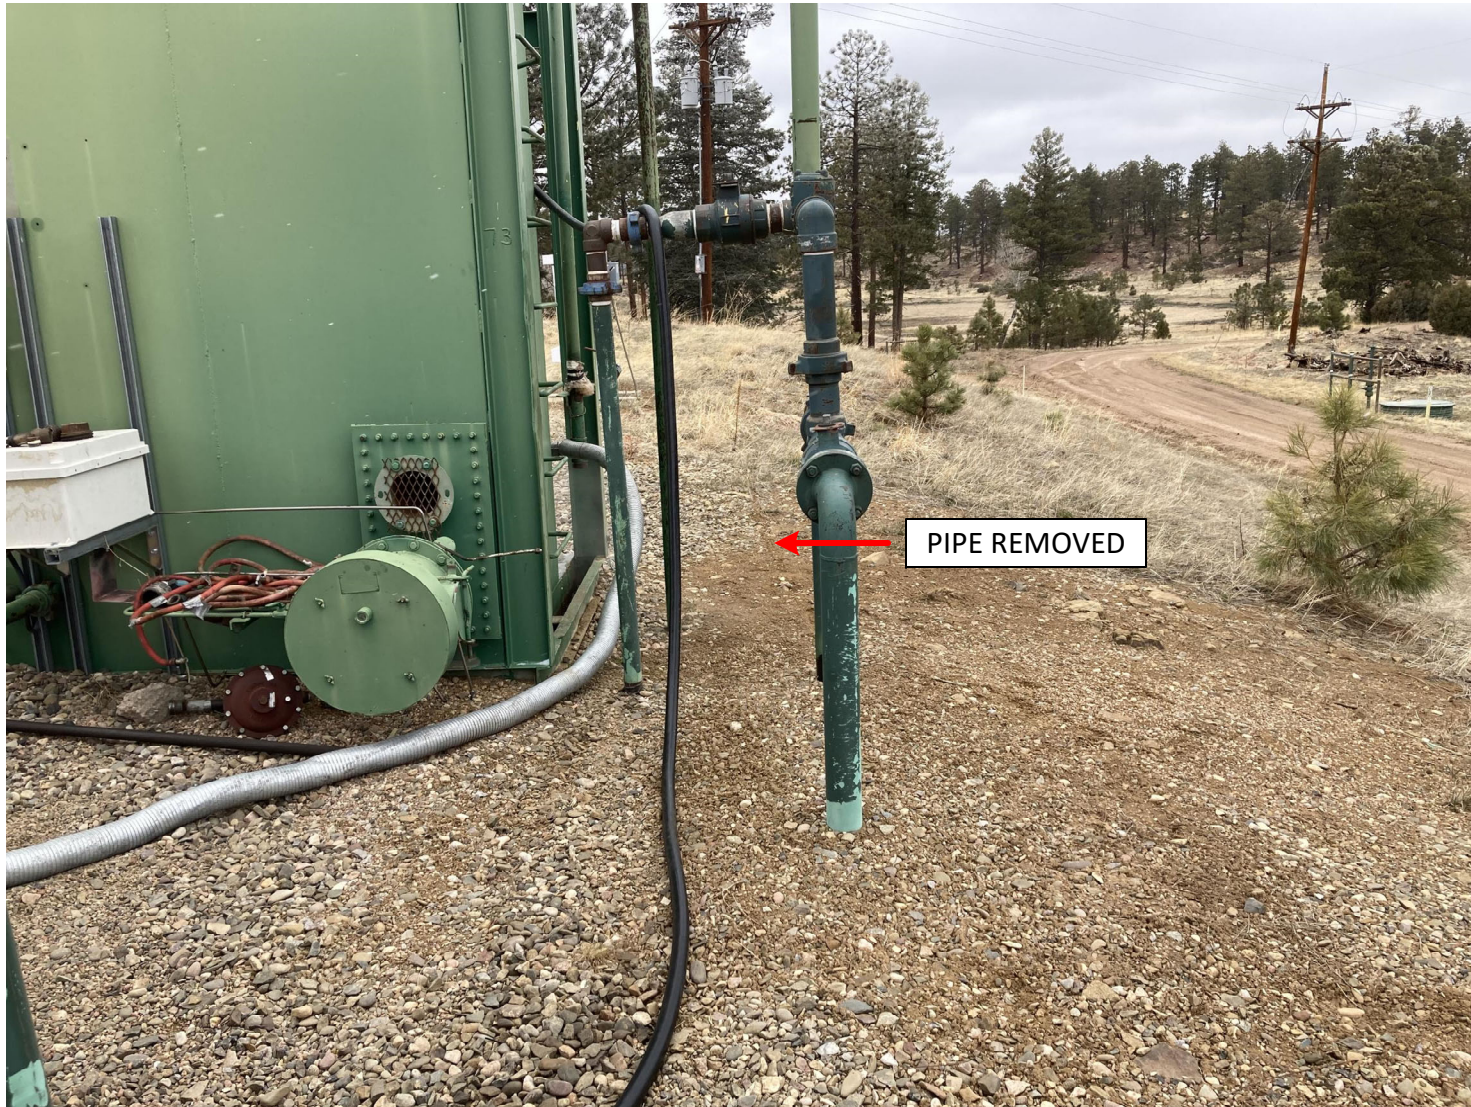
PHOTO 1: THE UNUSED EQUIPMENT WAS REMOVED FROM LOCATION.

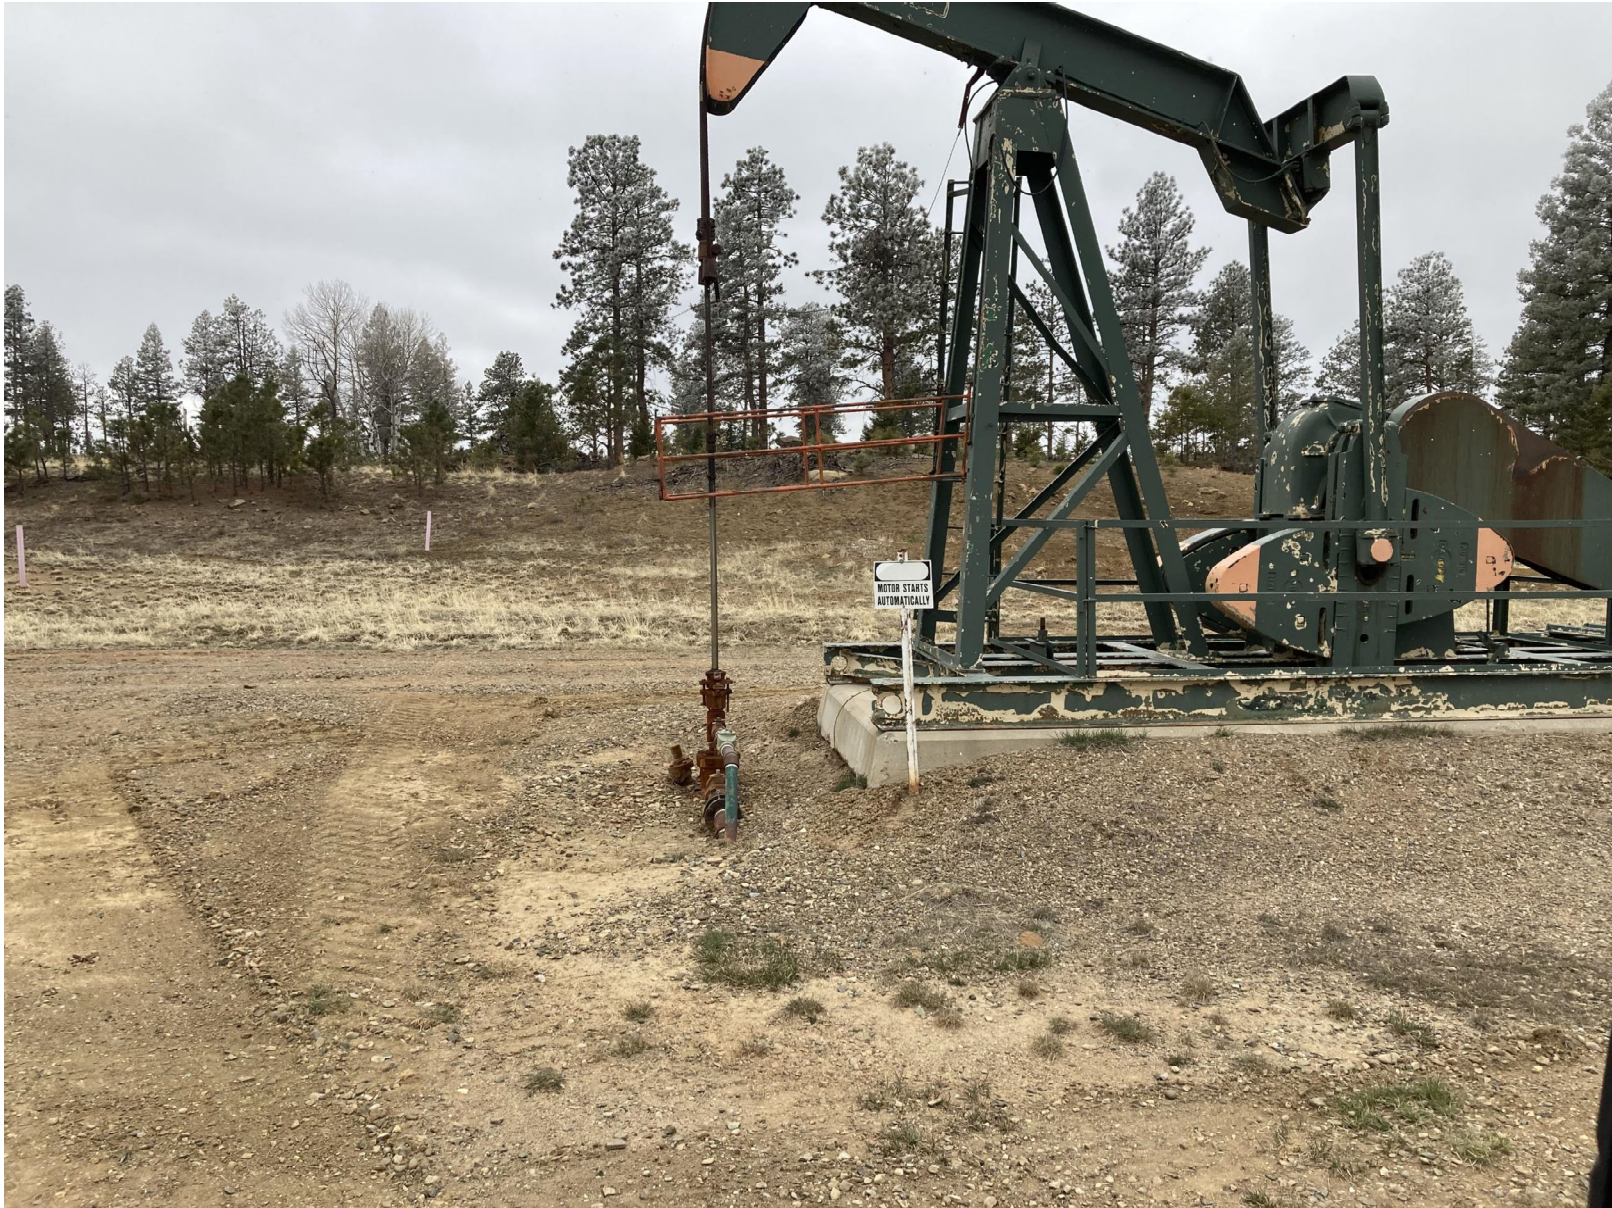
PHOTO 2: THE WELLHEAD PACKINGS WERE REPLACED AND THE STUFF BOX WAS SECURELY FASTENED TO STOP THE WATER LEAK. THE GROUND IS DRY AND NO IMPACTS WERE DISCOVERED.

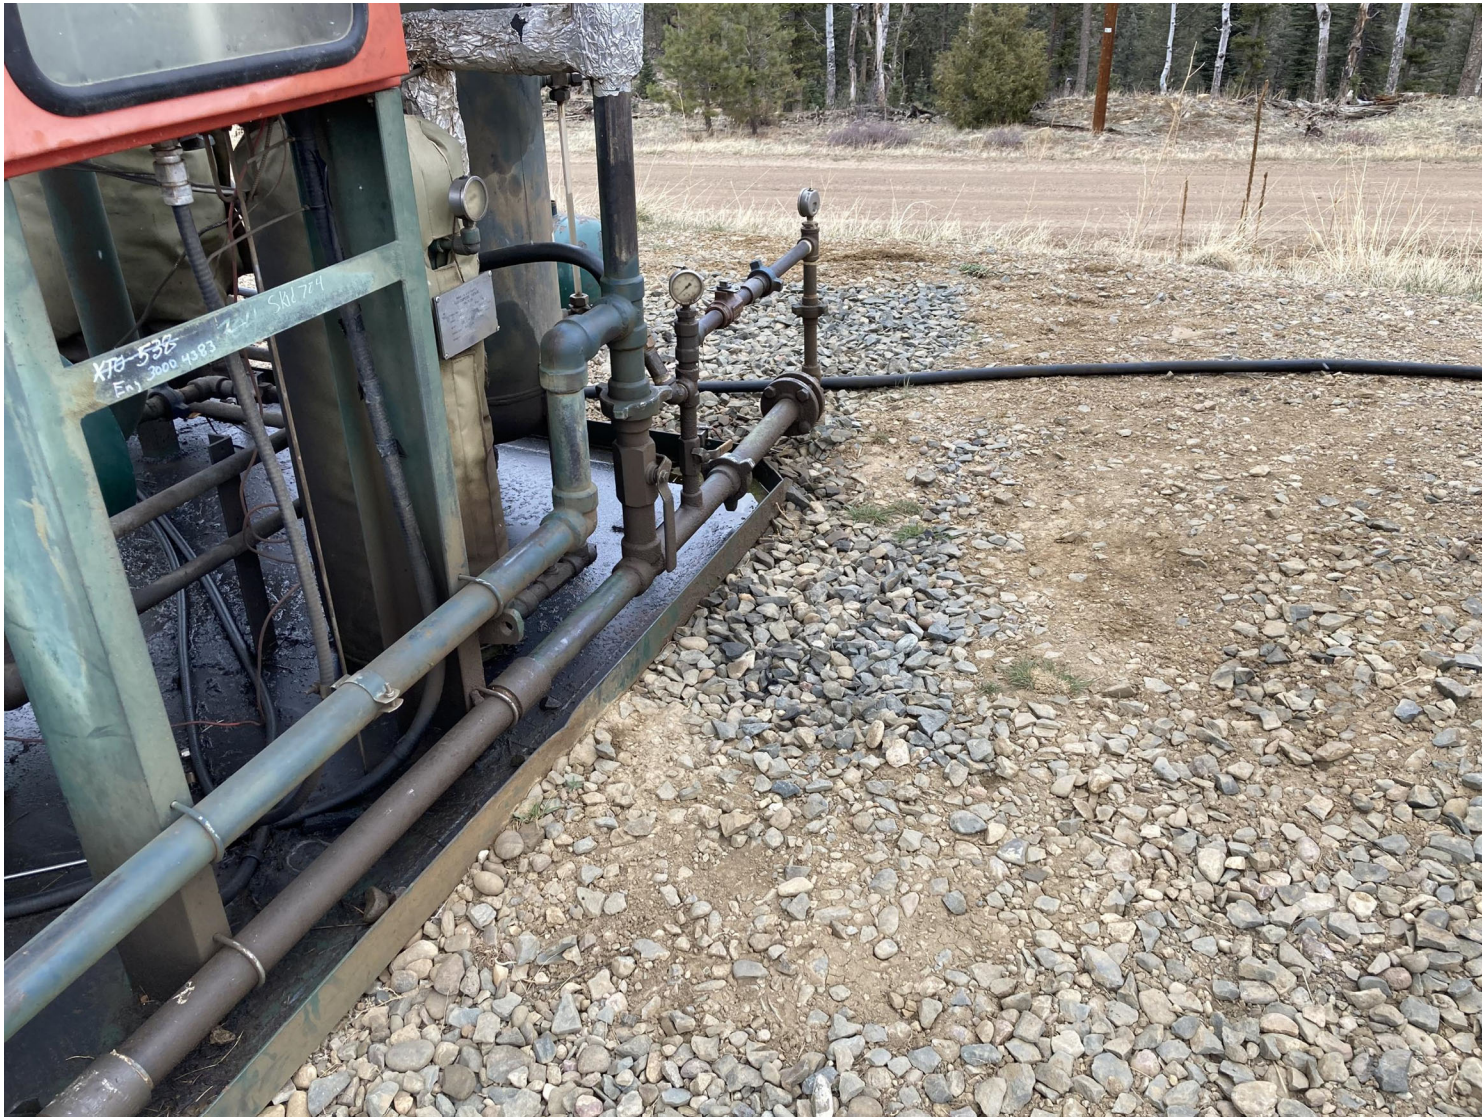
PHOTO 3: THE FLUID ACCUMULATION WAS REMOVED FROM THE CONTAINMENT OF THE LIQUID RING COMPRESSOR.

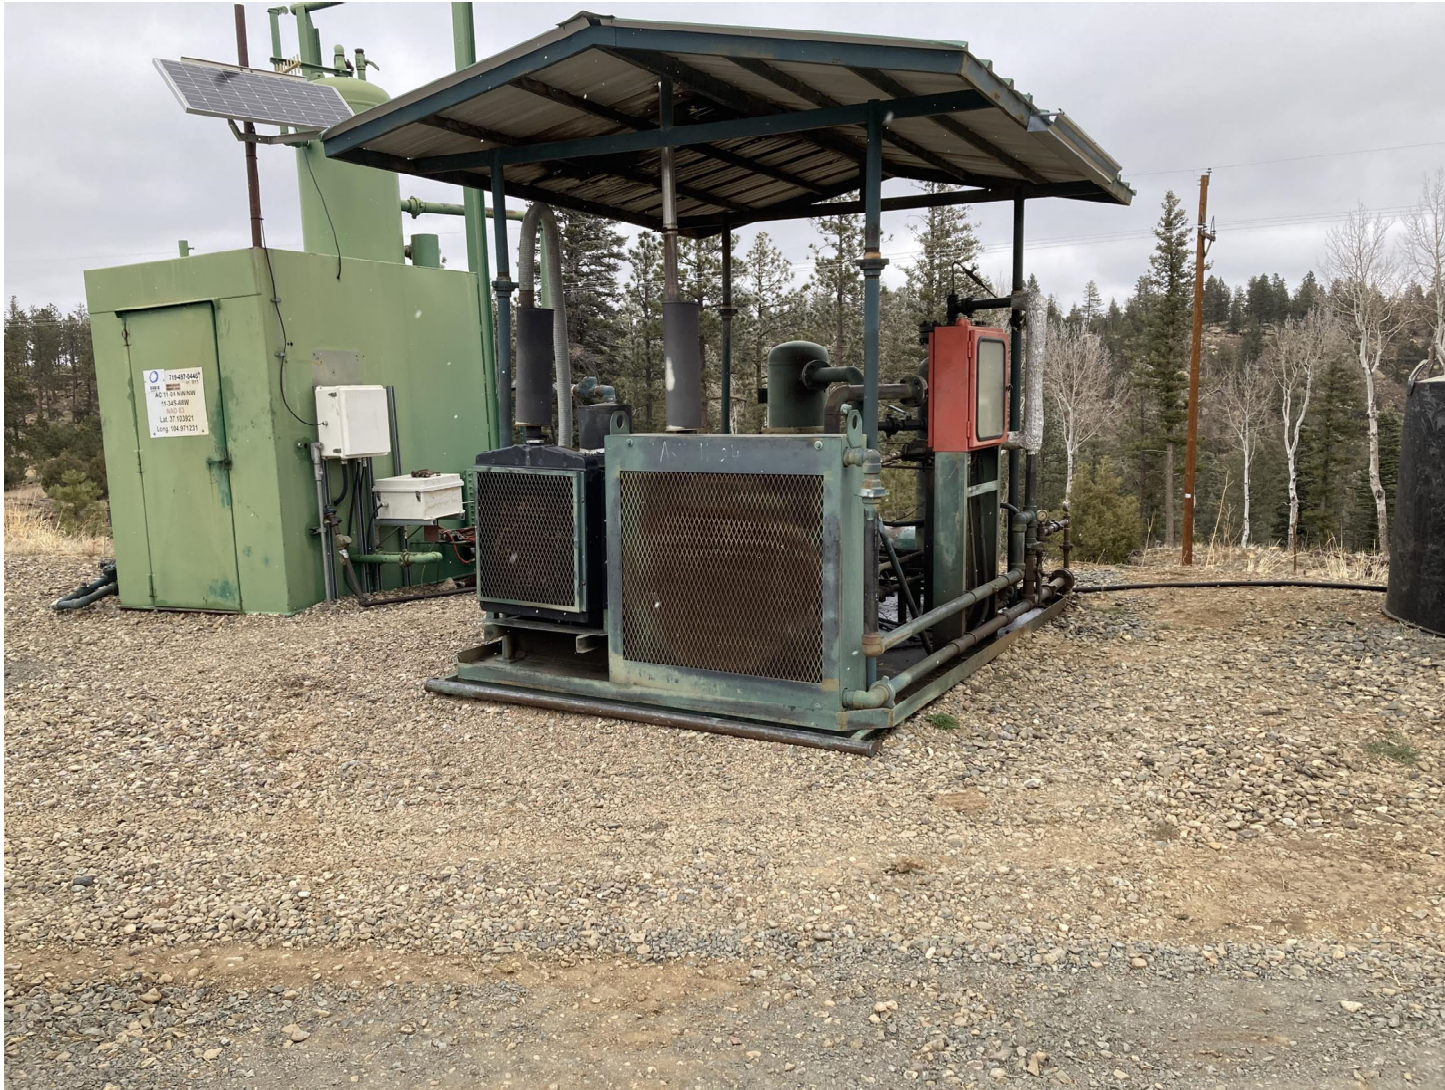
PHOTO 4: THE SCRUBBER LIQUID WAS REMOVED FROM THE PRODUCED WATER TANK AND DISPOSED OF PER OGRIS'S WASTE MANAGEMENT PLAN AND THE COGCC RULES AND REGULATIONS.
