Inspection Photos

5/11/2021

Operator: LARAMIE ENERGY LLC - 10433

Location ID: 427315

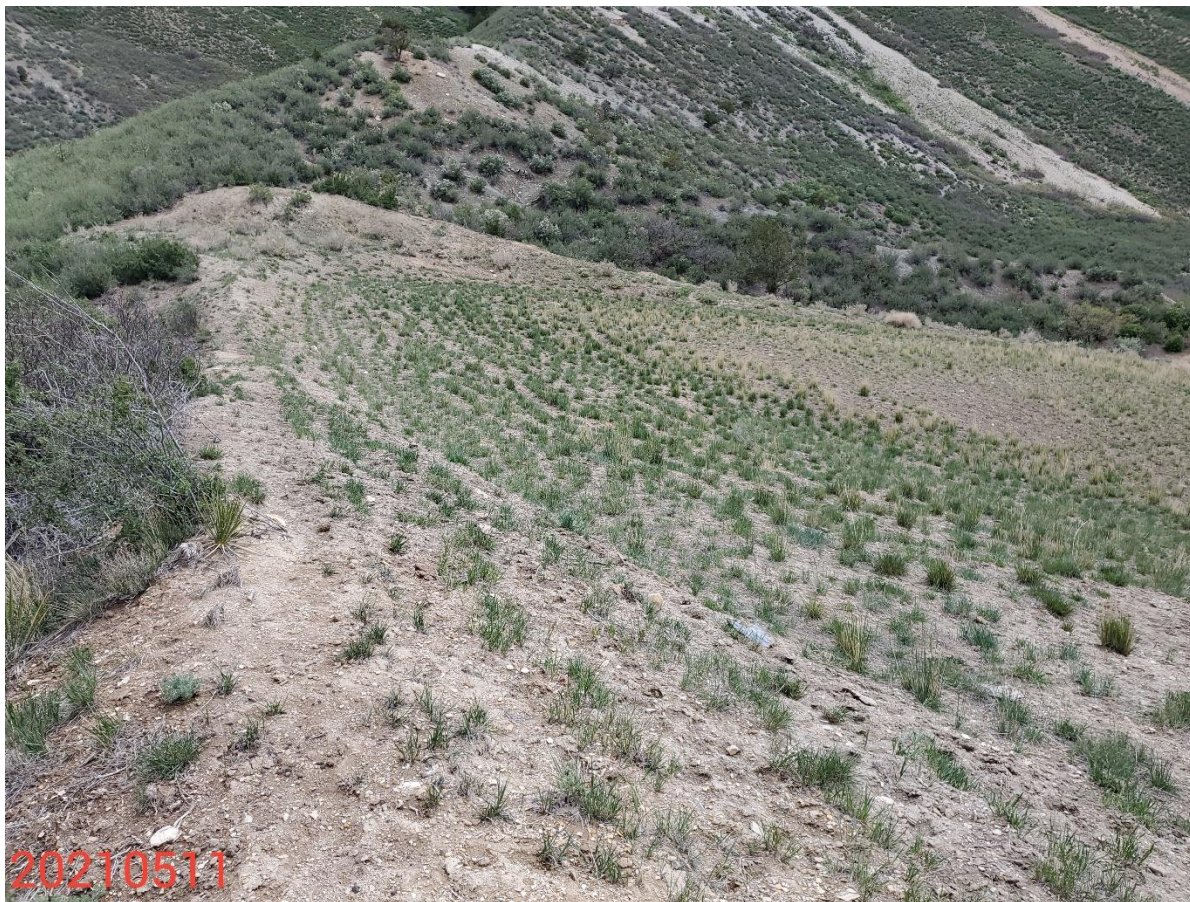
Photo 1: Photo taken from the north end of the Location, facing southeast. Photos 1-3 provide an overview of the Location from southeast, south to southwest. Photos also show areas of the Location not needed for production that require reclamation in accordance with Rule 1003.b.

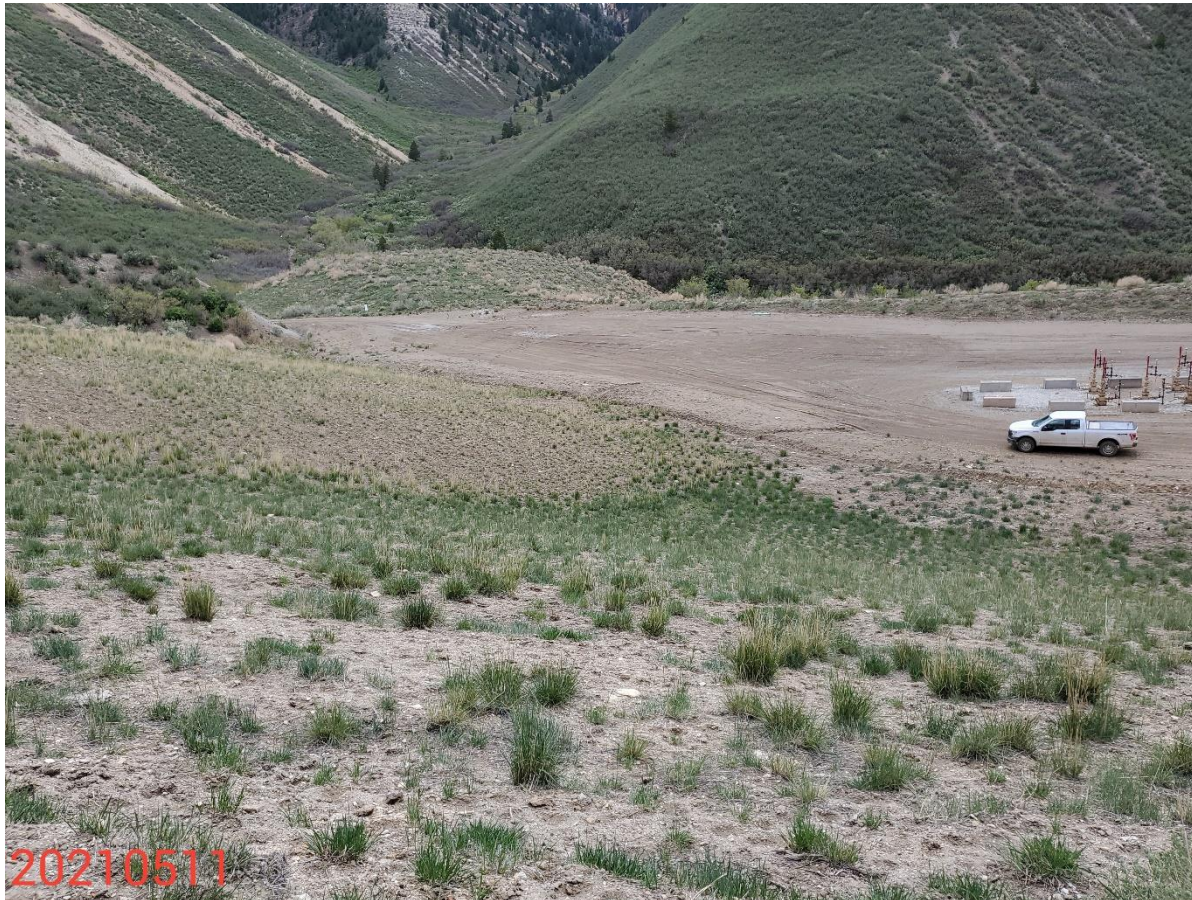
Photo 2: See comments under photo 1.

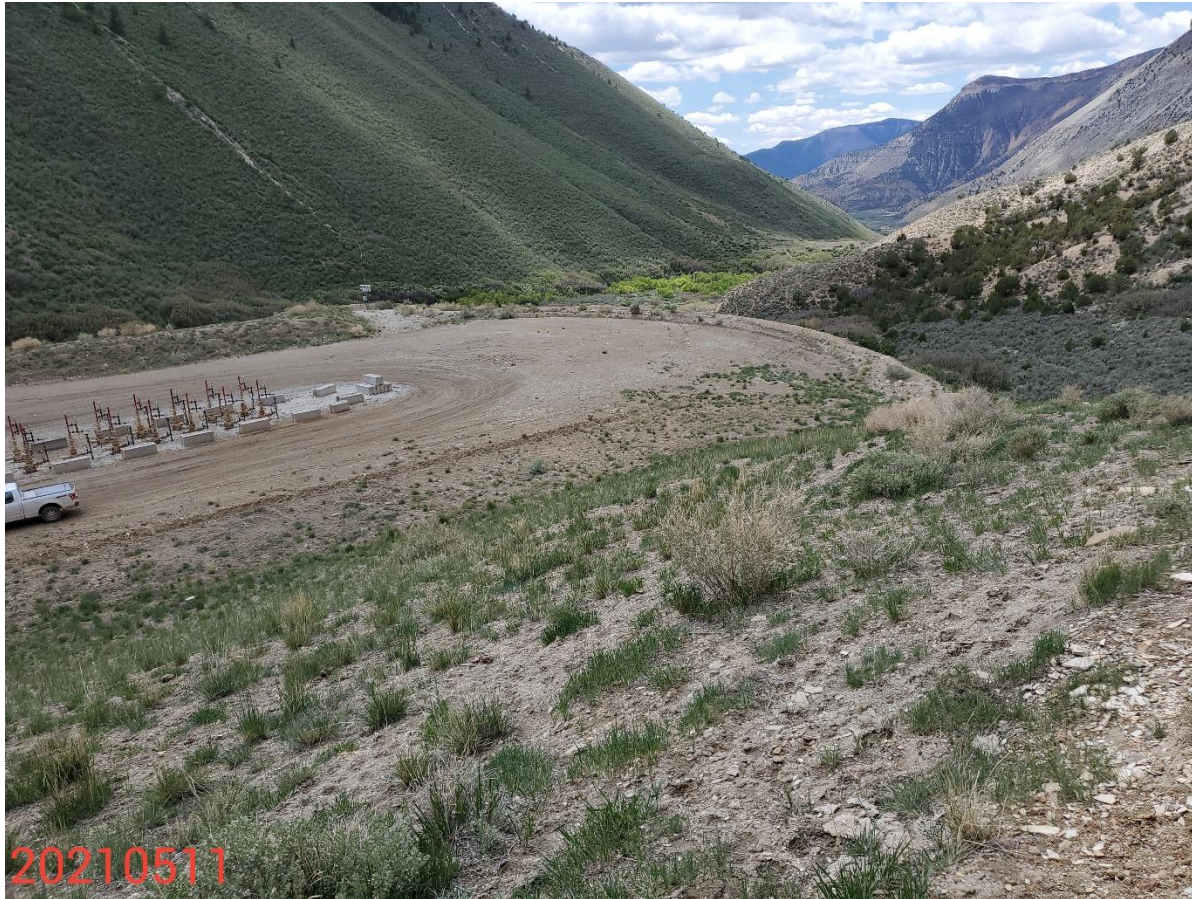
Photo 3: See comments under photo 1.

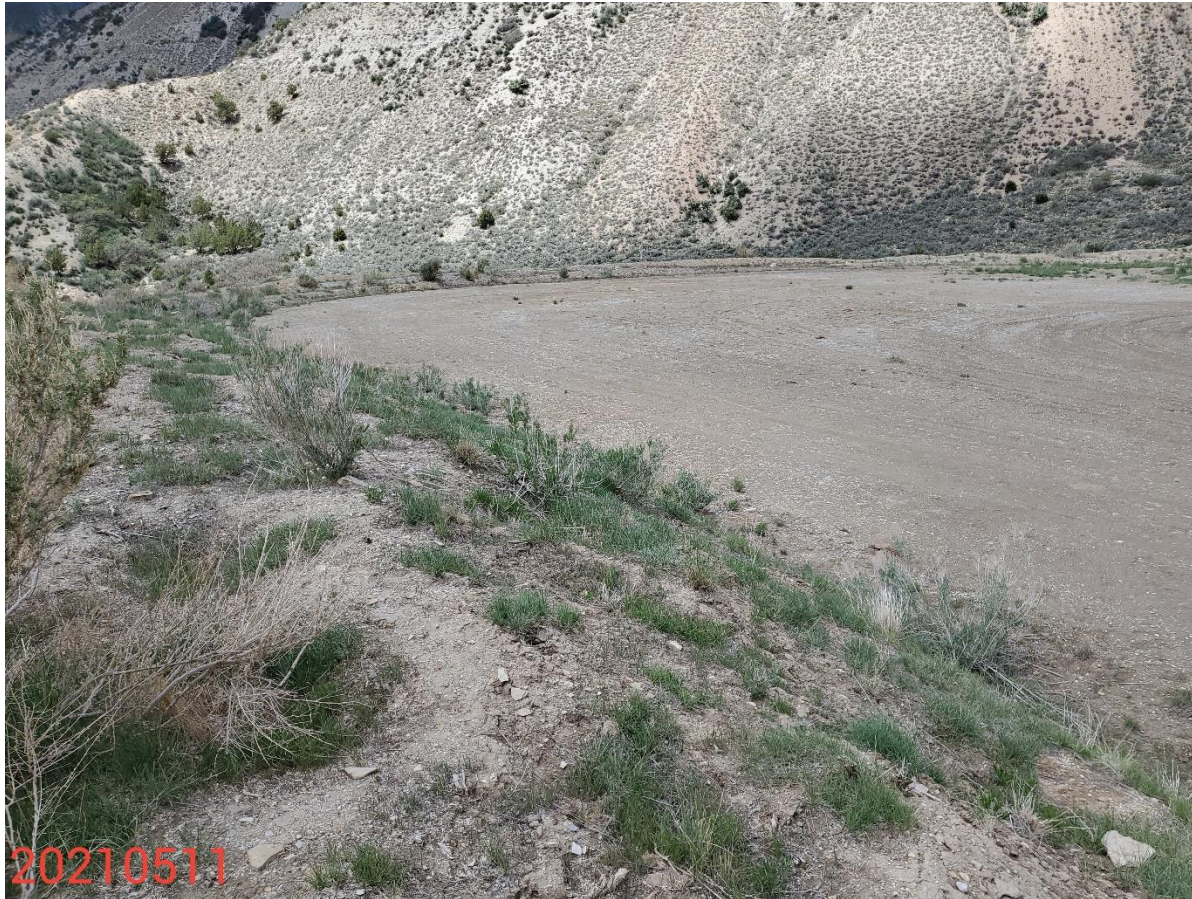
Photo 4: Photo taken from the south end of the production area, facing west. Photos 4-6 provide an overview of the Location from west, north to east. Photos also show areas of the Location not needed for production that require reclamation in accordance with Rule 1003.b.

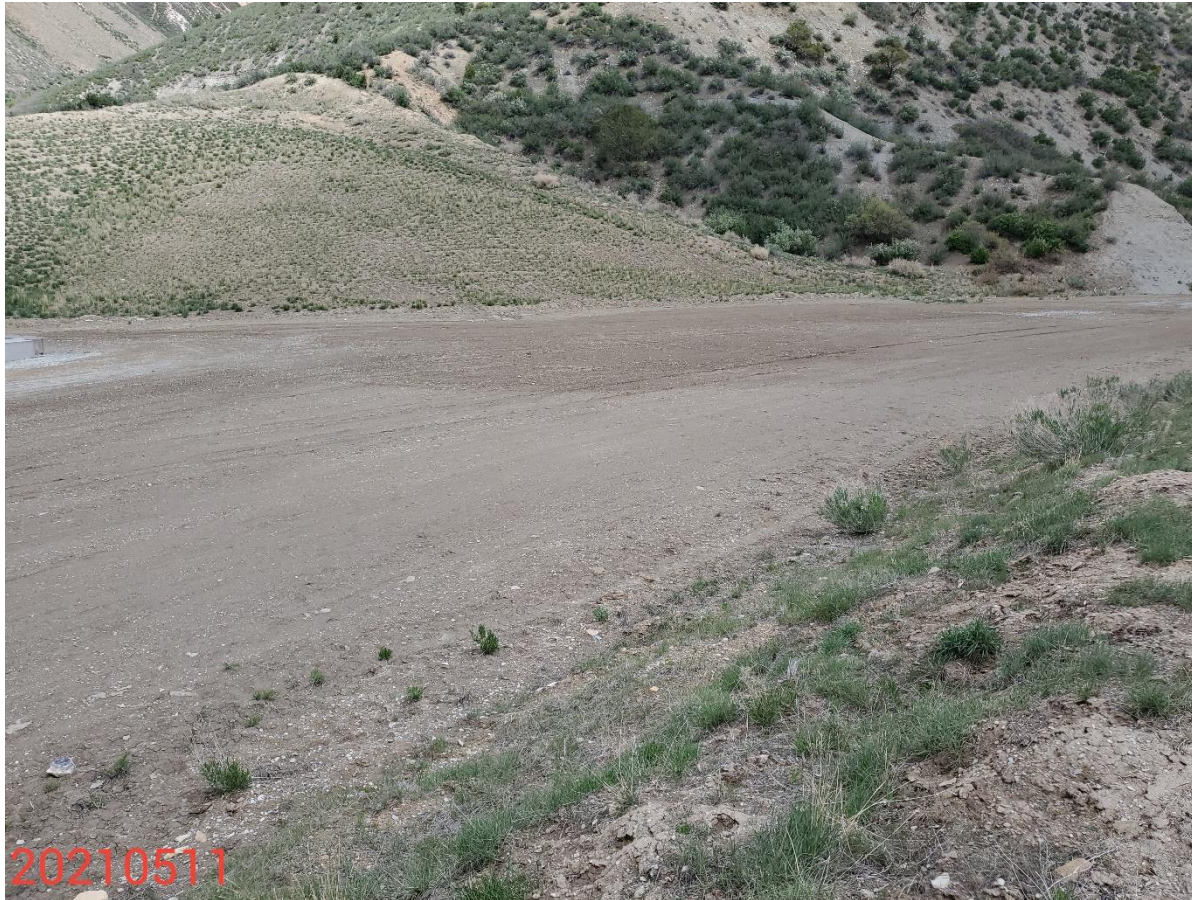
Photo 6: Photo taken from the slopes on the west end of the Location. Photo shows erosion degradation remains evident on the slopes; control measures to stabilize/protect slopes remain missing or insufficient.

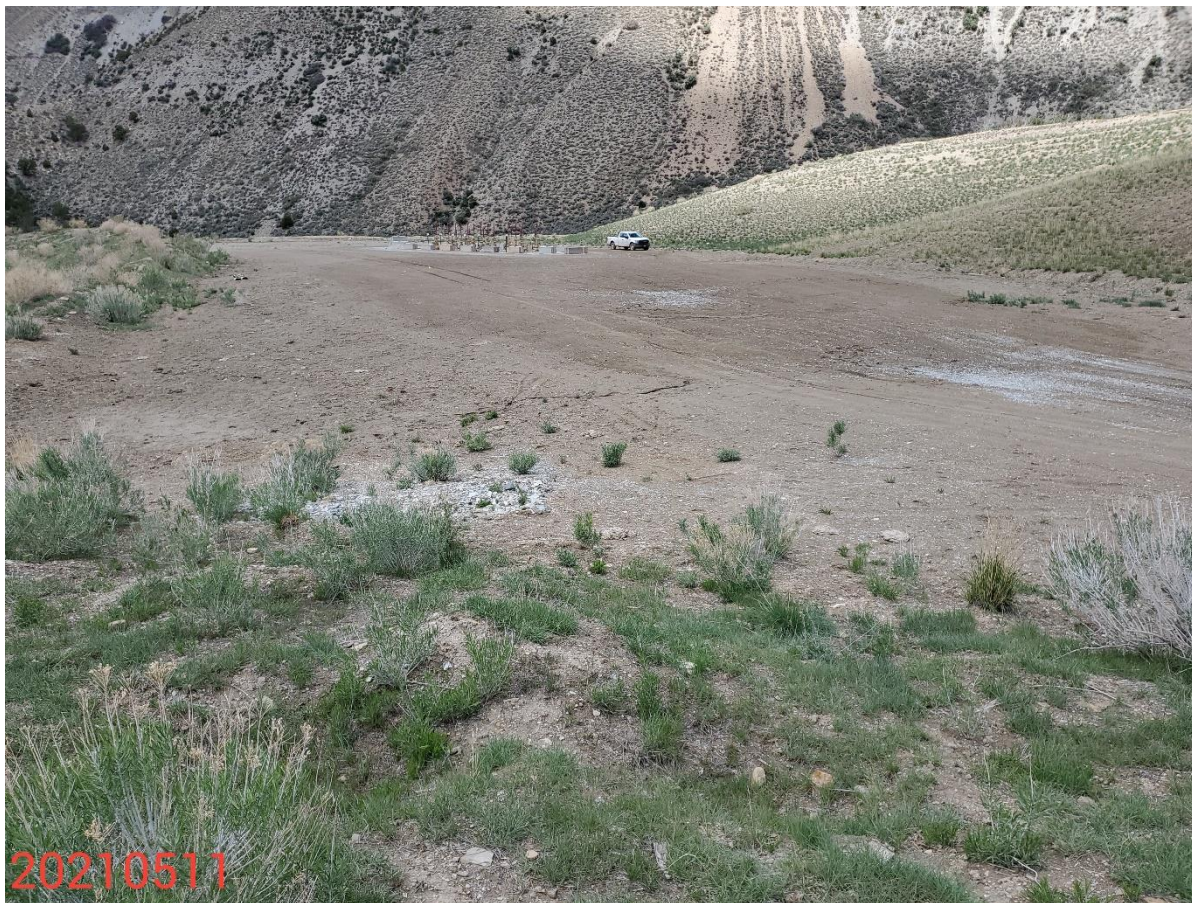
Photo 7: Photo taken from the southeast end of the production area, facing northwest. Photos shows areas of the Location not needed for production that require reclamation in accordance with Rule 1003.b.

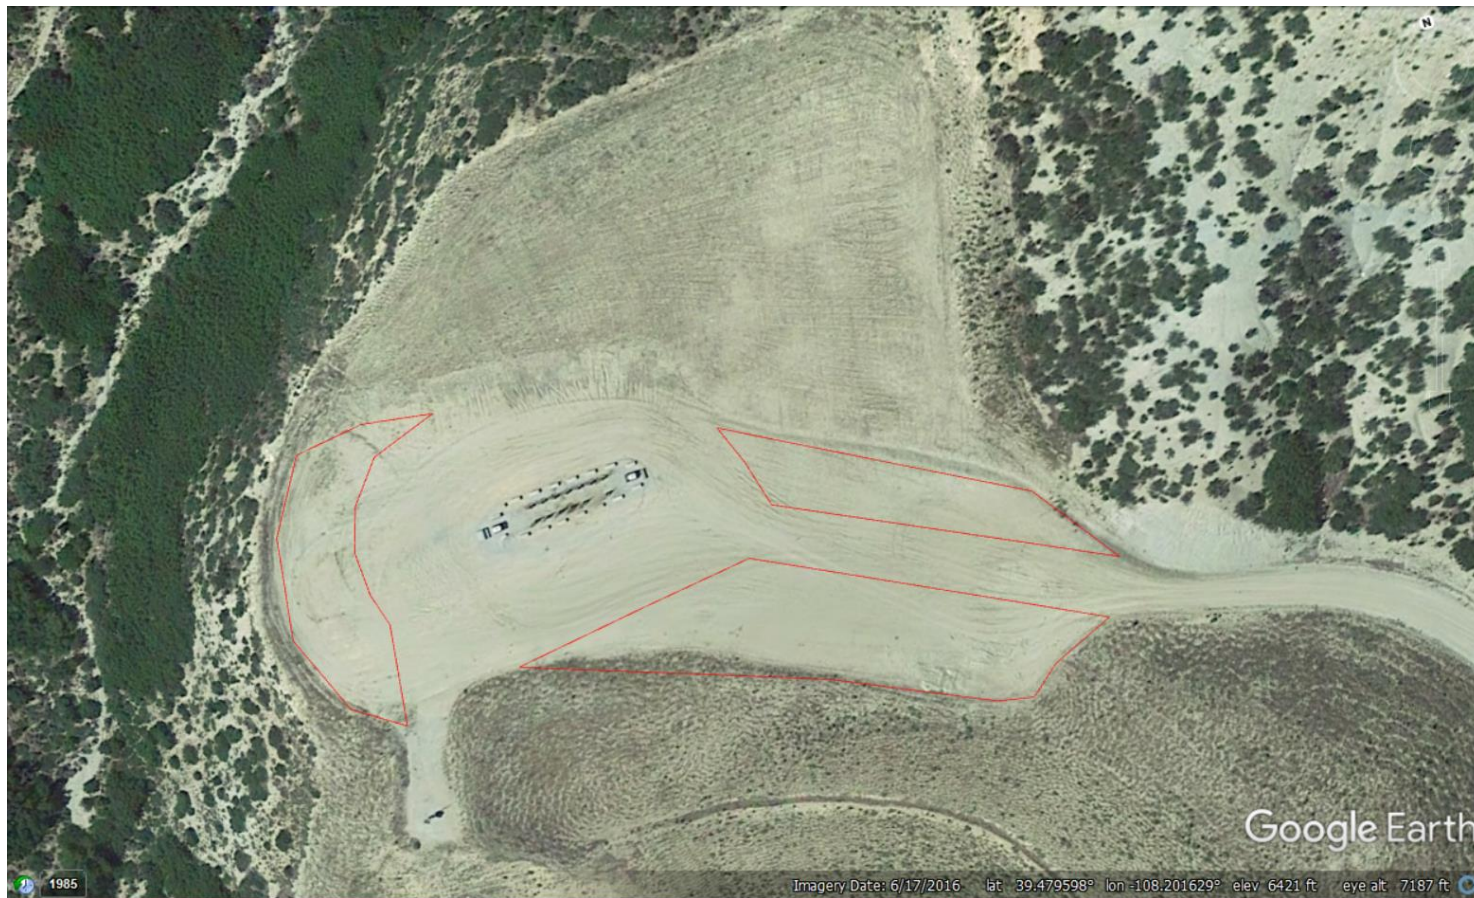
Photo 8: Most current Google Earth Aerial imagery of the Location (2016). Photo shows approximate areas of the Location that are not reasonably needed for production (red polygons).
