Subject: This Addendum Is Related to CWMF #149017. Revised Estimated Cost to Provide Remediation and Closure of the Wellington Produced Water Treatment Facility.

Subject: This Estimate is Related to CWMF #149017. Amended Estimated Cost to Provide Remediation and Closure of the Wellington Produced Water Treatment Facility.

Wellington Operating Company is providing this summary of the tasks and estimated costs to provide the remediation and closure of the Wellington Produced Water Treatment Facility and the support systems involved with its operation and monitoring:

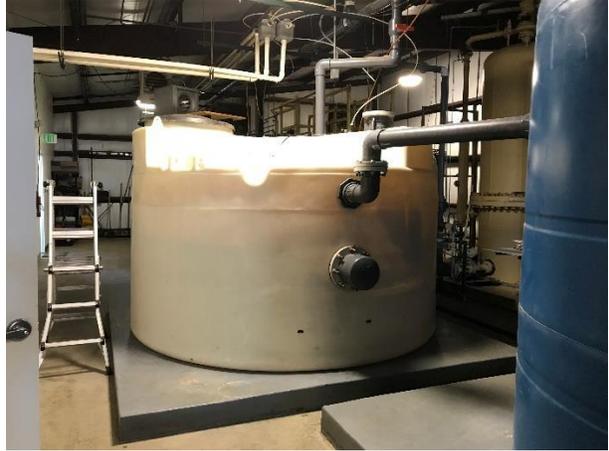
GAC Supply Tank & Walnut Shell Filter in Background

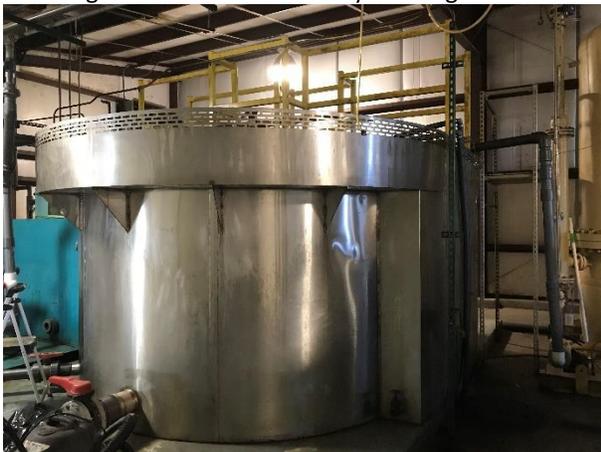
Former DAF Used as Backwash Storage Tank

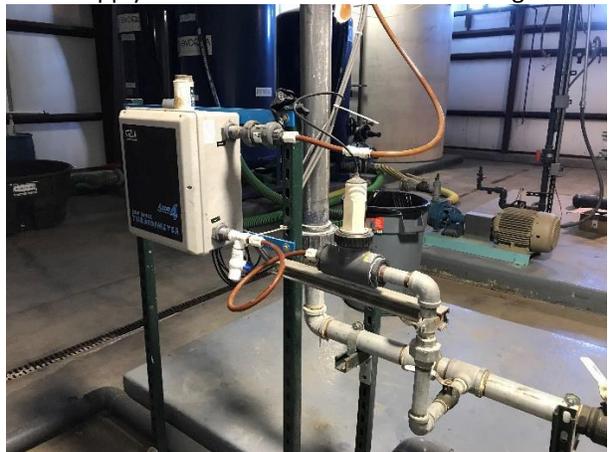
Plant Floor, GACs, Plant Water Tank, Process Piping

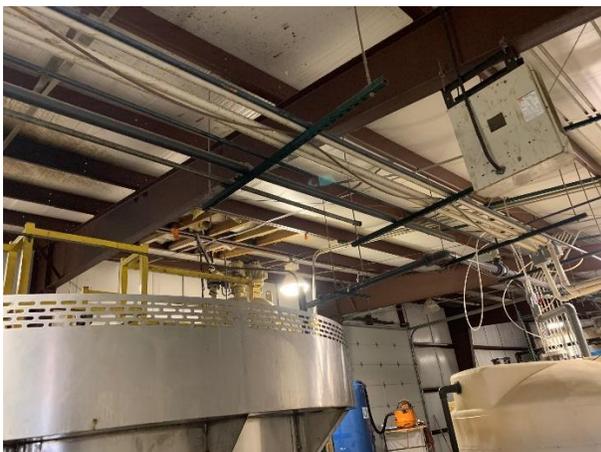
Overhead Process Piping and Racks
