Corrective Action Report

Response to Document #692402693

Gulf Exploration, LLC. Eagle Hill 1-32

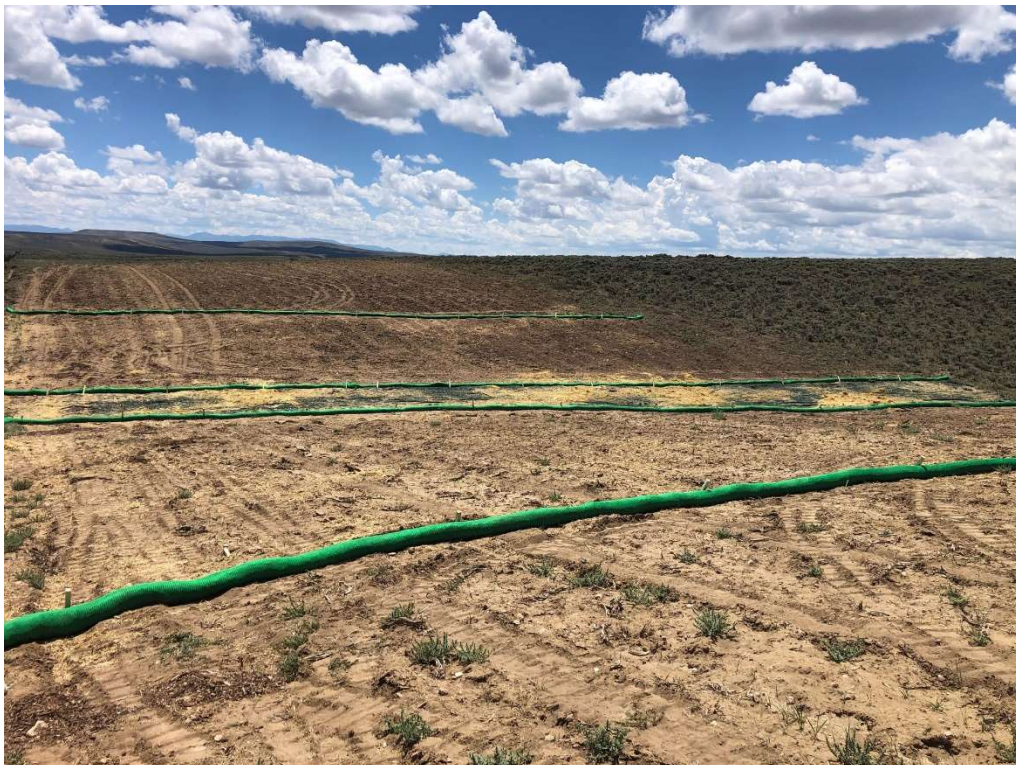
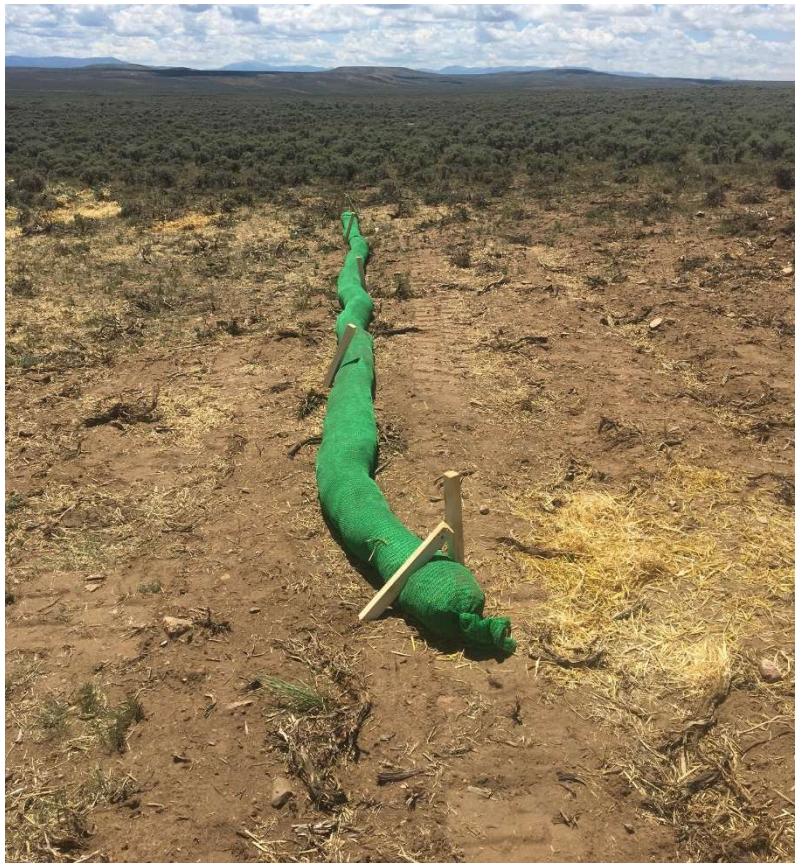
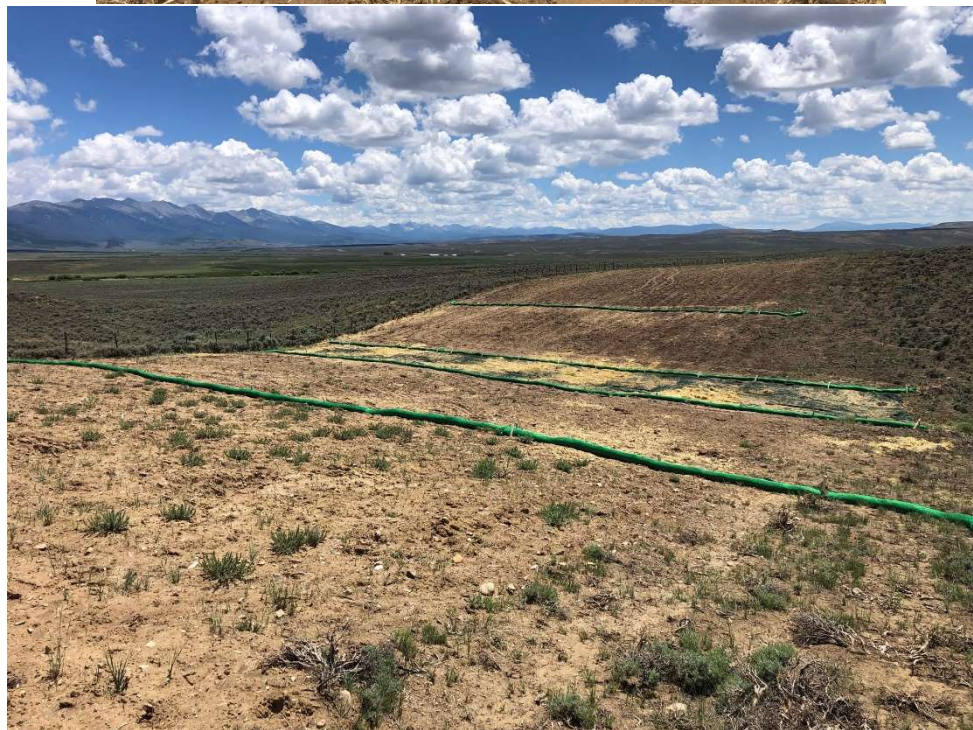
7/2/21 Post Installation Photo's:

The pictures below document the most recent installation of Compost Filled Erosion Control Logs on the Swale on the access road to the Eagle Hill 1-32 Pad. Straw wattles installed previously were destroyed and eaten by livestock, necessitating an improvement. These BMP's were installed on July 2nd, 2021 and will continue to be inspected and maintained on a regular interval in the following months until final stabilization BMP's (seed and mulch) and winter exclusion occurs this fall. The temporary BMP's will remain in place, inspected, and maintained, until revegetation achieves 70% cover for final stabilization requirements.

Western States was contracted to develop and implement a plan, which was communicated and accepted by COGCC staff. Temporary erosion control BMP's to control soil migration have been installed, inspected, and maintained since December of 2020 until appropriate conditions exist to reapply seed and appropriate mulch during the fall of 2021.
