## 6 Month Abatement Summary

<b>Well:</b>	Wilmoth E 5A-312
<b>API:</b>	05123454840000

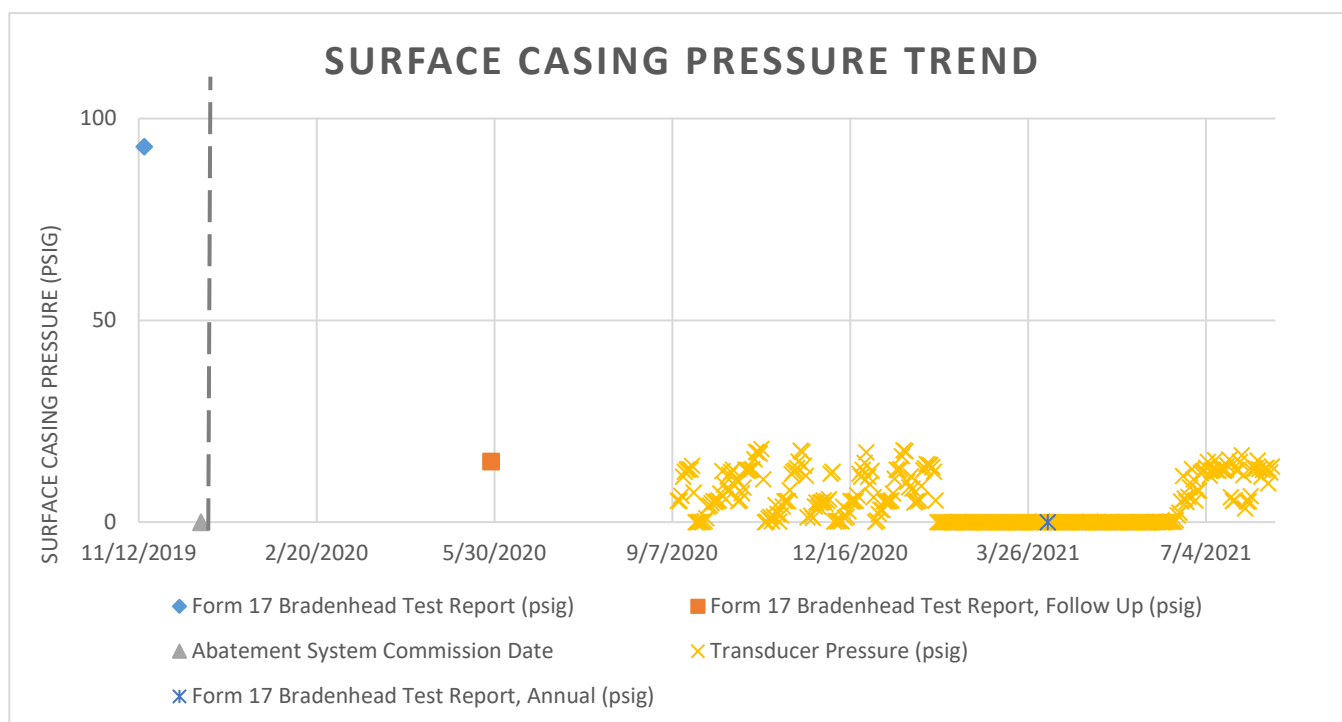
Bradenhead Test Data	Date	Event Measurement
Form 17 Bradenhead Test Report (psig)	11/15/2019	93
Abatement System Commission Date	12/17/2019	-
Form 17 Bradenhead Test Report, Follow Up (psig)	5/28/2020	15
Form 17 Bradenhead Test Report, Annual (psig)	4/6/2021	0
Abatement System Volume Measurement (CF/Day)	3/22/2020	3.2

**Comments:** 2019 post-production test had 93 that blew down to 0 psi instantly with no flow for the remainder of the test. 6-month follow up test had 15 PSI that blew down to 0 psi within thirty minutes. 2021 annual test had 0 PSI with no pressure or flow observed for the duration of the test. A sample was able to be collected and analyzed. Bradenhead gas determined to be mixed microbial/thermogenic gas with somewhat similar composition as the production gas sample. Bradenhead pressure remains below 50 psi limit when abatement system is operating. PDC will continue to remediate pressure using the installed abatement system.
