KP Kauffman - COGCC Inspection Photos
Location: Martin J Schaefer #2 OLF Release
Spill ID # 480698 Date 09/01/2021

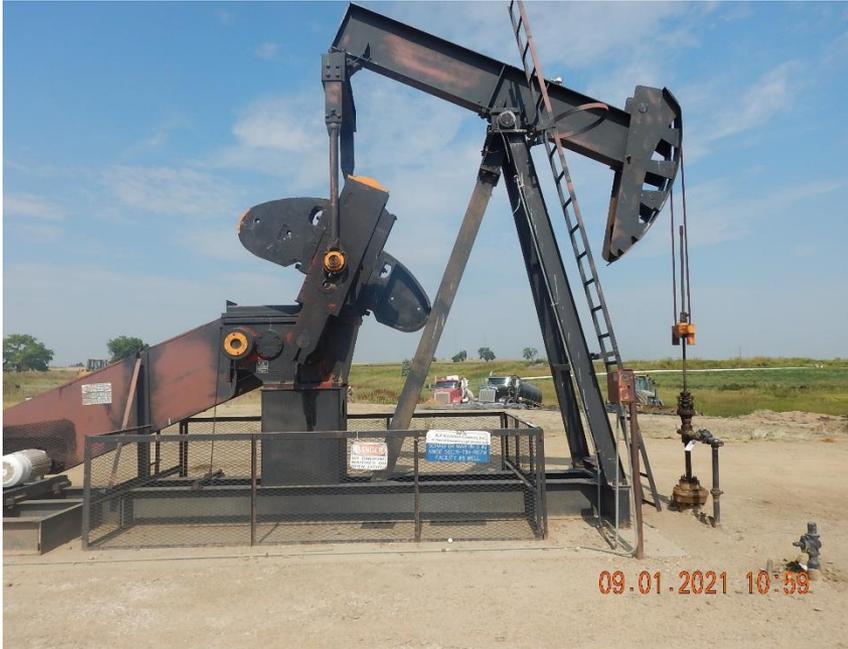
Wellhead and signage; view North

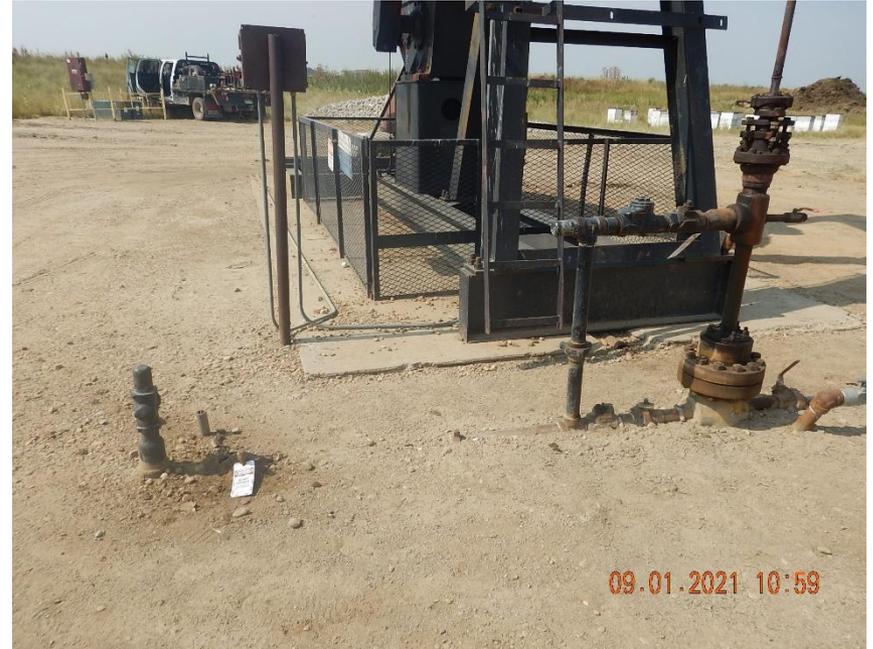
Martin J Schaefer #2 wellhead; flowline valves SI/ OOSLAT

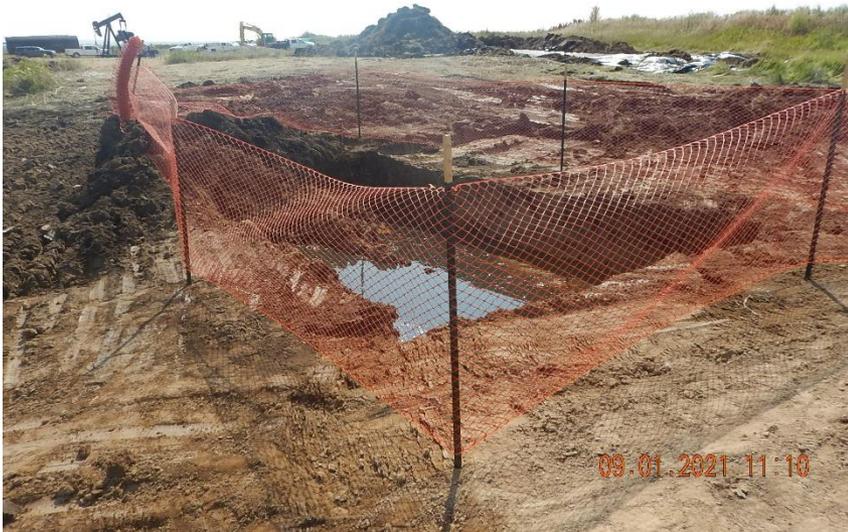
**Excavation (fenced) at off location flowline release point.
Fluids in excavation; View East to Martin J Schaefer #2 well.**

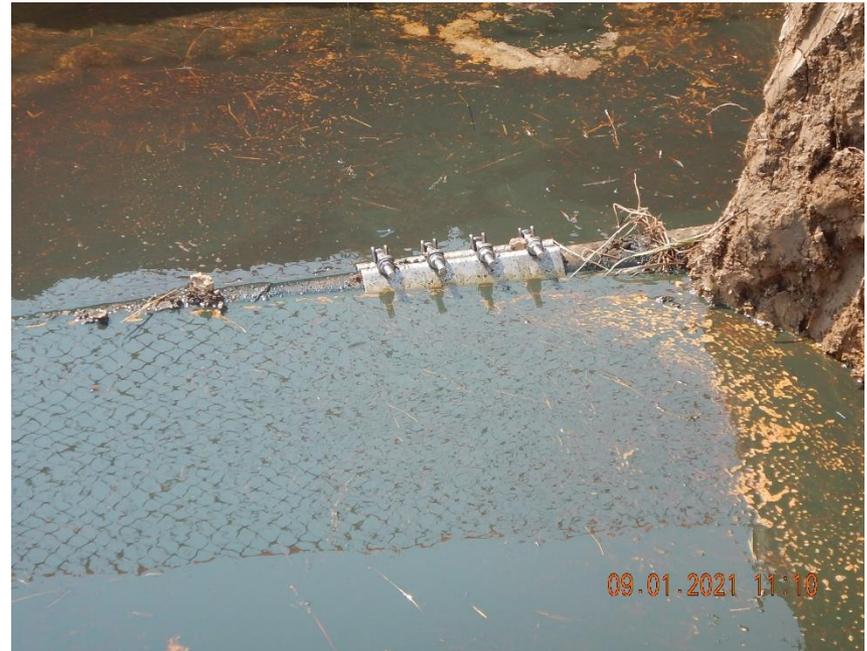
**(1) 4" carbon steel off location flowline exposed in
excavation; Bolted clamp installed around the flowline pipe
at the point of failure. Standing fluids in excavation.**
