# Interim Reclamation Inspection

Operator: RENEGADE OIL & GAS COMPANY LLC - #74165

Location ID: 401324

Inspection Photos  
Location Name: HORN #2-4  
Location ID: 401324

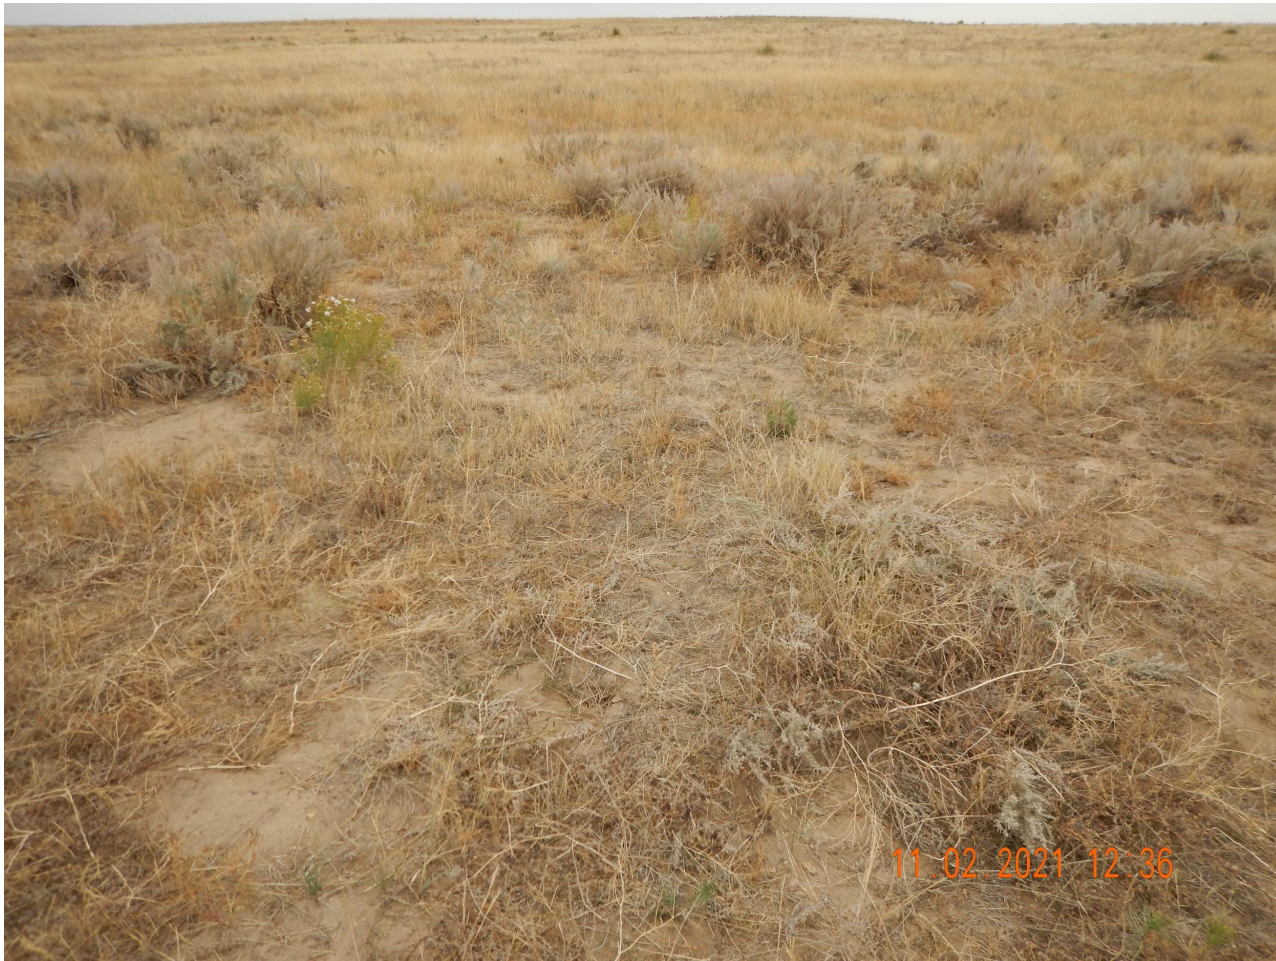
**Photo 1.** Photo taken from the well location, facing East. Photo illustrates the well location meets Rule 1004 standards.

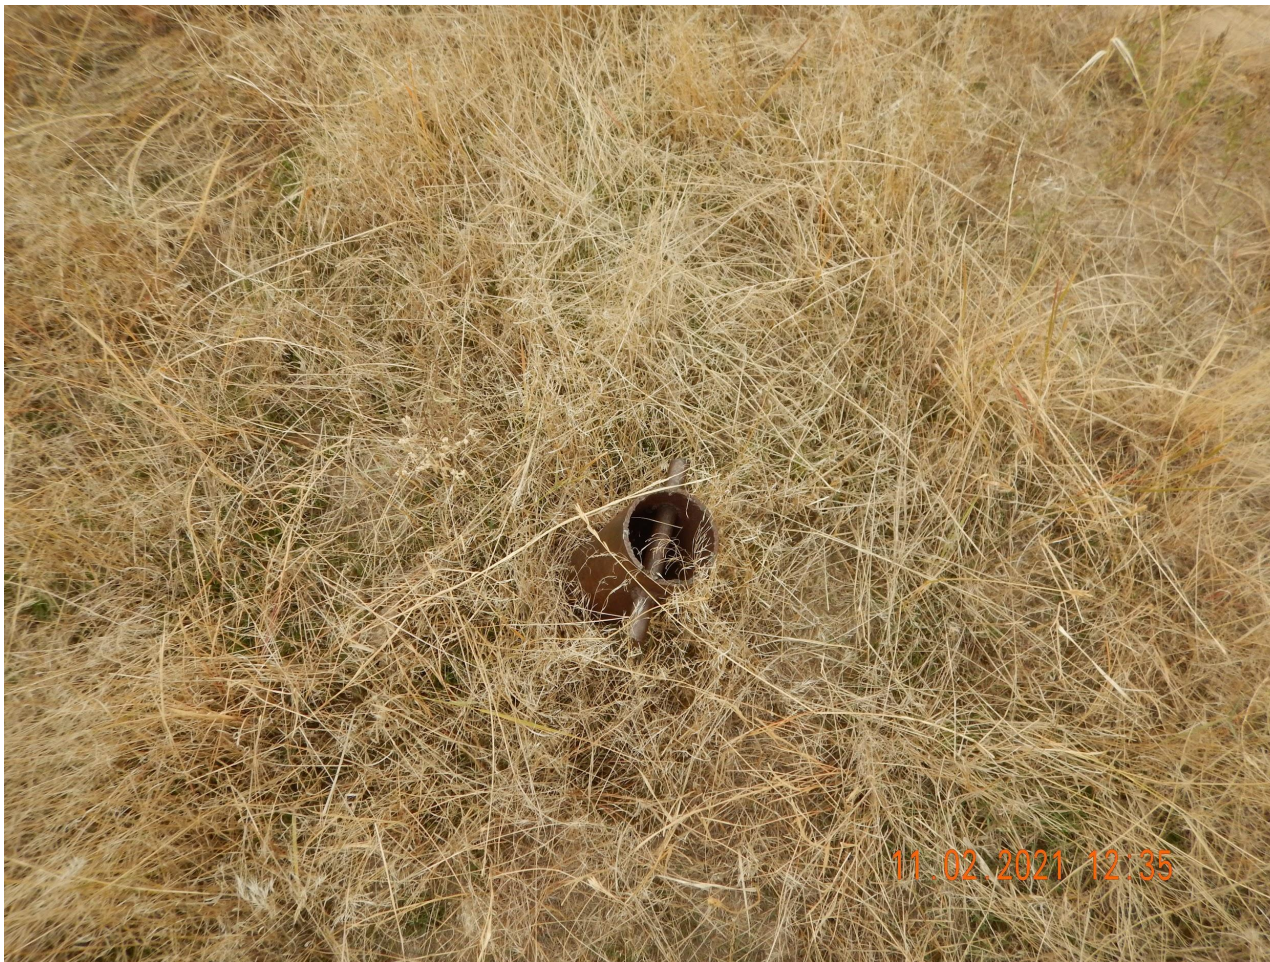
**Photo 2.** Photo illustrates 1 of 5 guy line anchors that have not been removed.

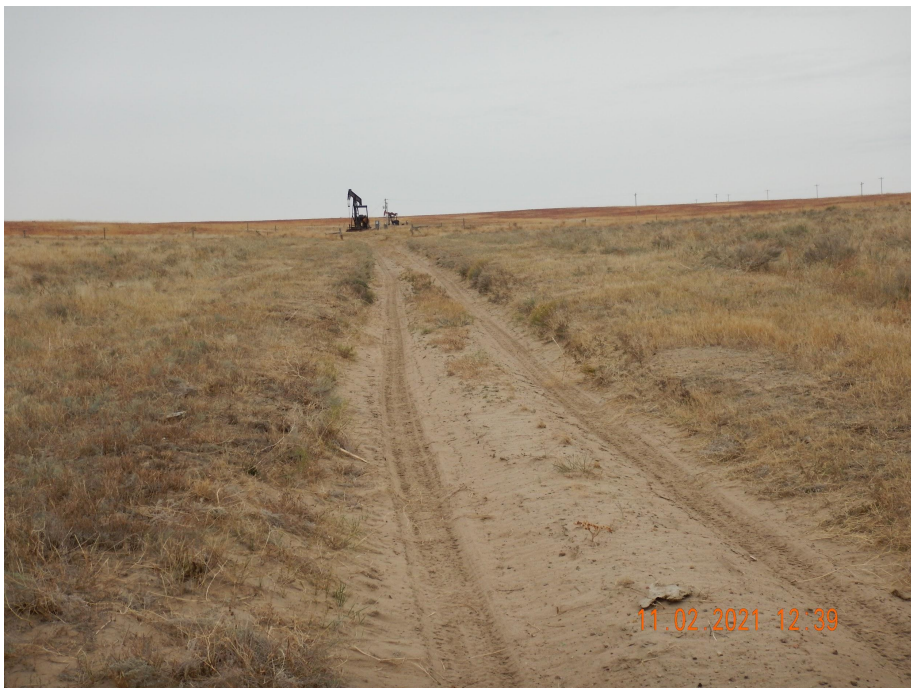
**Photo 3.** Photo taken from the well location, facing South. Photo illustrates the lease road is still in use for other nearby wells.

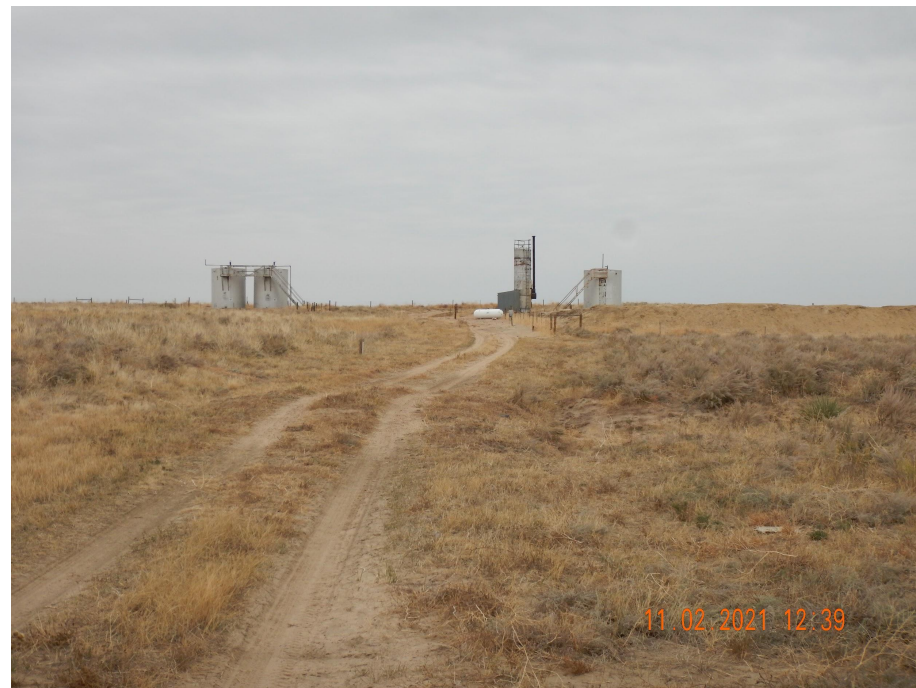
**Photo 4.** Photo taken from the well location, facing North. Photo illustrates the tank battery is still in use for other nearby wells.

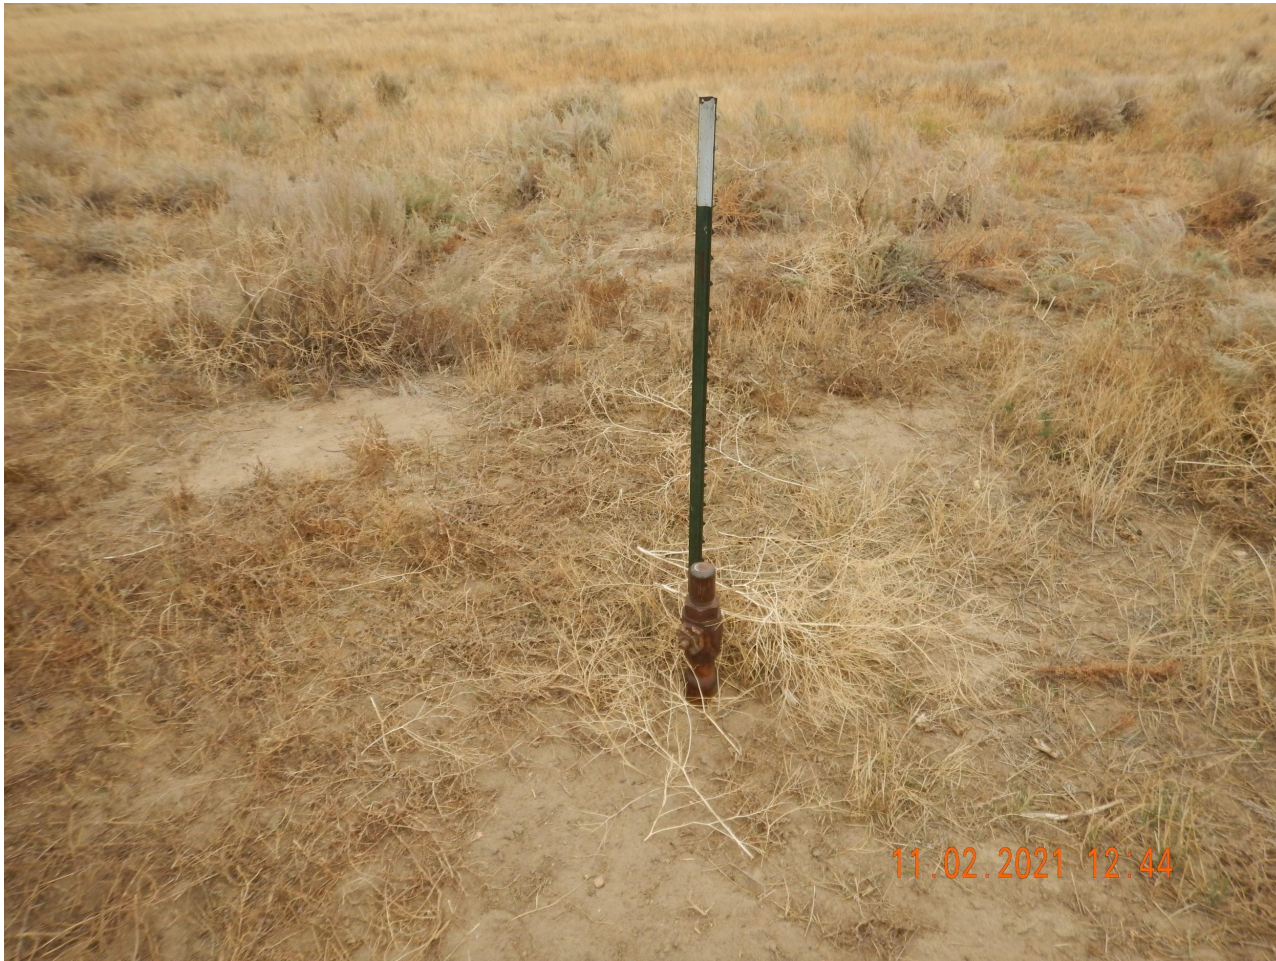
**Photo 5.** Photo illustrates an active flowline riser based on previous inspections.
