Final Reclamation Inspection

Operator: KERR MCGEE OIL & GAS ONSHORE LP #47120

Location ID: 319236

Inspection Document #: 697503524

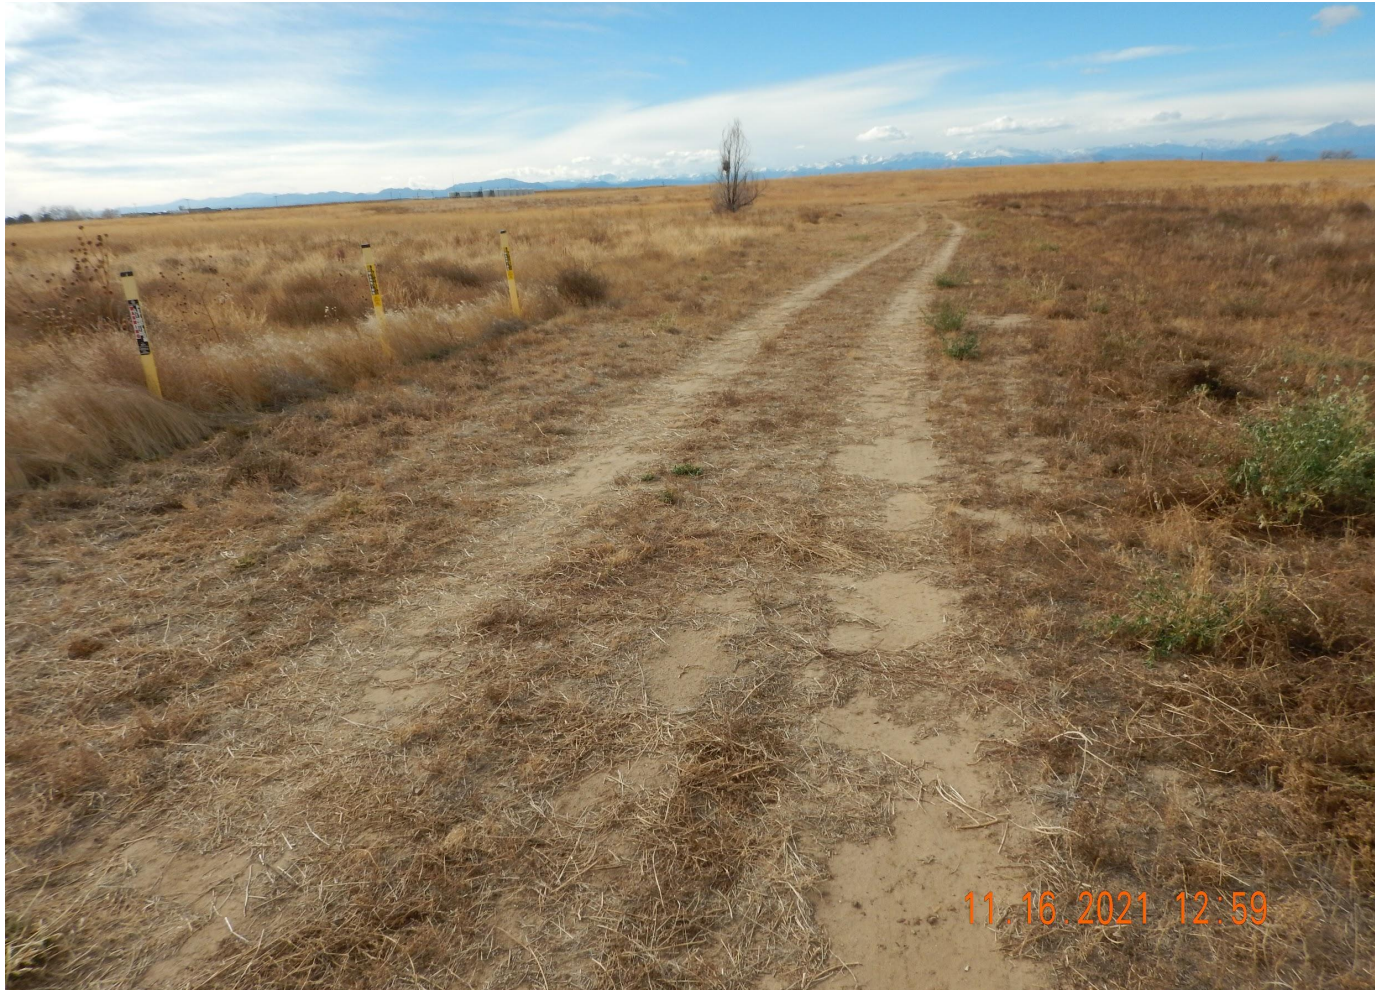
Photo 1. Photo taken from the eastern well location access road, facing West. Photo illustrates the access is evident and needs to be reclaimed per Rule 1004 standards.

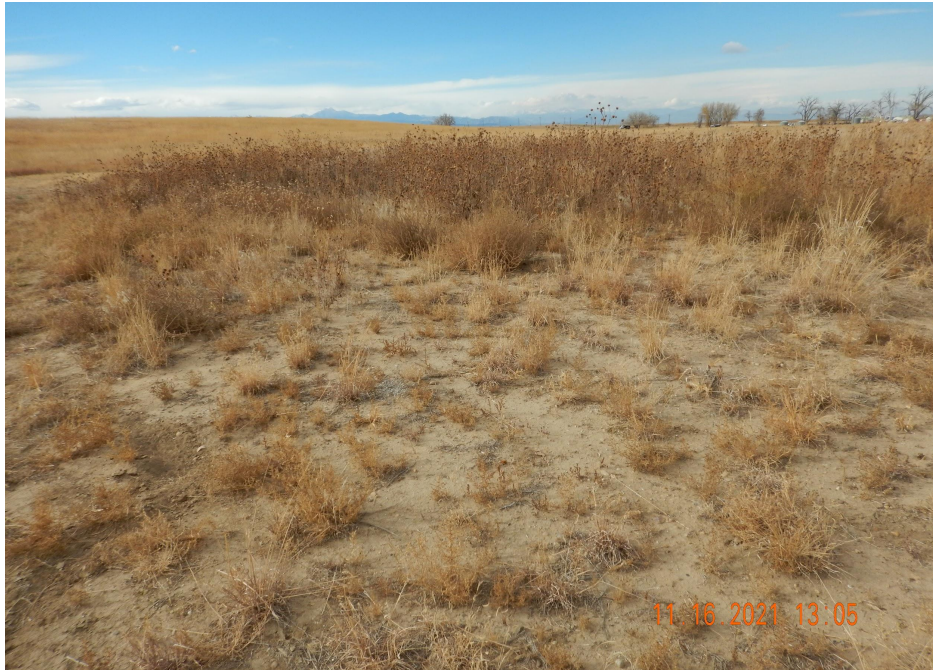
Photo 2. Photo taken from the well location, facing Northwest. Photo illustrates the evidence of desirable plant species; however, the well location will remain in-process.

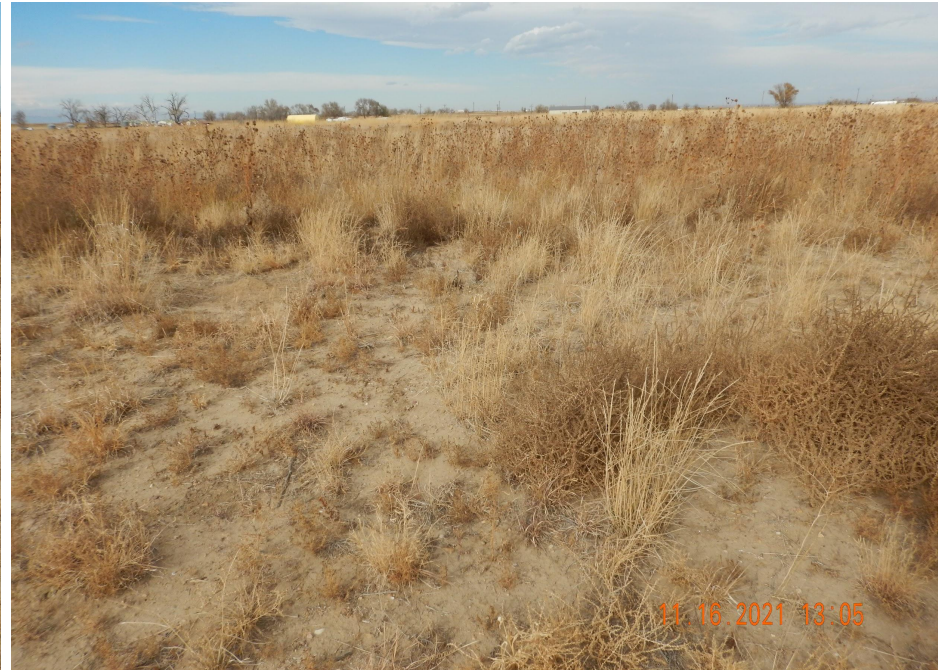
Photo 3. Photo taken from the well location, facing North. See comments under Photo 2.

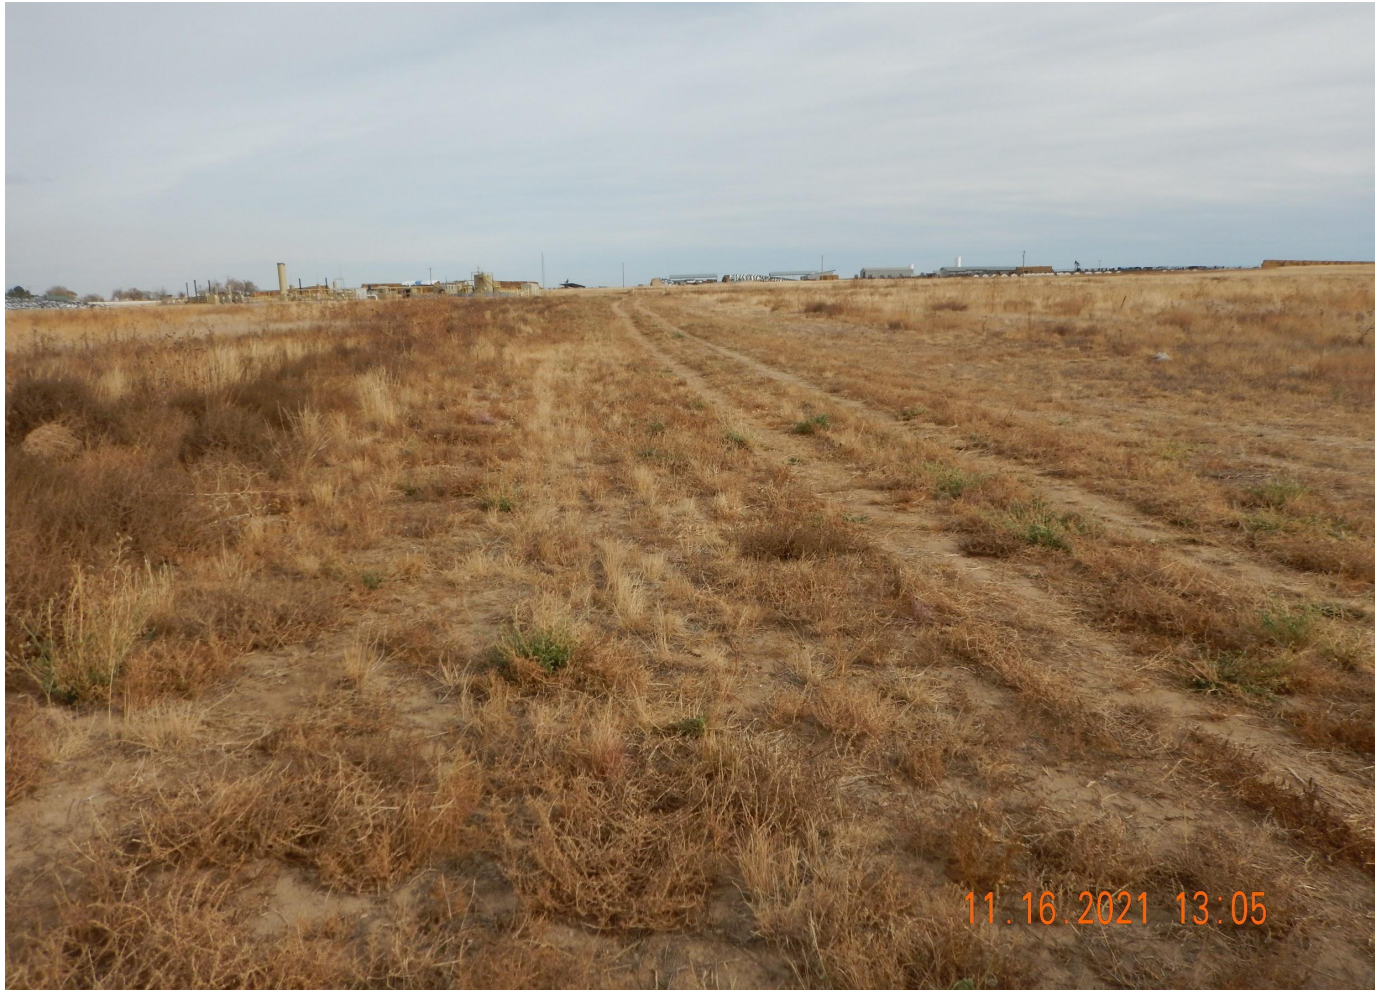
Photo 4. Photo taken from the well location, facing East. See comments under Photo 1.

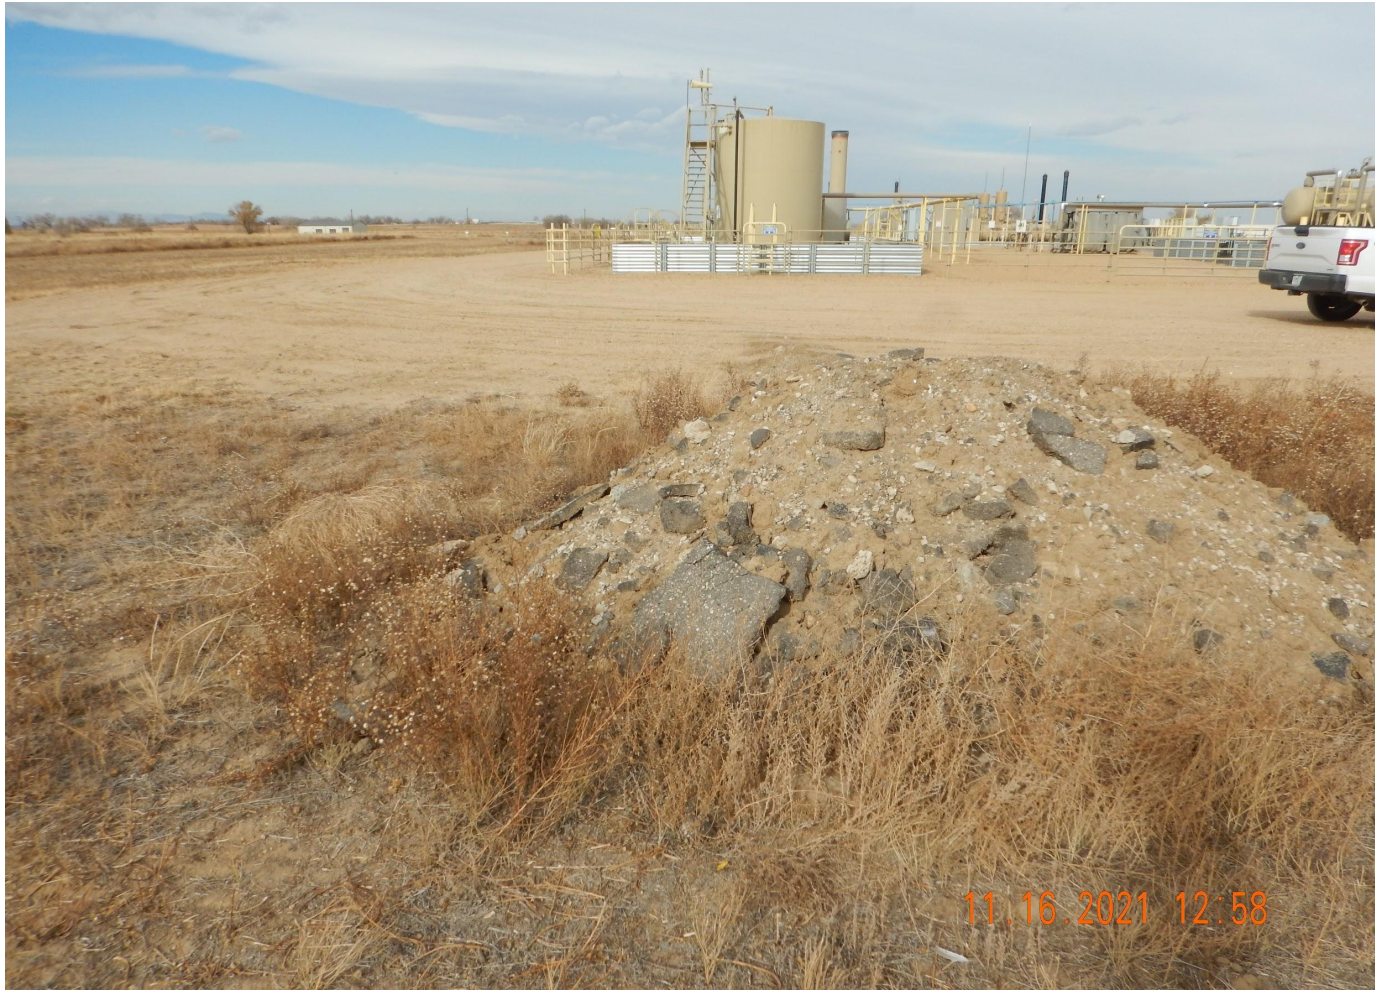
Photo 5. Photo taken from the associated offsite tank battery, facing North. The associated offsite tank battery has been removed and replaced with a new production facility for other nearby active wells. Note: A corrective action has been submitted to remove the debris pile.
