Final Reclamation Inspection

Operator: NOBLE ENERGY INC - #100322

Location ID: 332740

Inspection Photos
Location Name: KAMMERZELL #7-44
Location ID: 332740

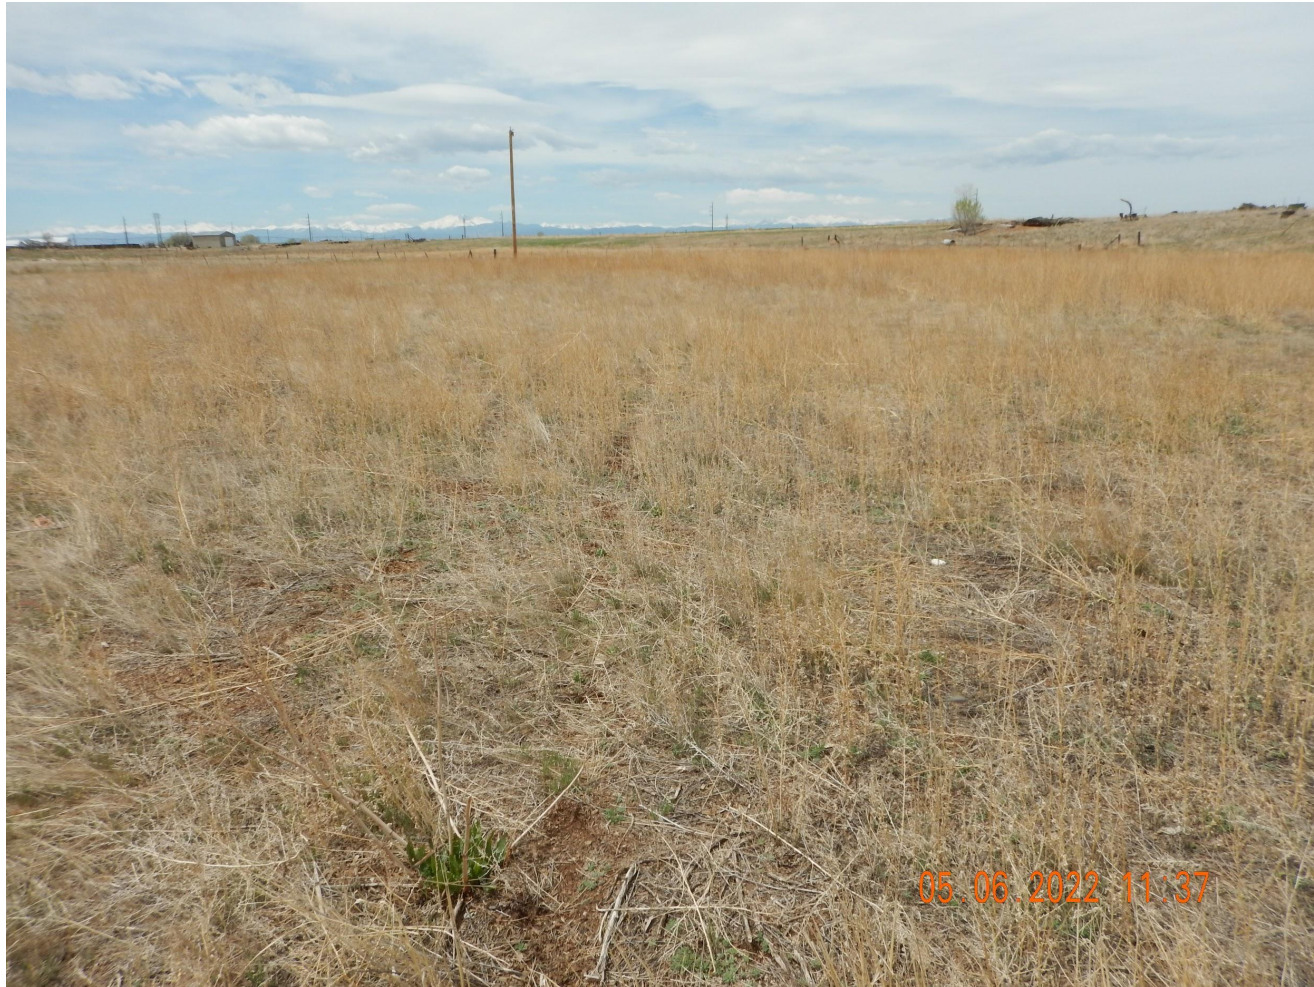
Photo 1. Photo taken from the location, facing West. Photo illustrates the location is dominated by annual, weedy vegetation (cheatgrass and Kochia). It appears as if there has been a significant amount of mulch applied throughout the location.

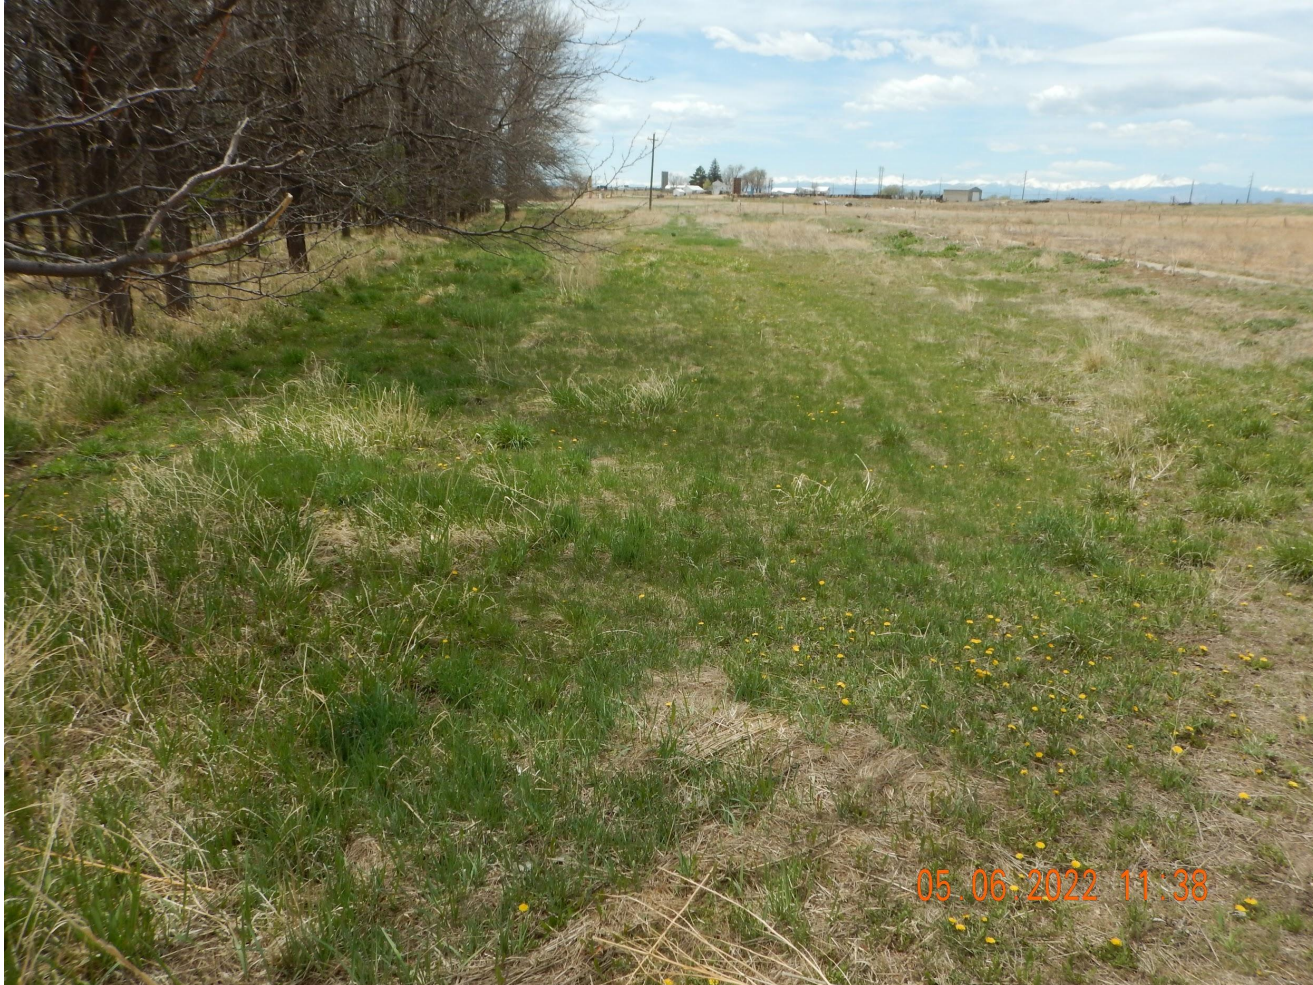
Photo 2. Reference photo taken south and adjacent to the location, facing West. The common grass species observed were Smooth brome, Orchard grass and Canada wildrye.
