## Isle Dome Pit Issues Observed 7/26/2022

07/26/2022 site visit the following where observed:

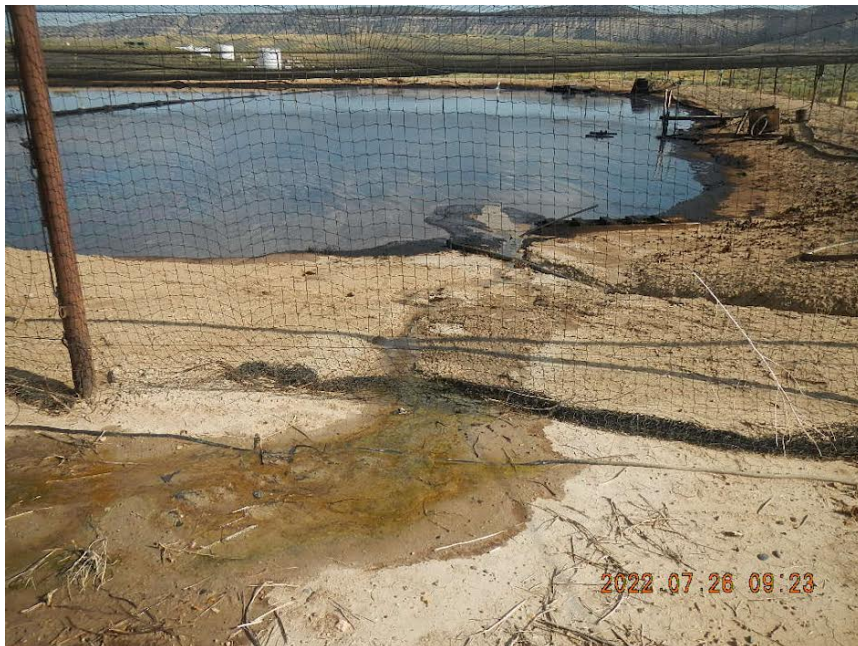
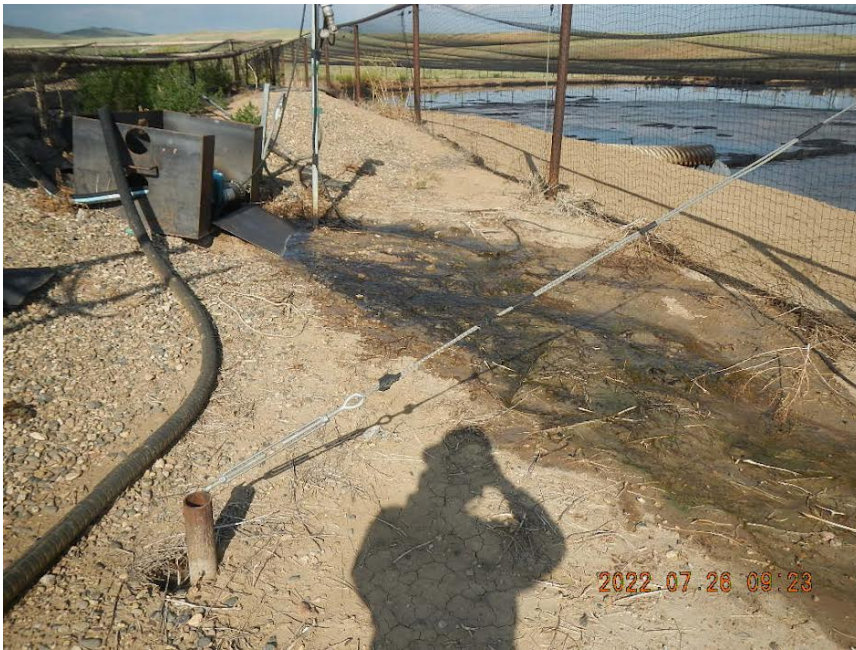
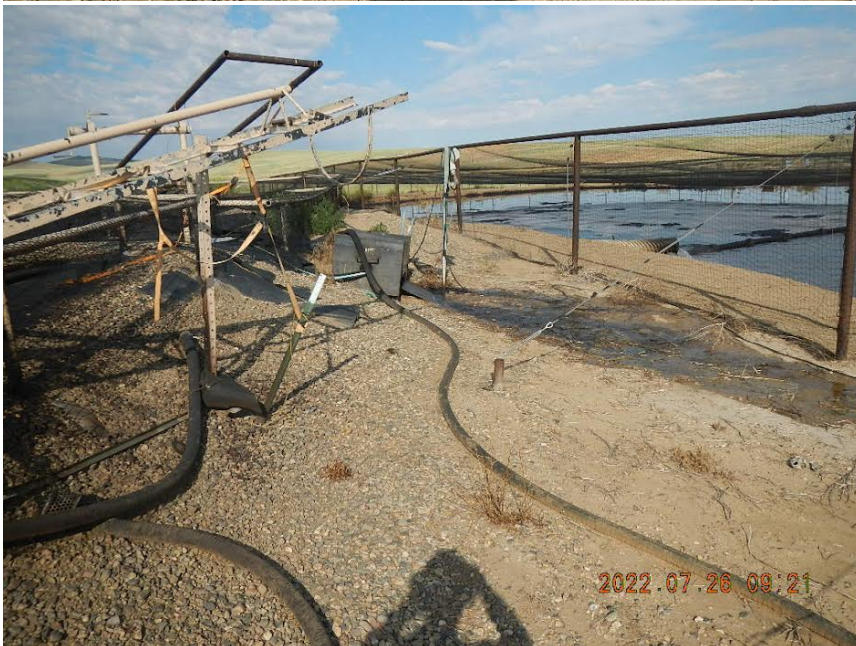
- Fluids were observed being discharged to the ground surface from a faulty transfer pump pumping from the second small pit to an unknown flowline;
- Liner compromised in the second small pit, floating on the oil surface with fluid level upto and possible onto the earthen pit berm (less than 2' of freeboard). Red circle illustrates liner area of concern and arrows illustrate liner floating on the oil and liner void of earthen berm; and
- Numerous holes and gaps in the netting of all three (3) pits.

Please see photos, attached movie clip, and attached PDF. Although the Spill/Release was inside of the pit complex and fluids were flowing over the surface from the second pit to the large pit, this is a reportable spill as the transfer pump was not functioning properly releasing fluids to the ground surface. The operator is required to follow the COGCC Rule 912 Spill and Release Rules.
