GMT Exploration Company LLC, Crystal 6-65 22-10 10HN  
039-06742

Inspection #688312882

7/18/2022

Noise Complaint #403096728/Frac Inspection

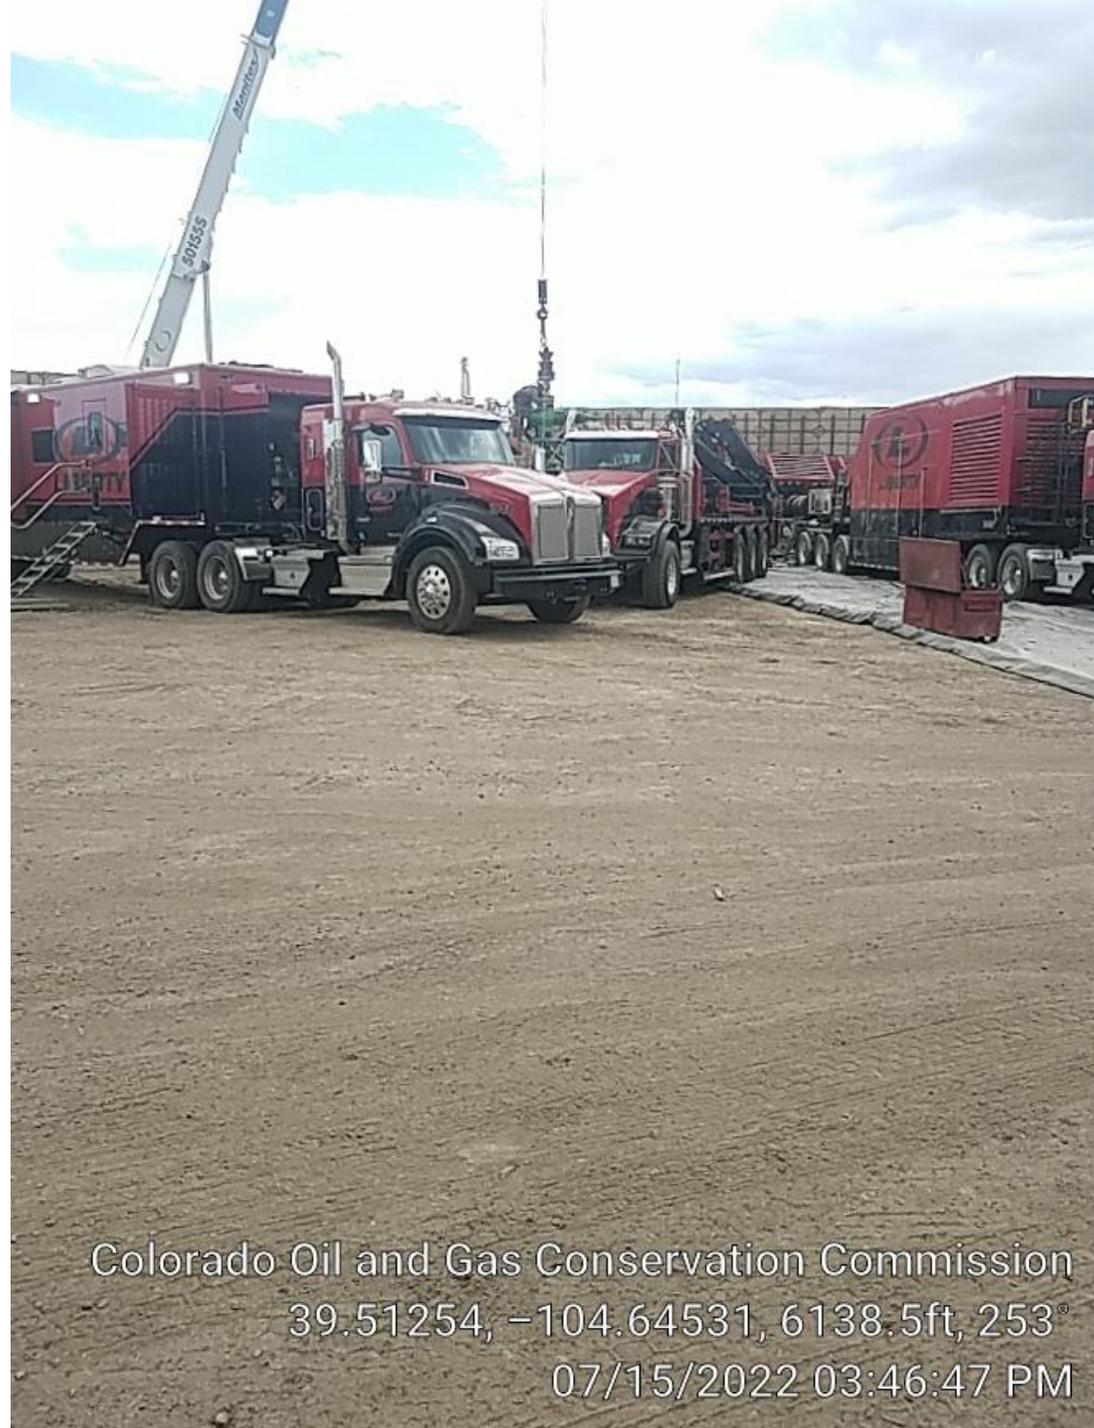
Colorado Oil and Gas Conservation Commission  
39.51254, -104.64531, 6138.5ft, 253°  
07/15/2022 03:46:47 PM

Liberty Frac Crew

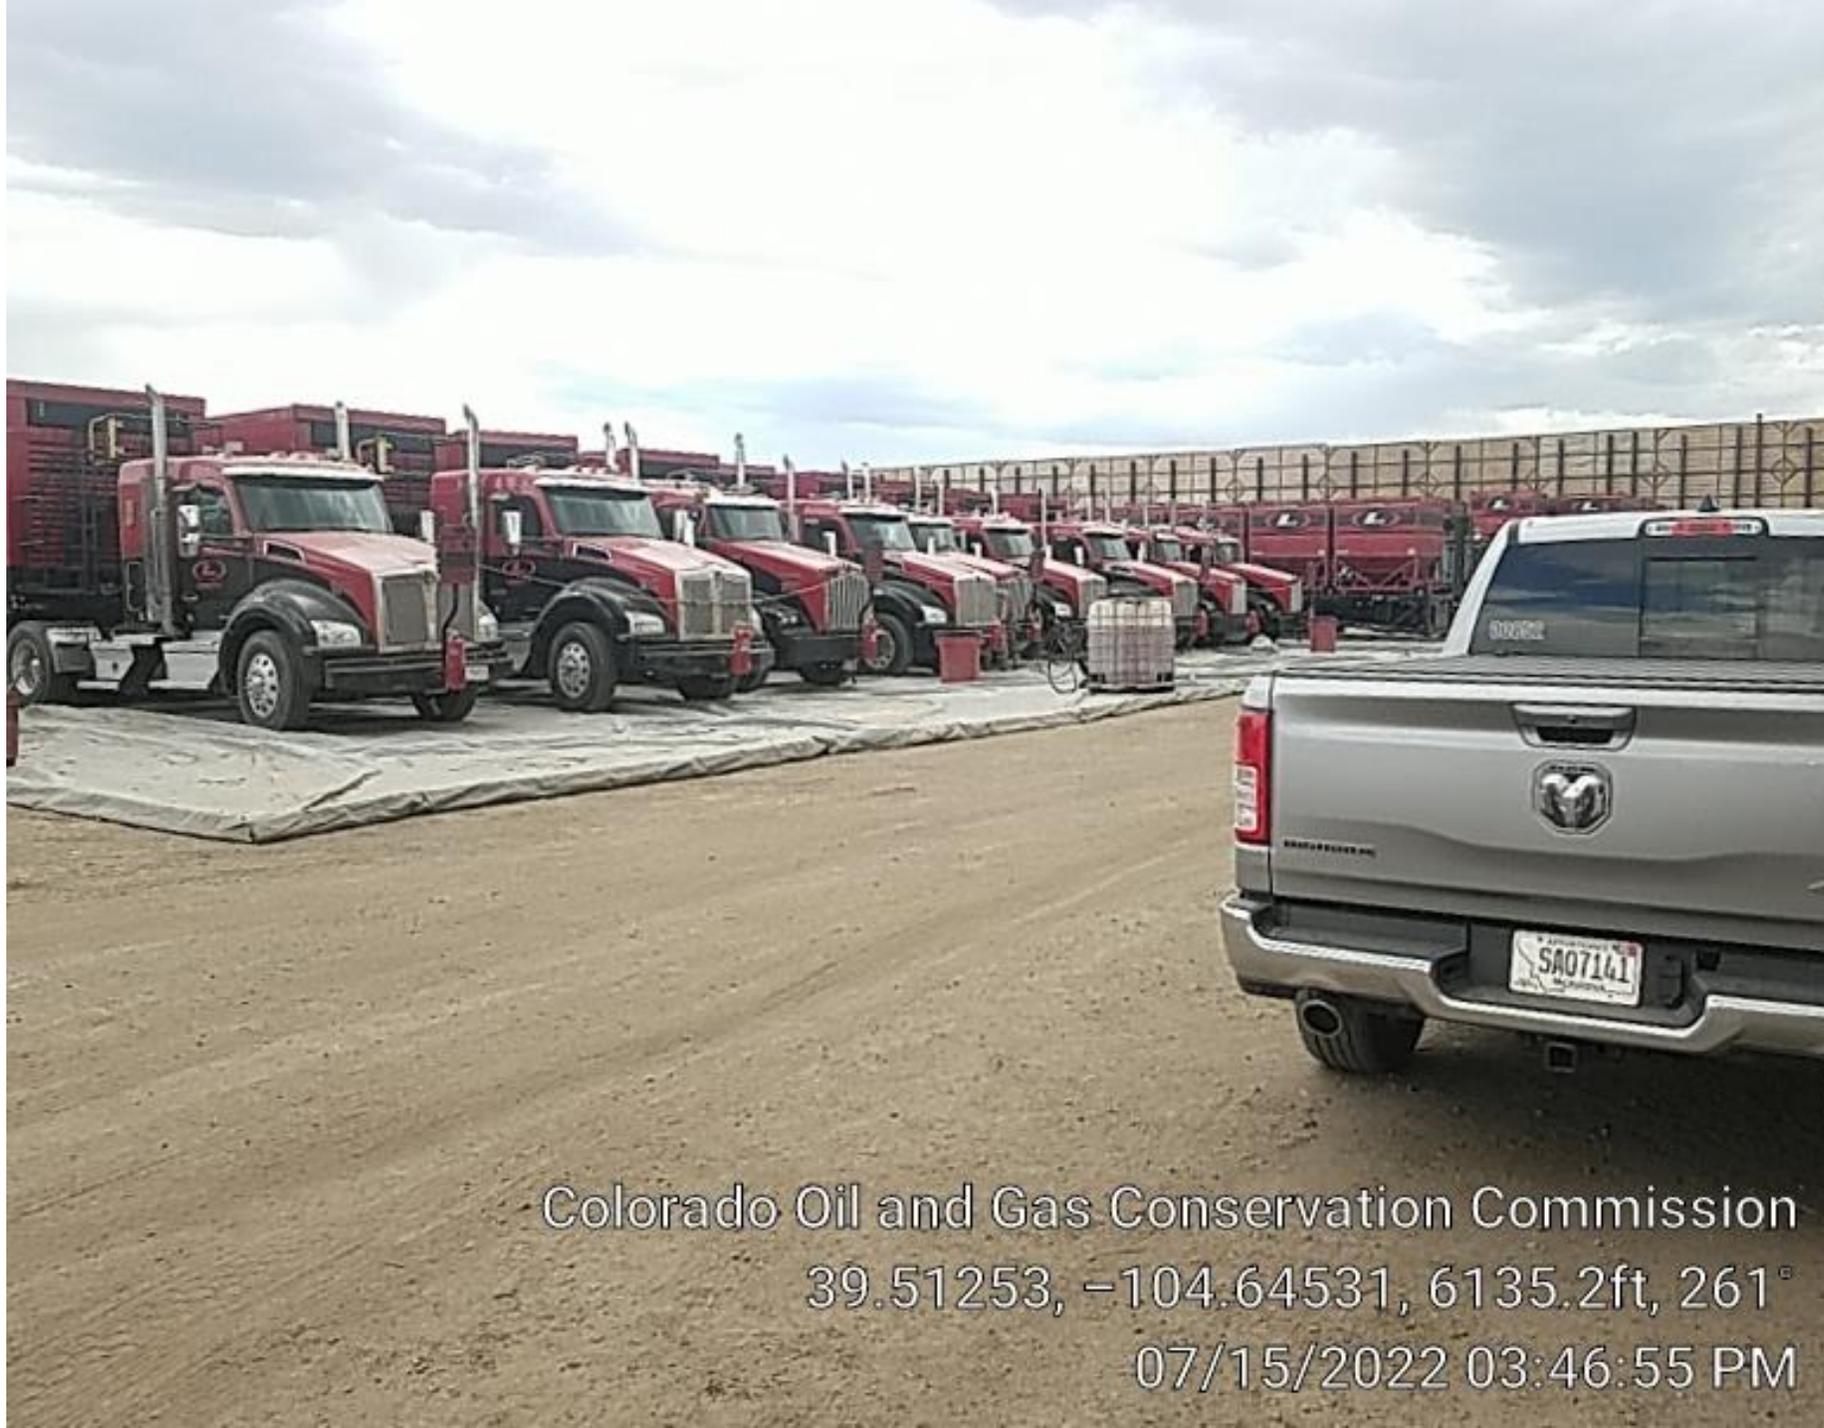
Colorado Oil and Gas Conservation Commission  
39.51253, -104.64531, 6135.2ft, 261°  
07/15/2022 03:46:55 PM

19 diesel  
pump trucks

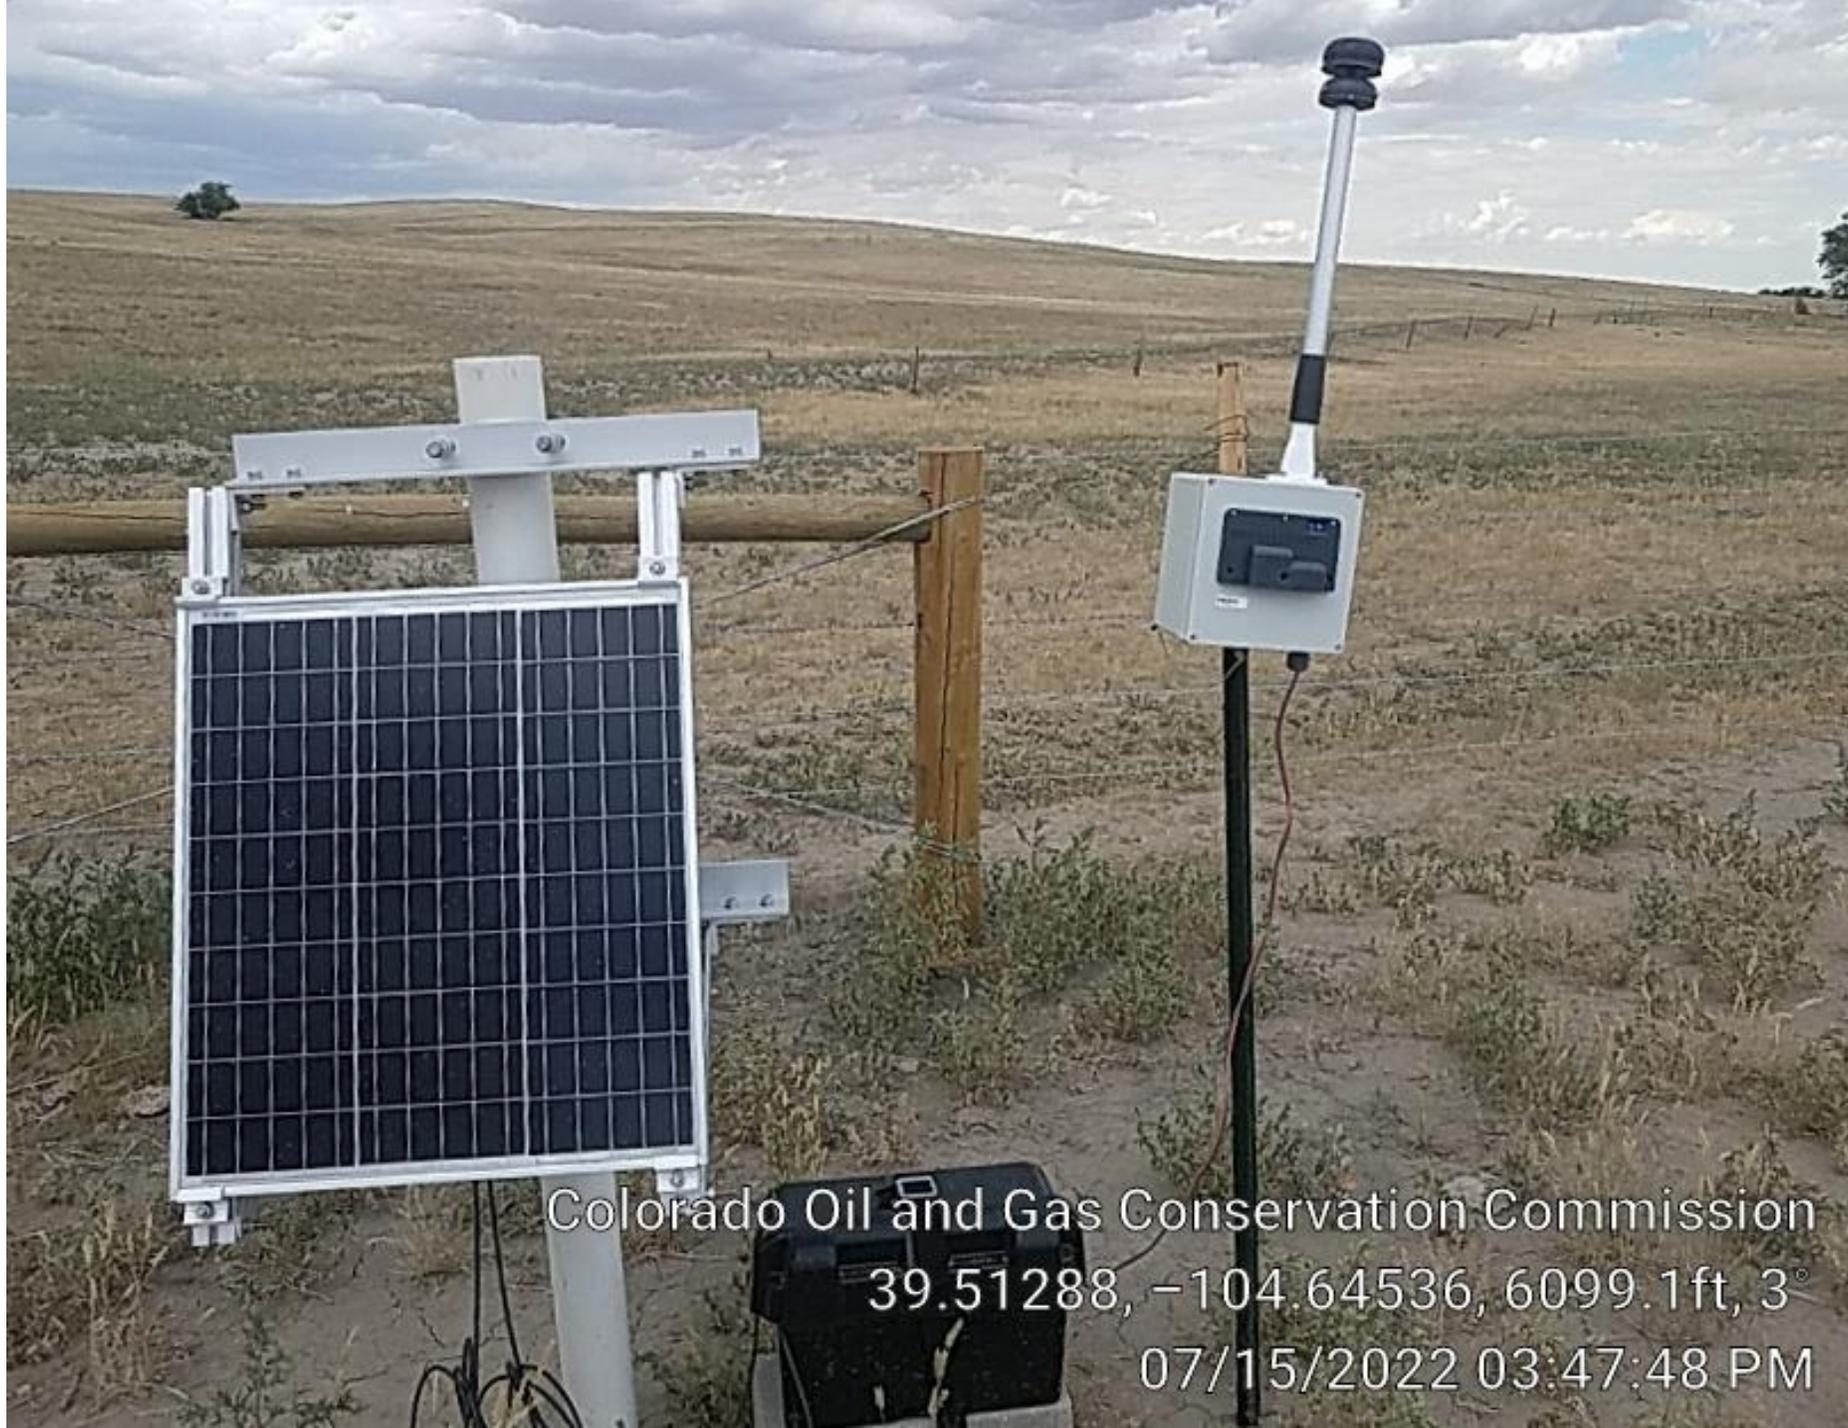
Colorado Oil and Gas Conservation Commission  
39.51288, -104.64536, 6099.1ft, 3°  
07/15/2022 03:47:48 PM

N meter at  
fence line,  
no sound  
wall

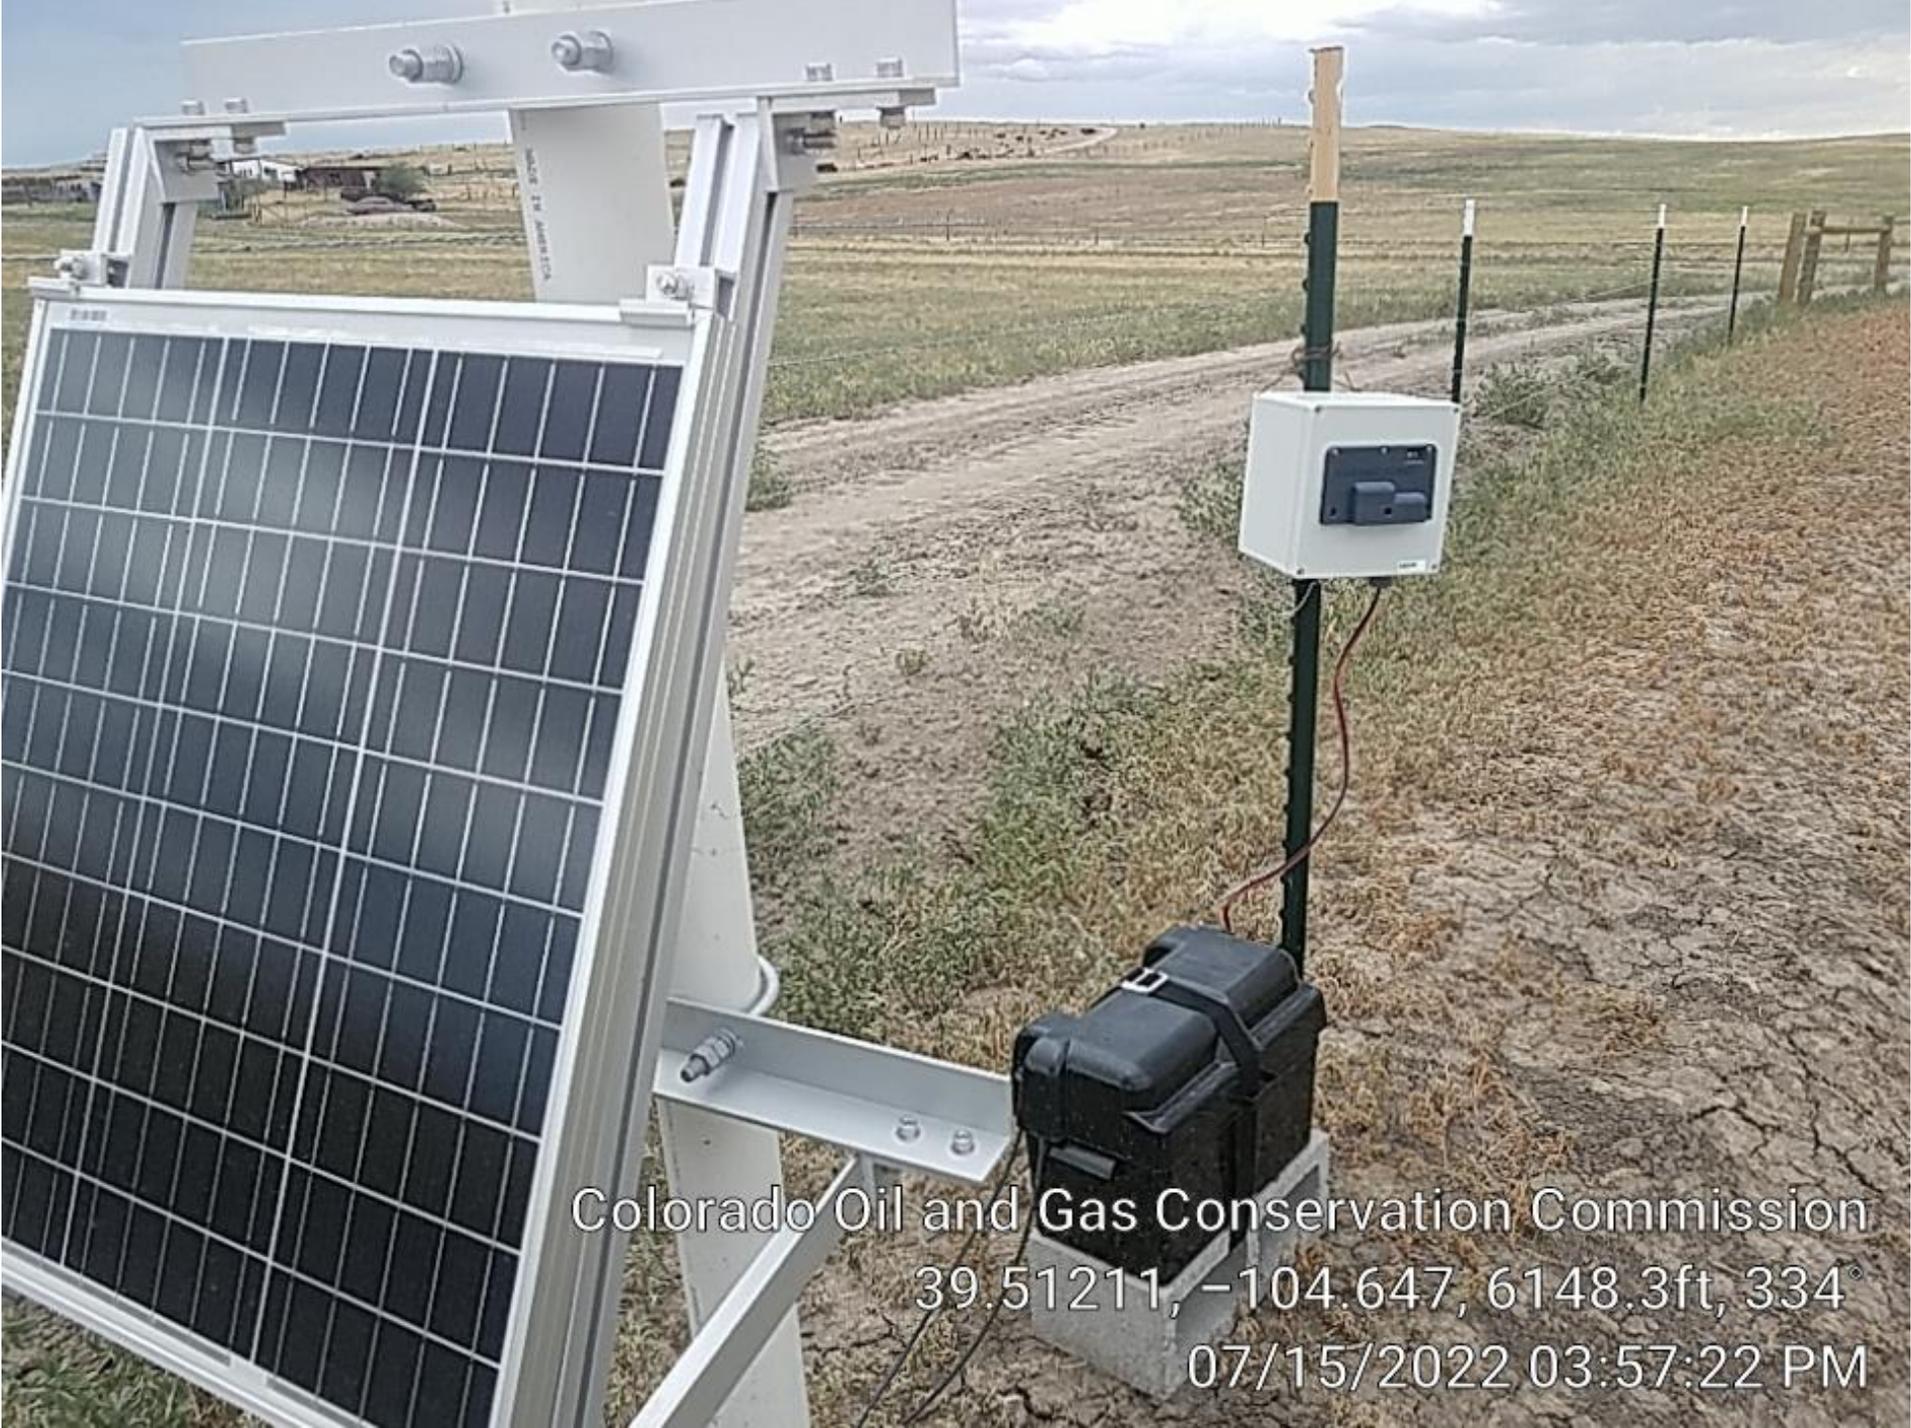
Colorado Oil and Gas Conservation Commission  
39.51211, -104.647, 6148.3ft, 334°  
07/15/2022 03:57:22 PM

W sound  
meter

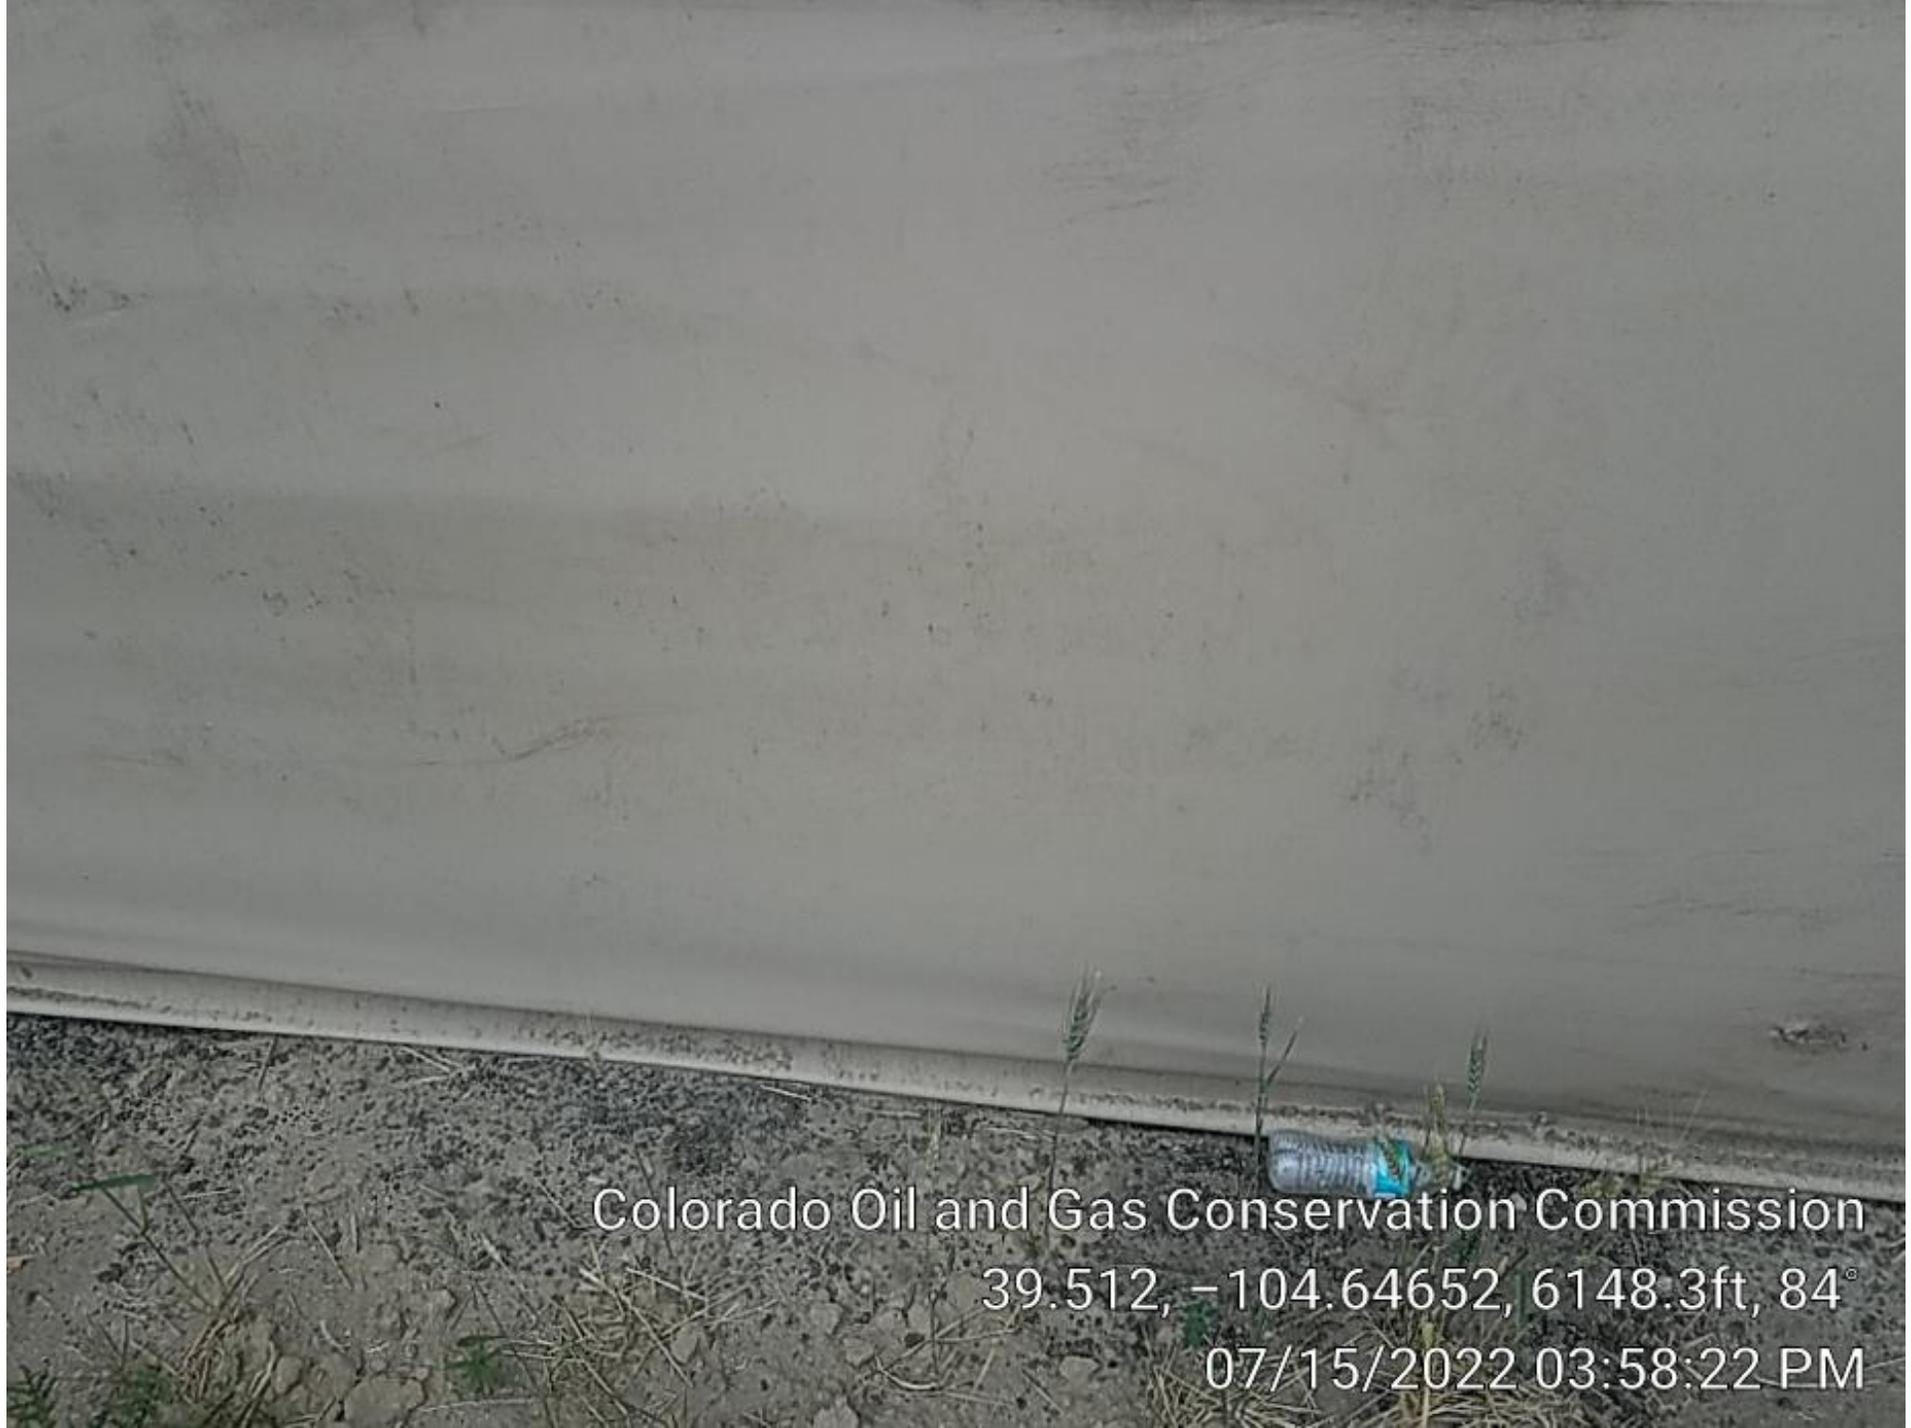
Sound  
wall east  
of west  
meter

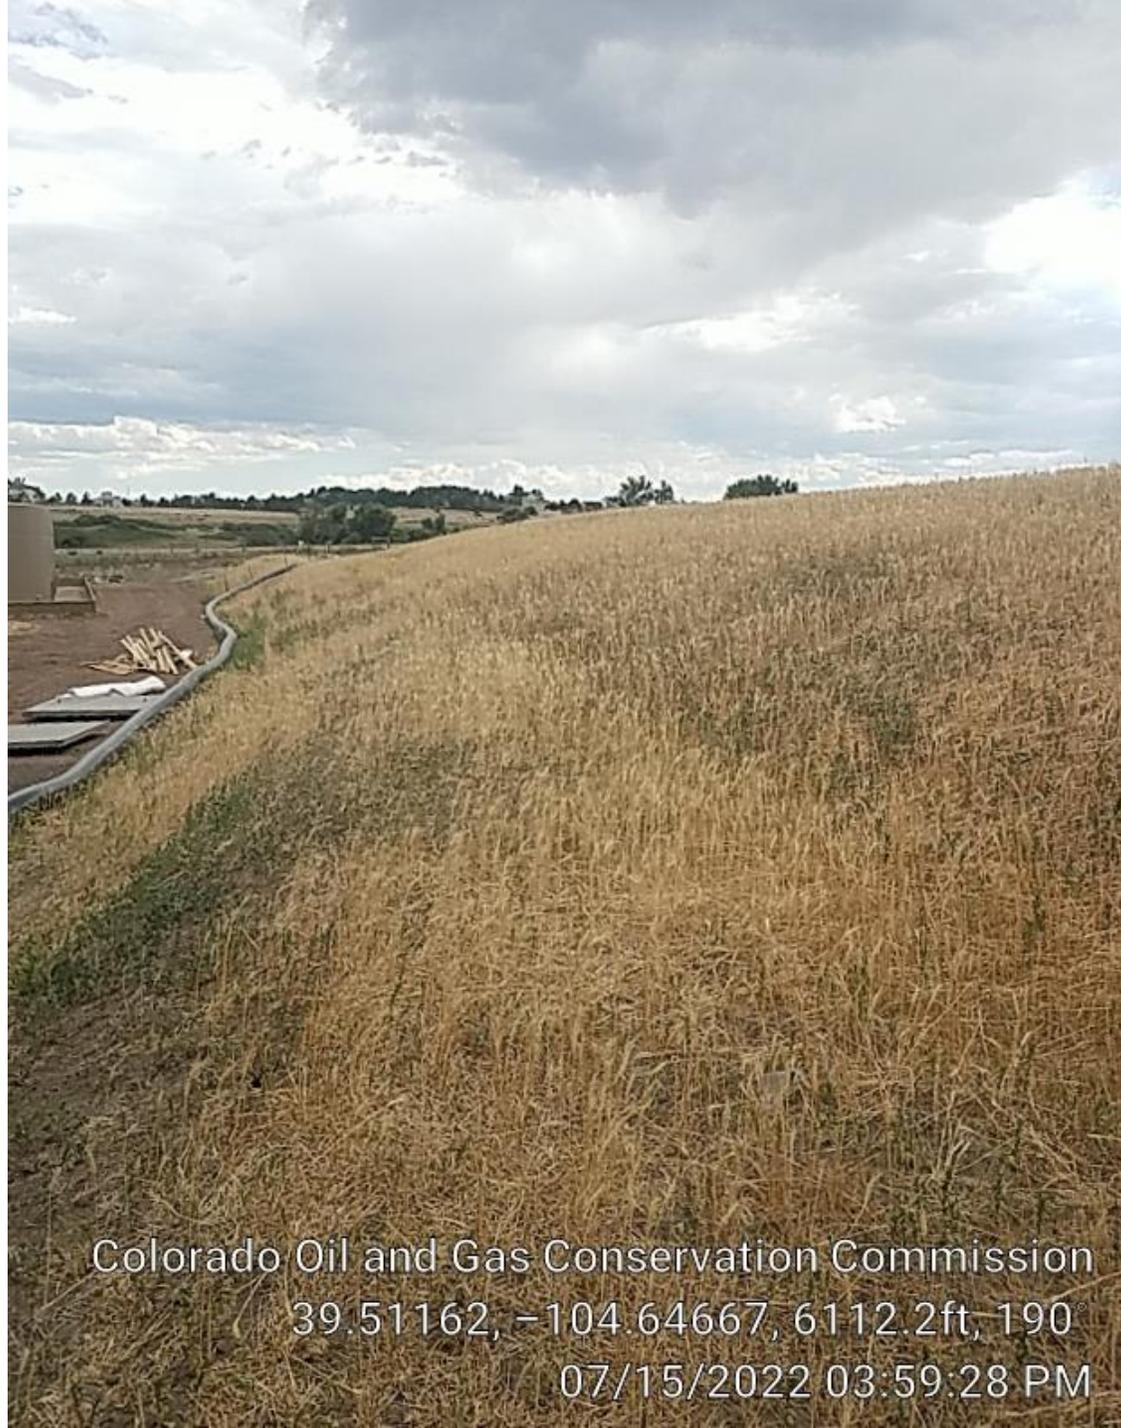
Colorado Oil and Gas Conservation Commission  
39.51162, -104.64667, 6112.2ft, 190°  
07/15/2022 03:59:28 PM

Production  
construction on  
other side of  
south sound  
wall

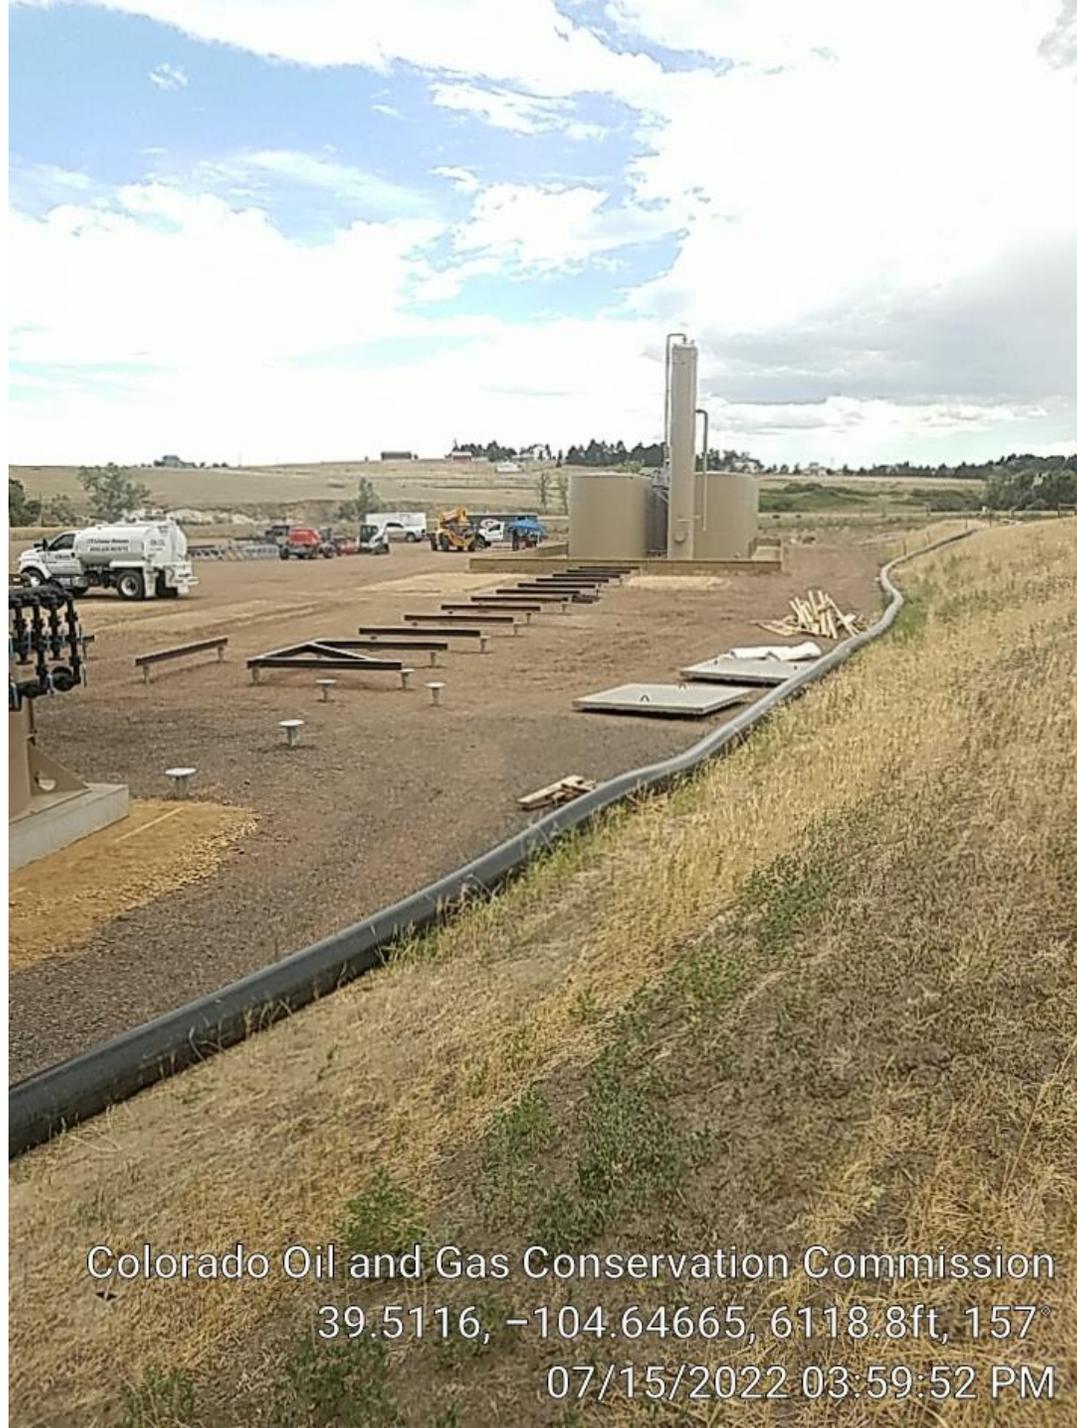
Colorado Oil and Gas Conservation Commission  
39.5116, -104.64665, 6118.8ft, 157°  
07/15/2022 03:59:52 PM

Water line for frac.

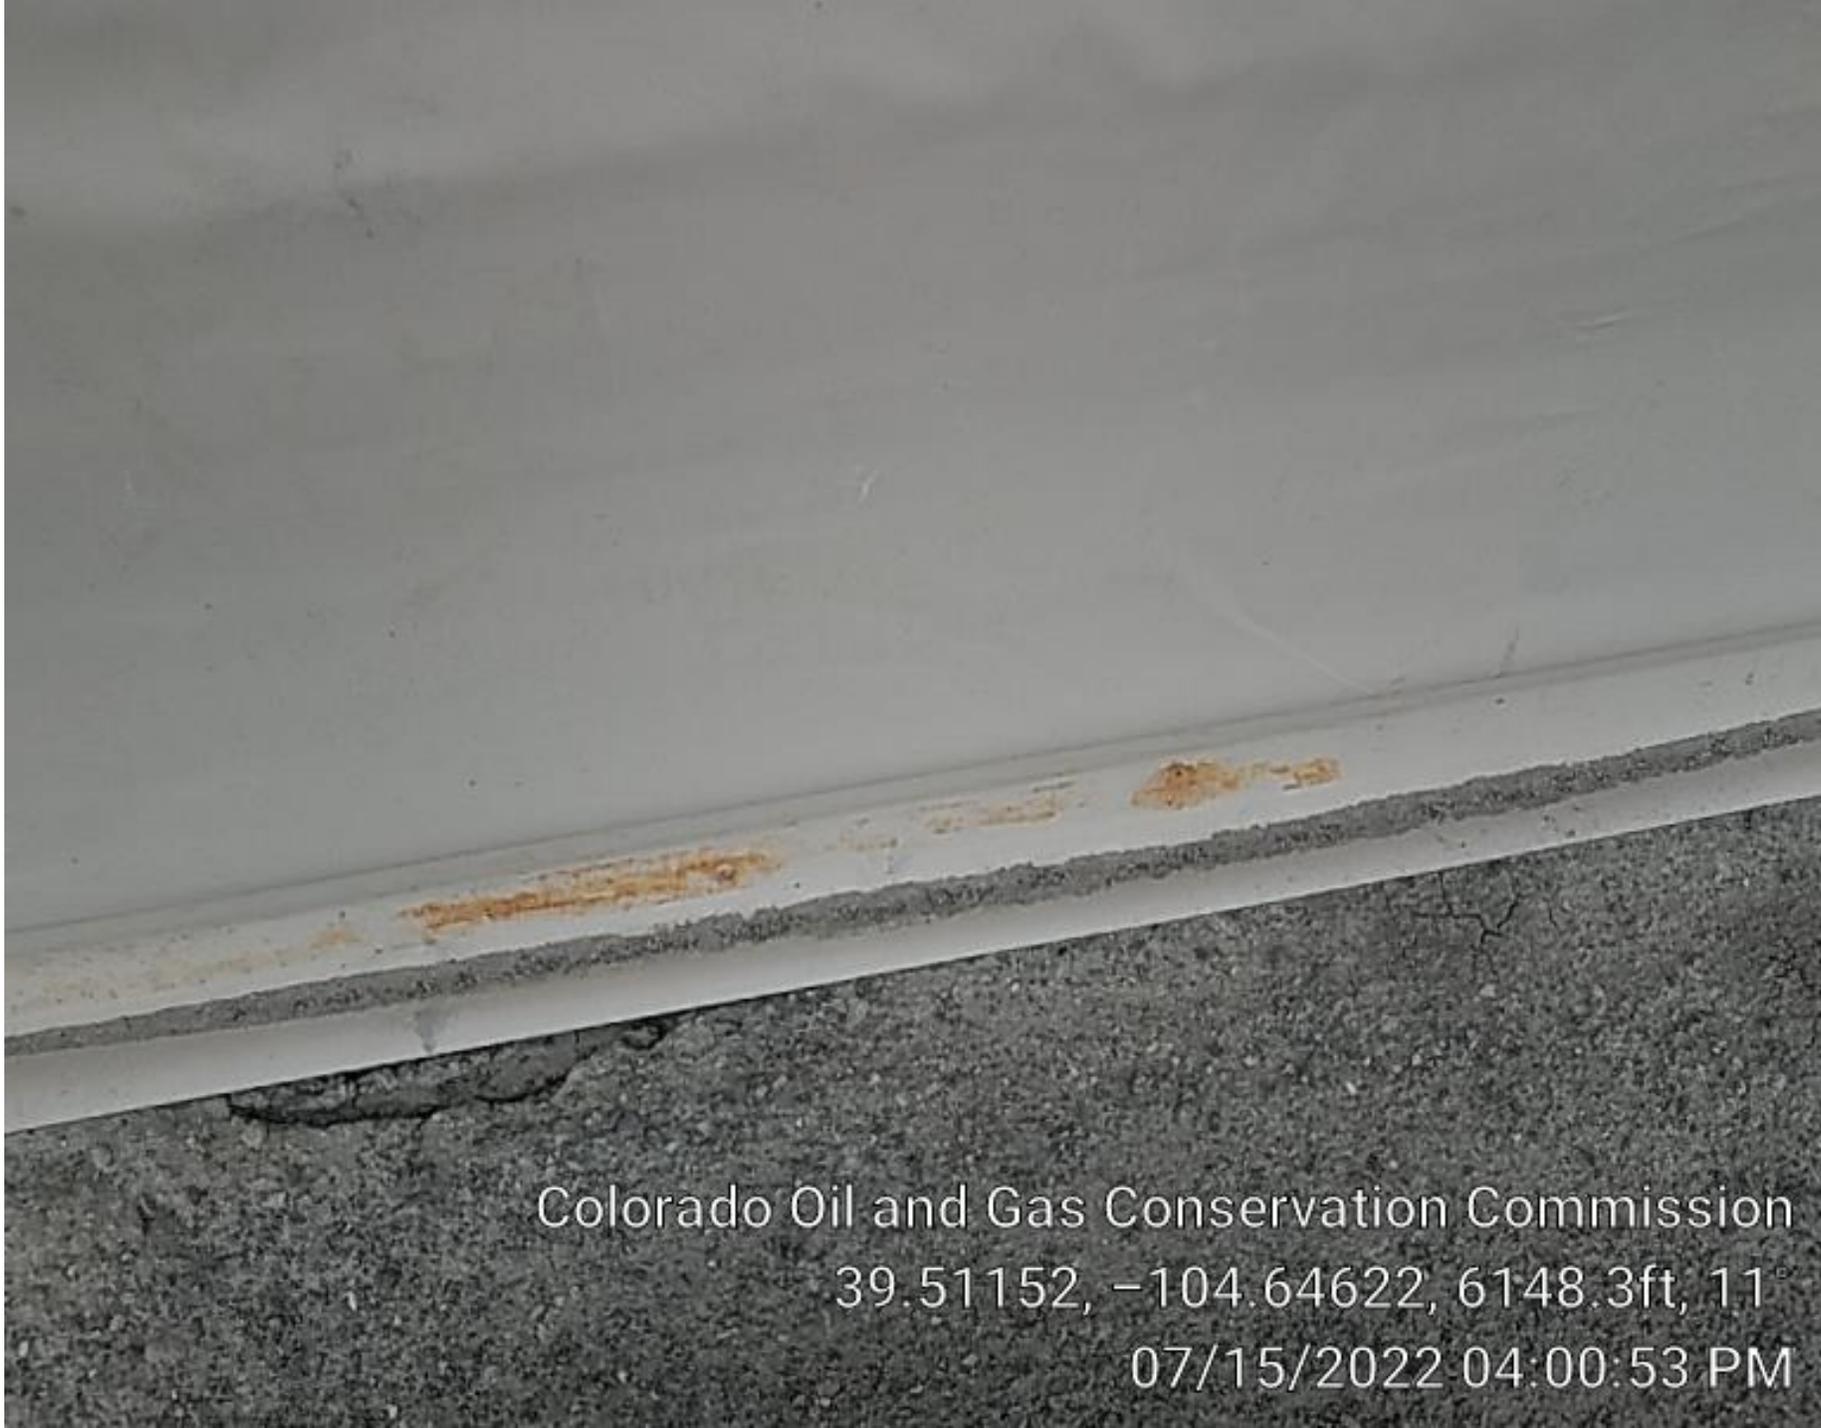
Colorado Oil and Gas Conservation Commission  
39.51152, -104.64622, 6148.3ft, 11°  
07/15/2022 04:00:53 PM

Sound wall  
south of frac

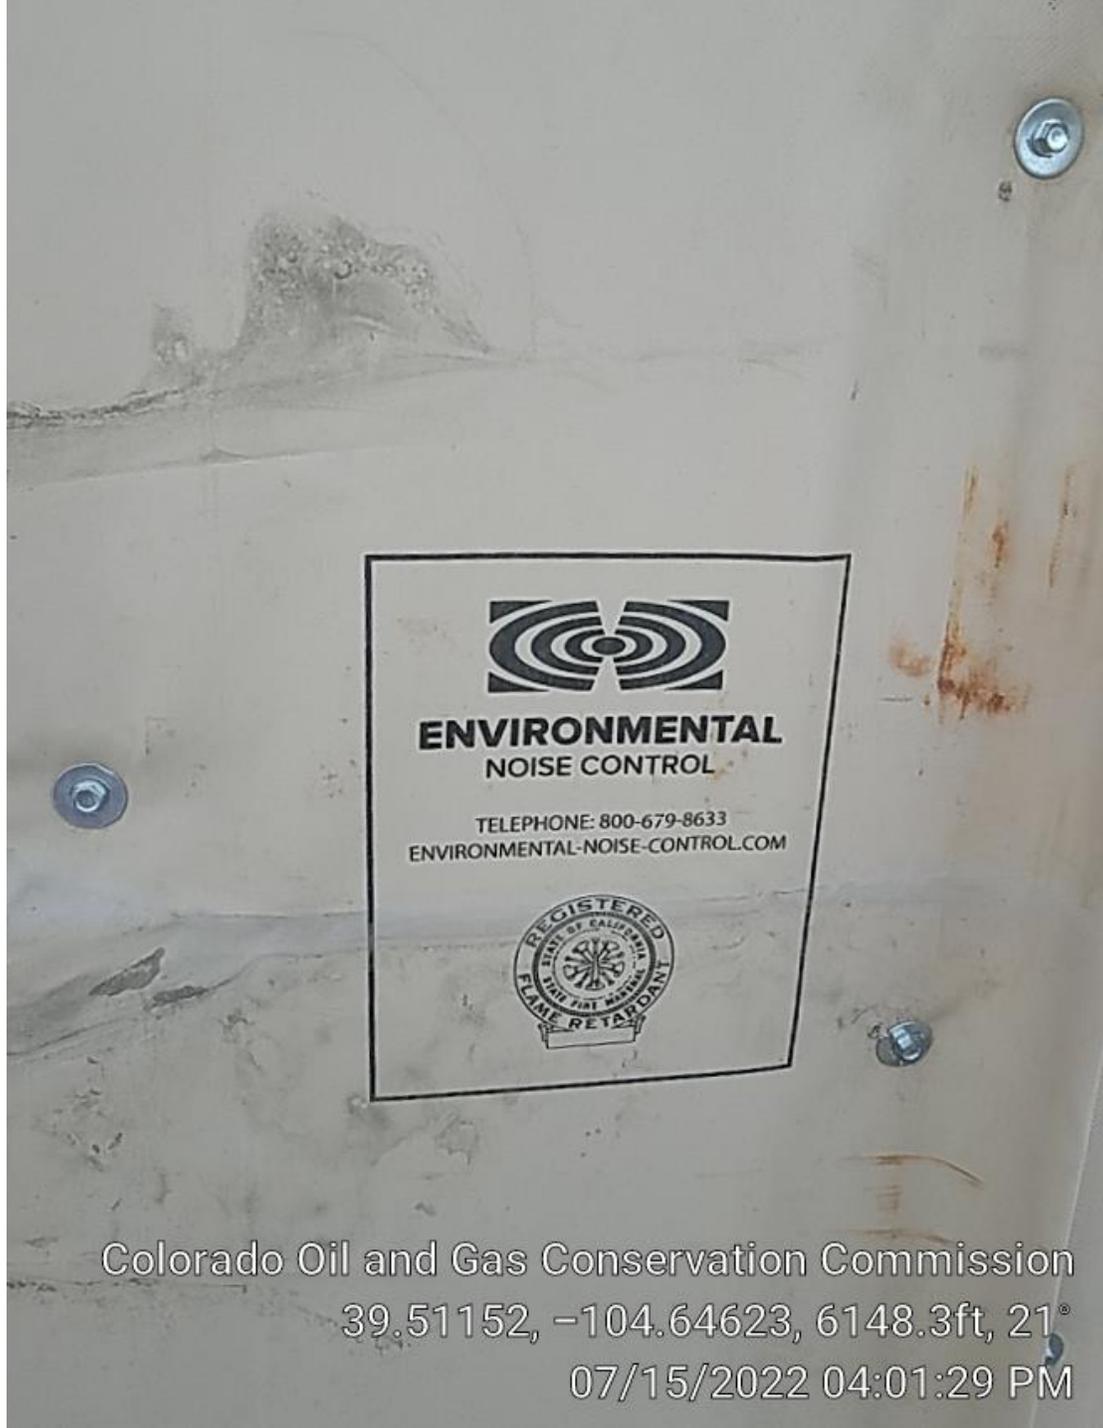
Colorado Oil and Gas Conservation Commission  
39.51152, -104.64623, 6148.3ft, 21°  
07/15/2022 04:01:29 PM

On sound wall

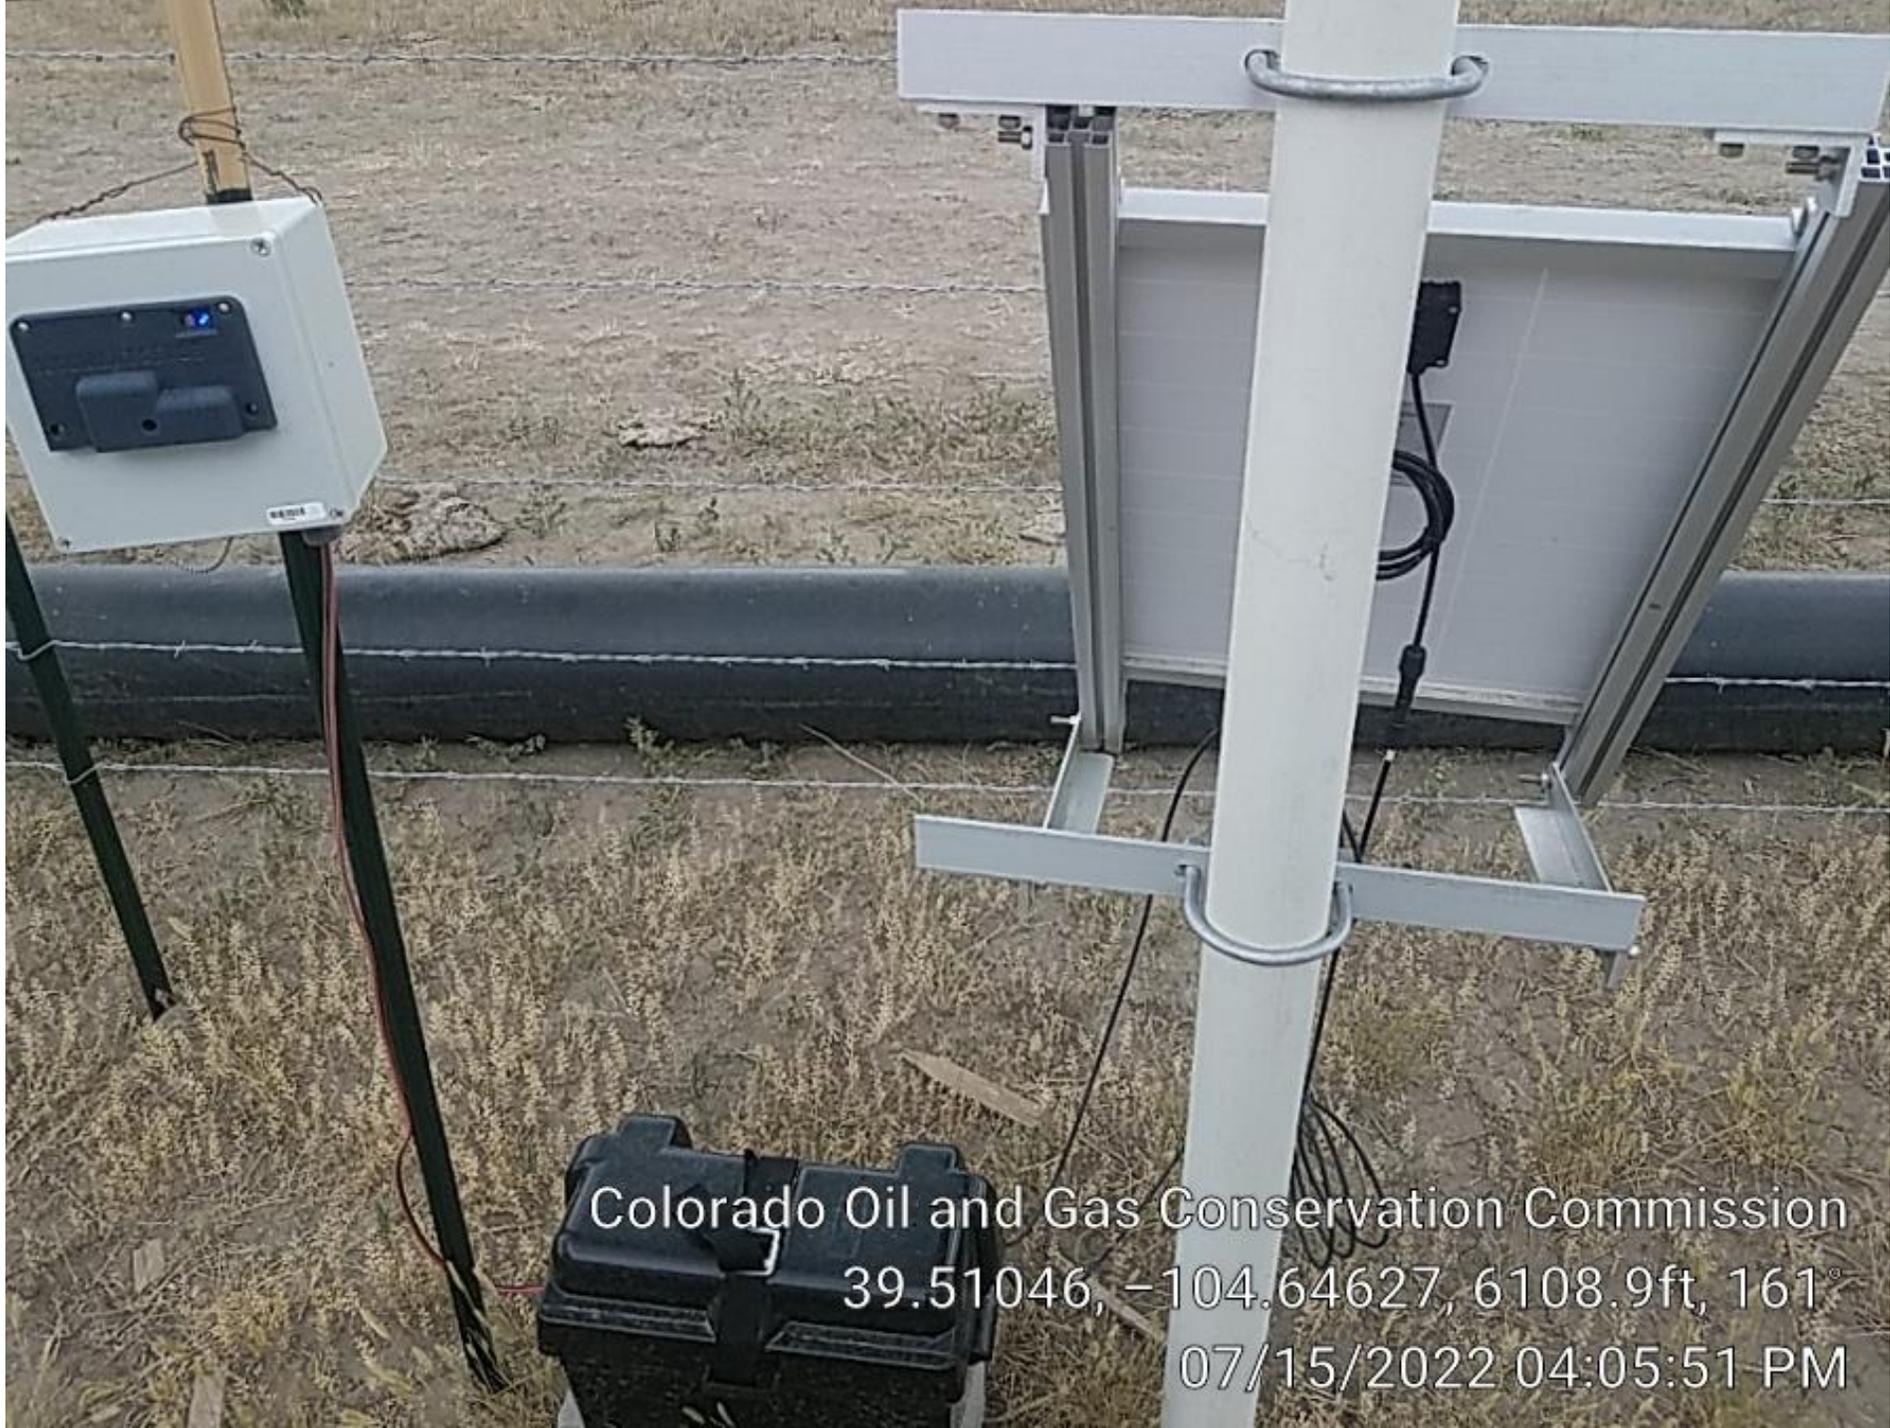
Colorado Oil and Gas Conservation Commission  
39.51046, -104.64627, 6108.9ft, 161°  
07/15/2022 04:05:51 PM

South  
meter
