GMT Exploration Company LLC, Crystal 6-65 22-10 10HN  
039-06742

Inspection #688312882

7/18/2022

Noise Complaint #403096728/Frac Inspection

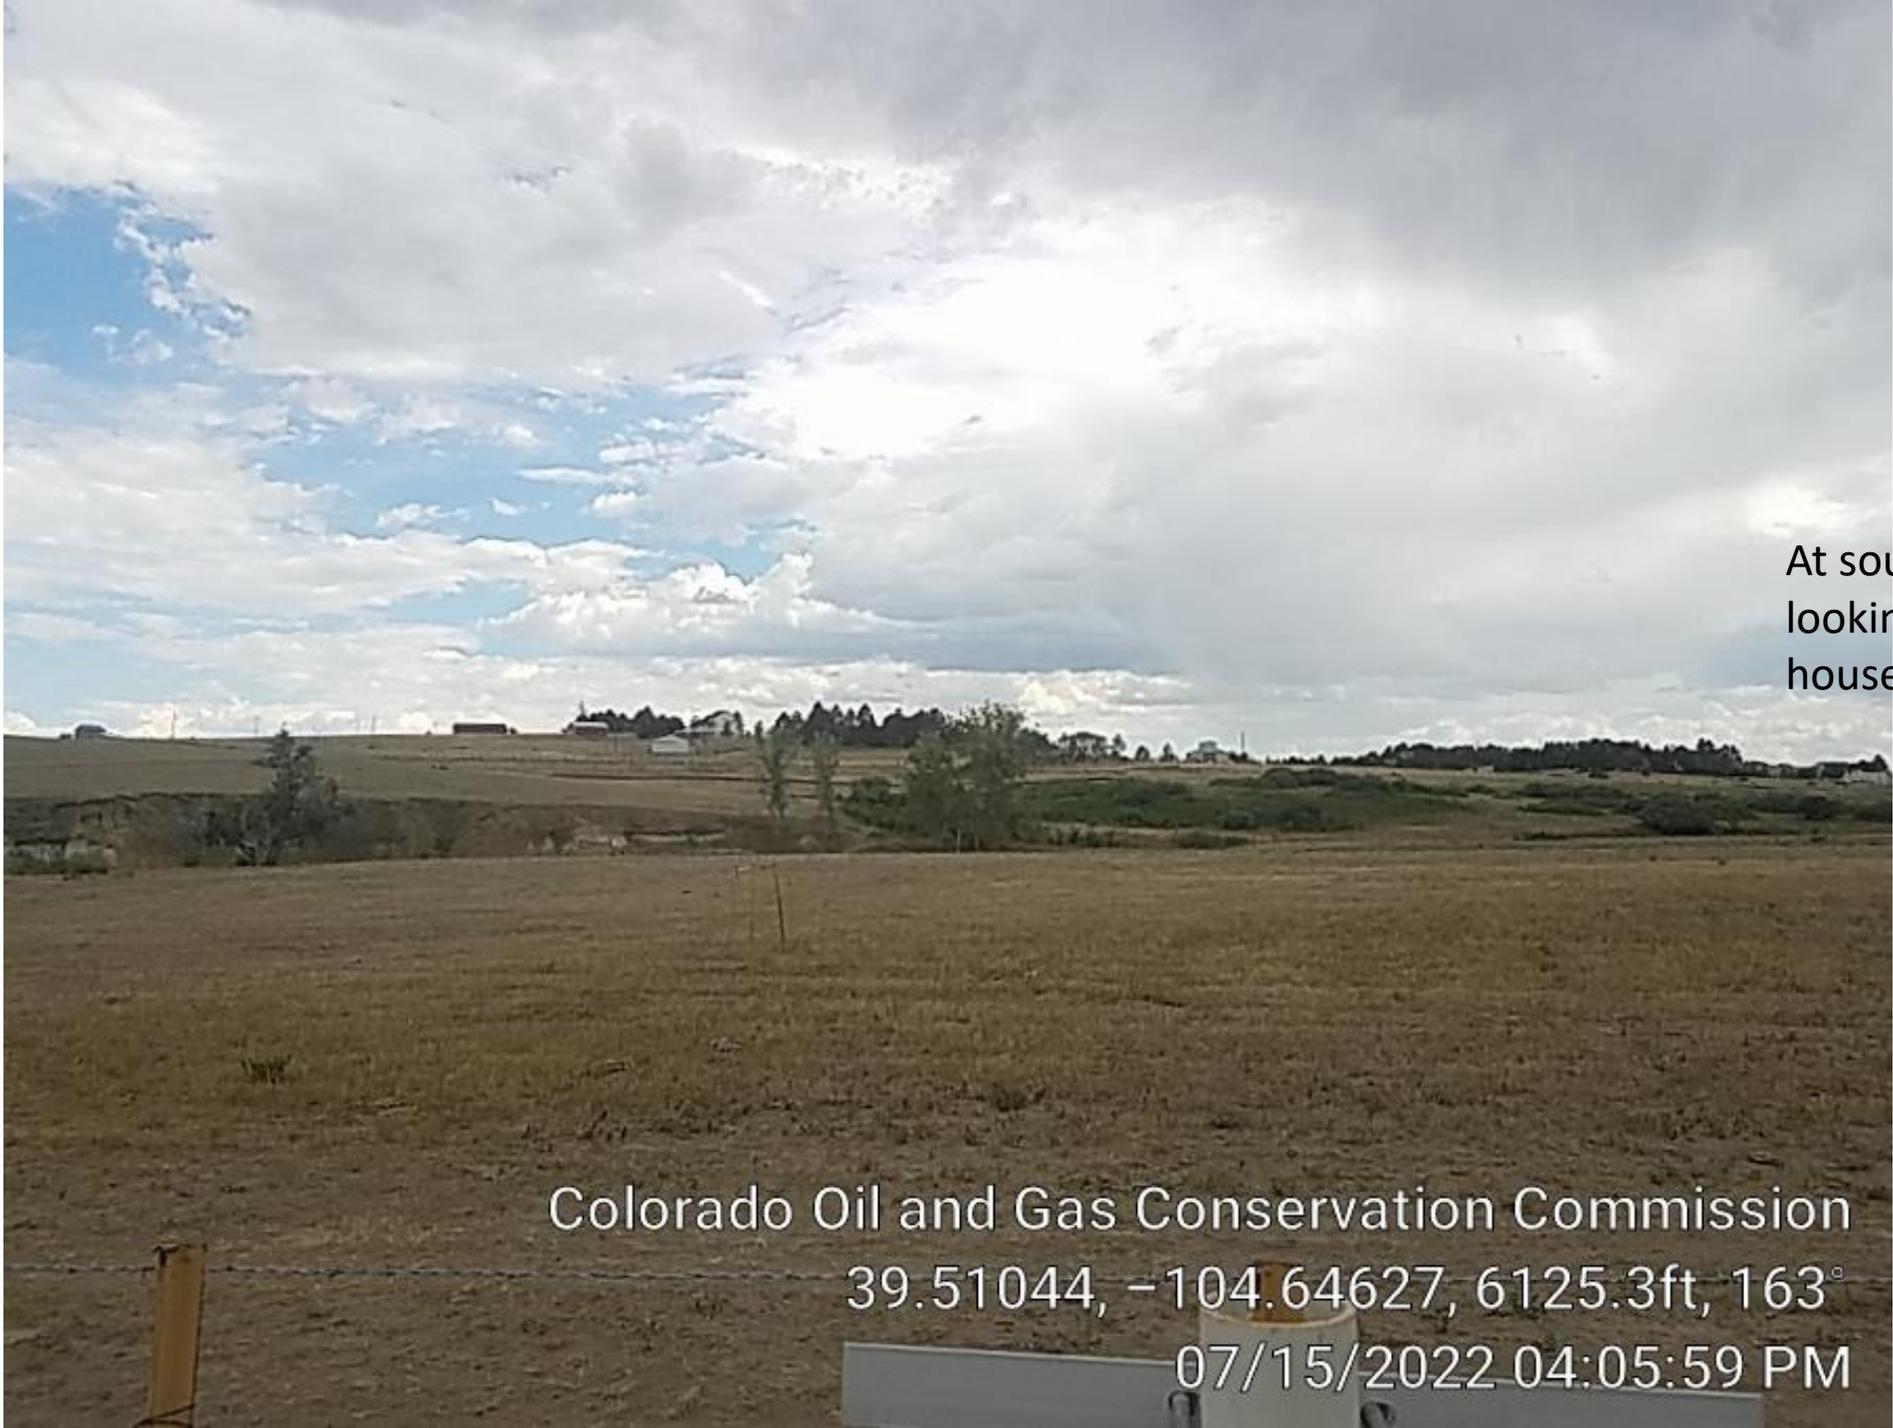
Colorado Oil and Gas Conservation Commission  
39.51044, -104.64627, 6125.3ft, 163°  
07/15/2022 04:05:59 PM

At sound meter  
looking south to  
houses

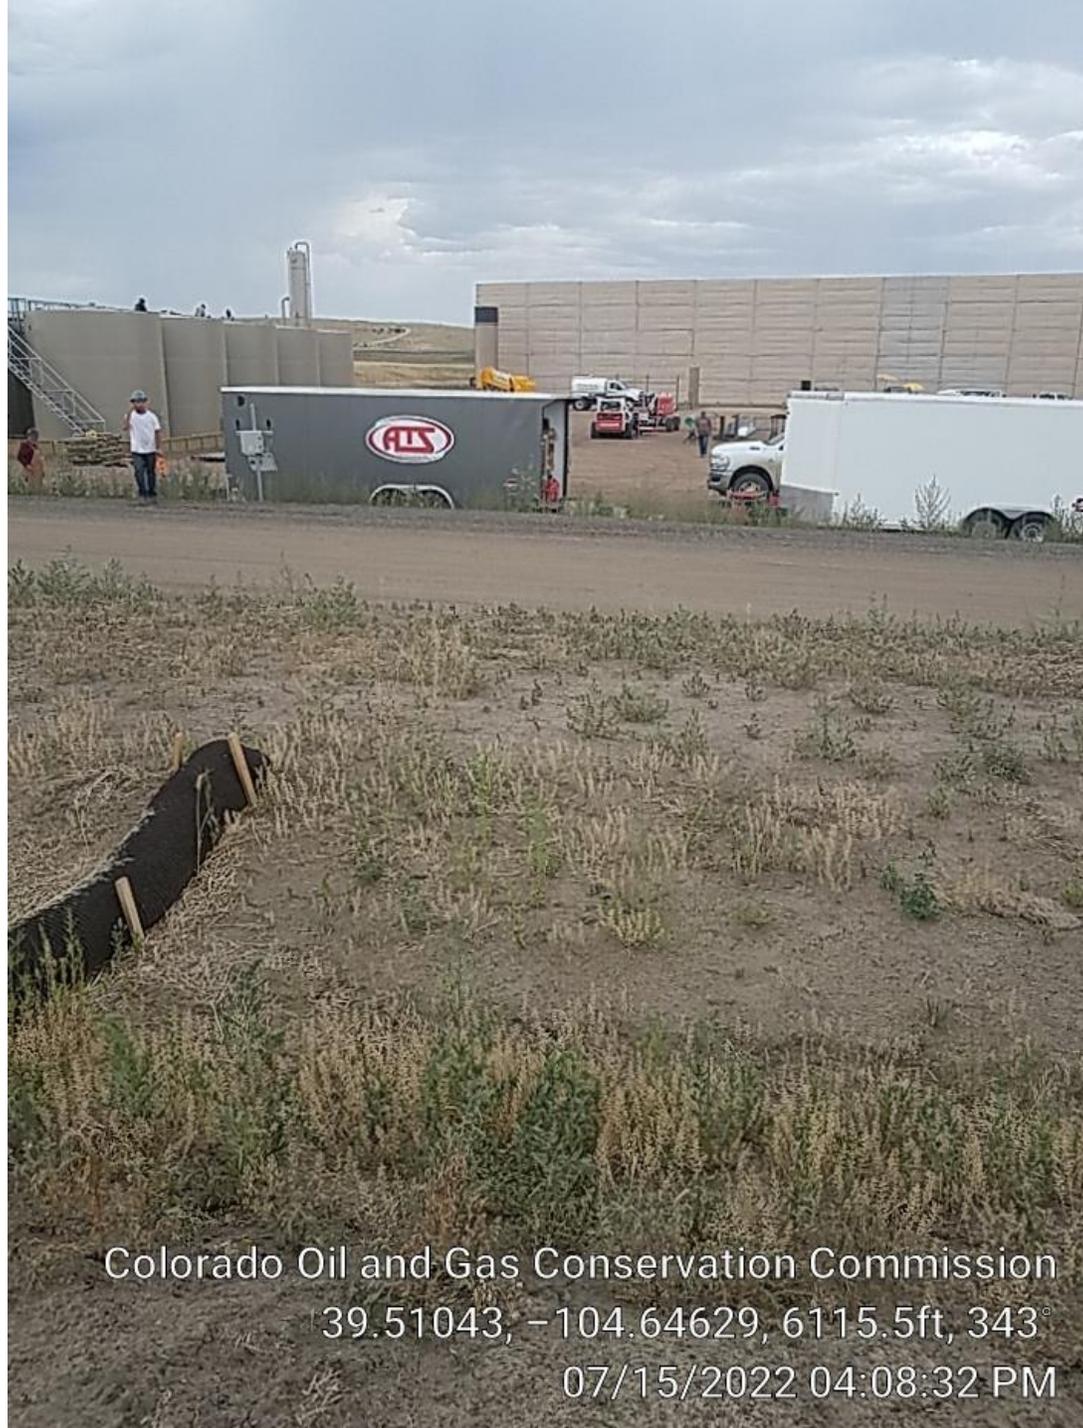
Colorado Oil and Gas Conservation Commission  
39.51043, -104.64629, 6115.5ft, 343°  
07/15/2022 04:08:32 PM

Construction area showing east sound wall.

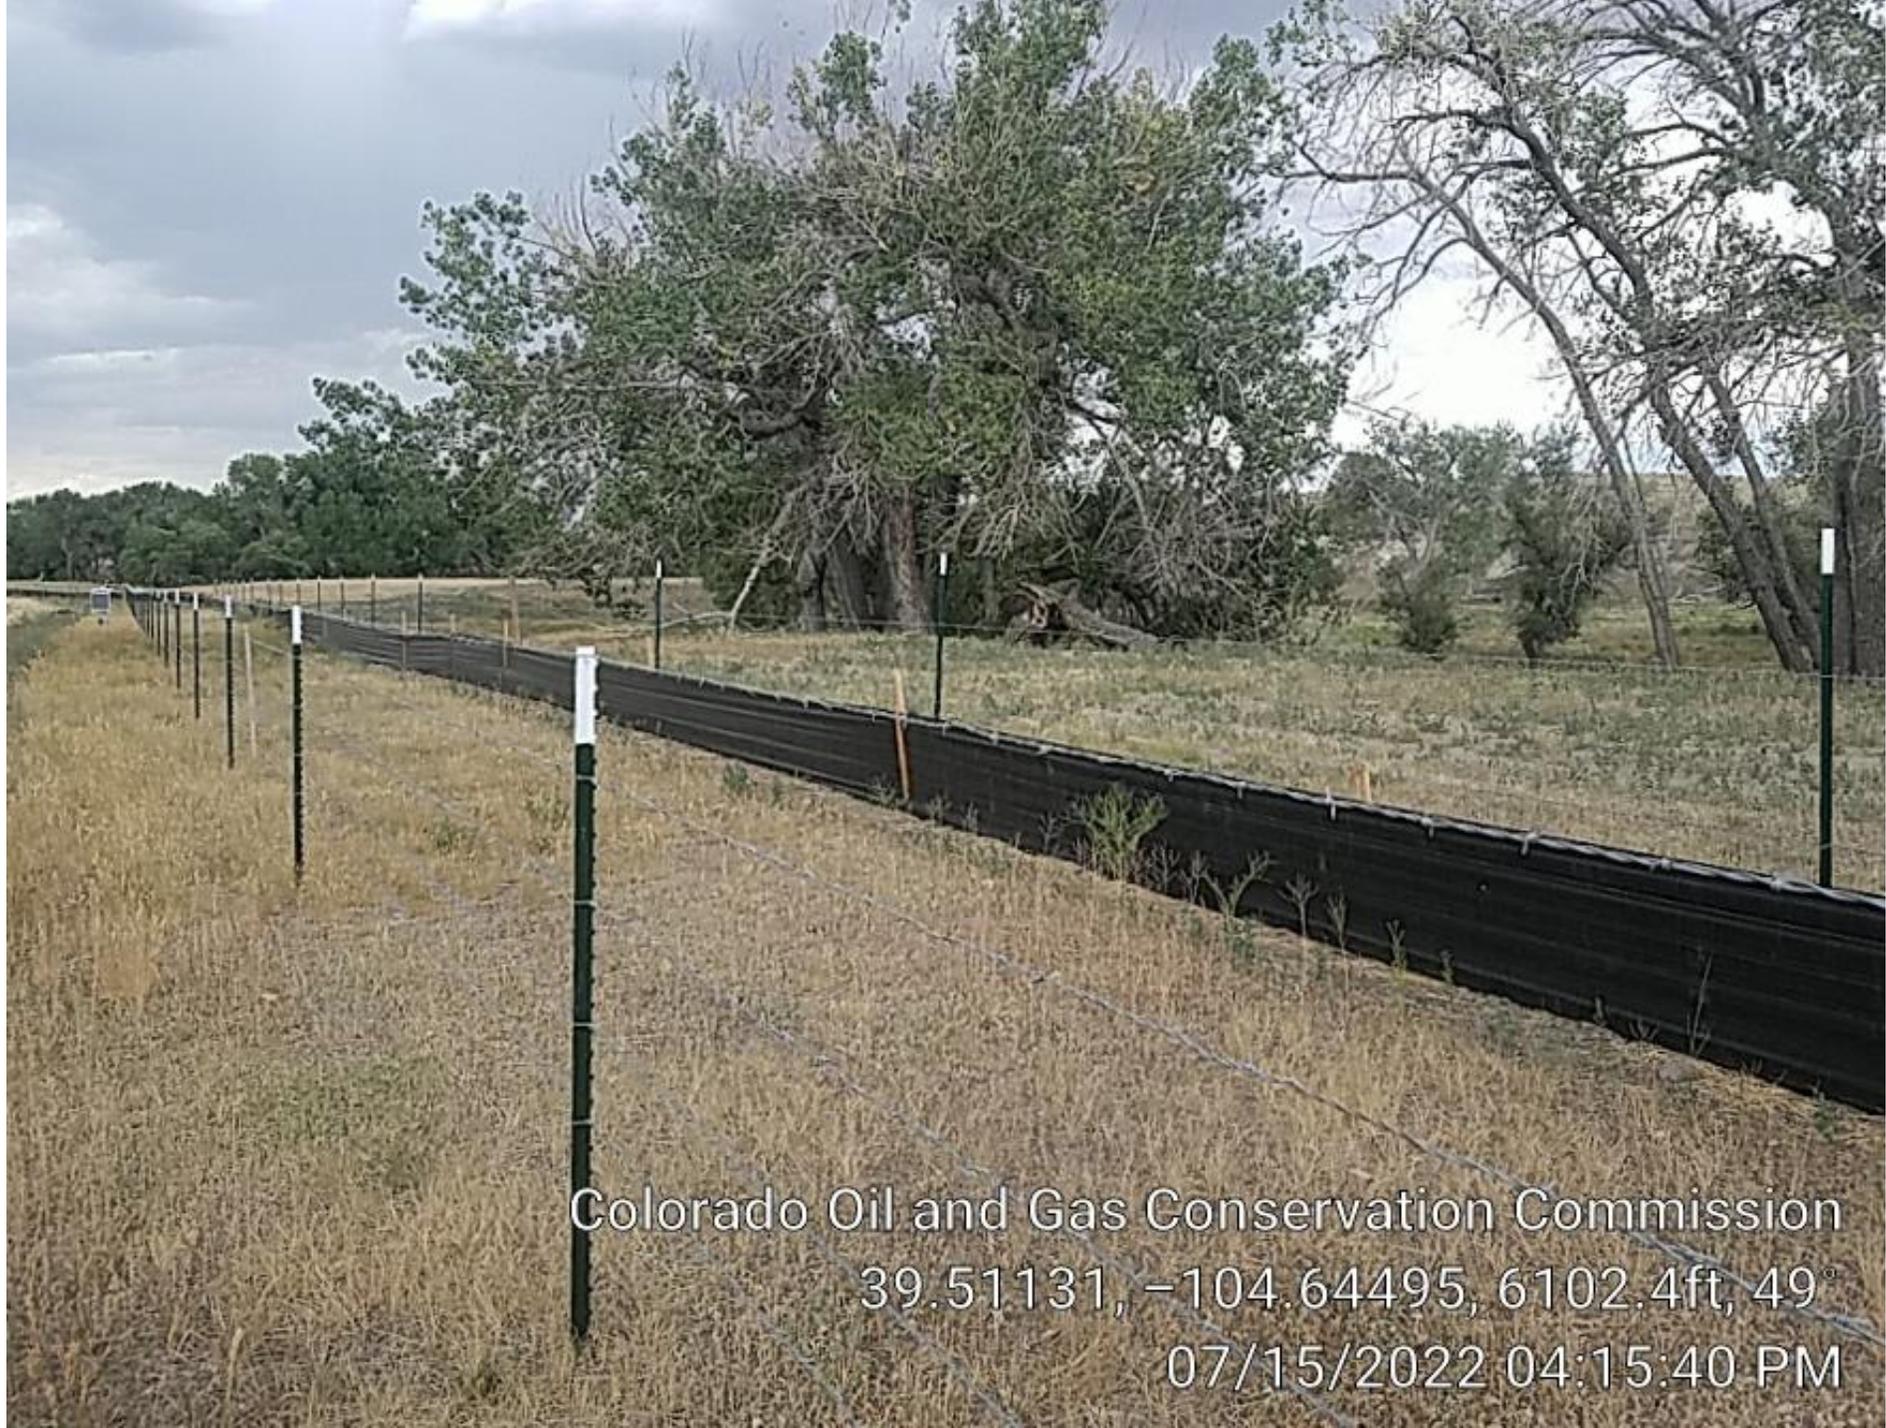
Colorado Oil and Gas Conservation Commission  
39.51131, -104.64495, 6102.4ft, 49°  
07/15/2022 04:15:40 PM

Frog fence  
on east  
side of  
location  
near Coal  
Creek.

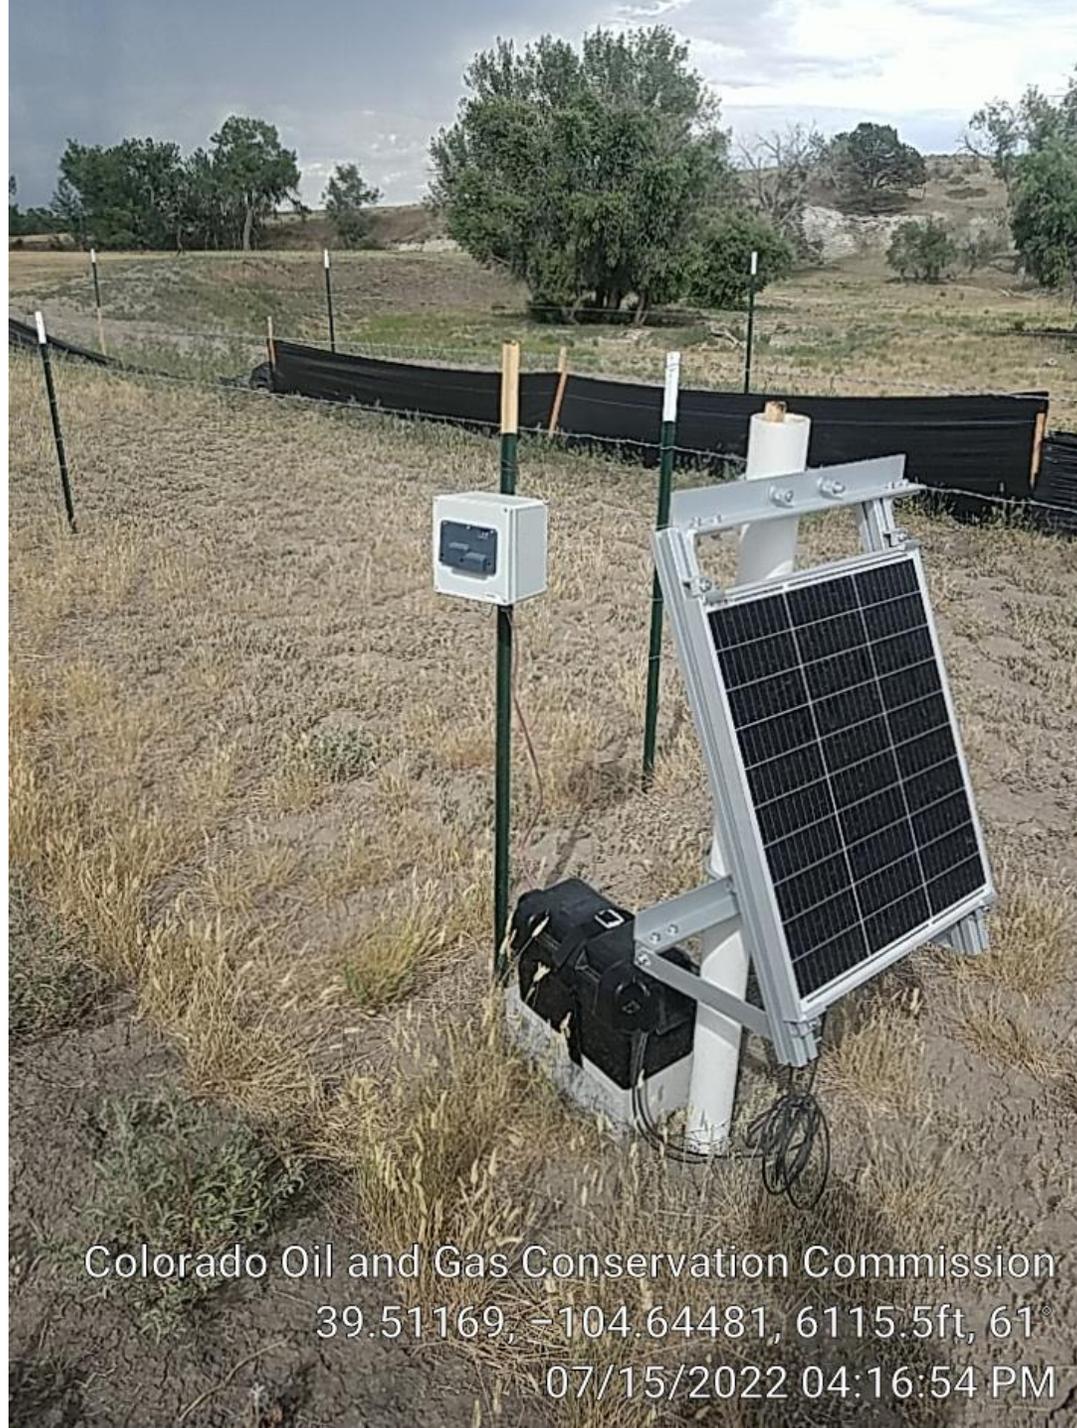
Colorado Oil and Gas Conservation Commission  
39.51169, -104.64481, 6115.5ft, 61°  
07/15/2022 04:16:54 PM

East meter, no  
sound wall

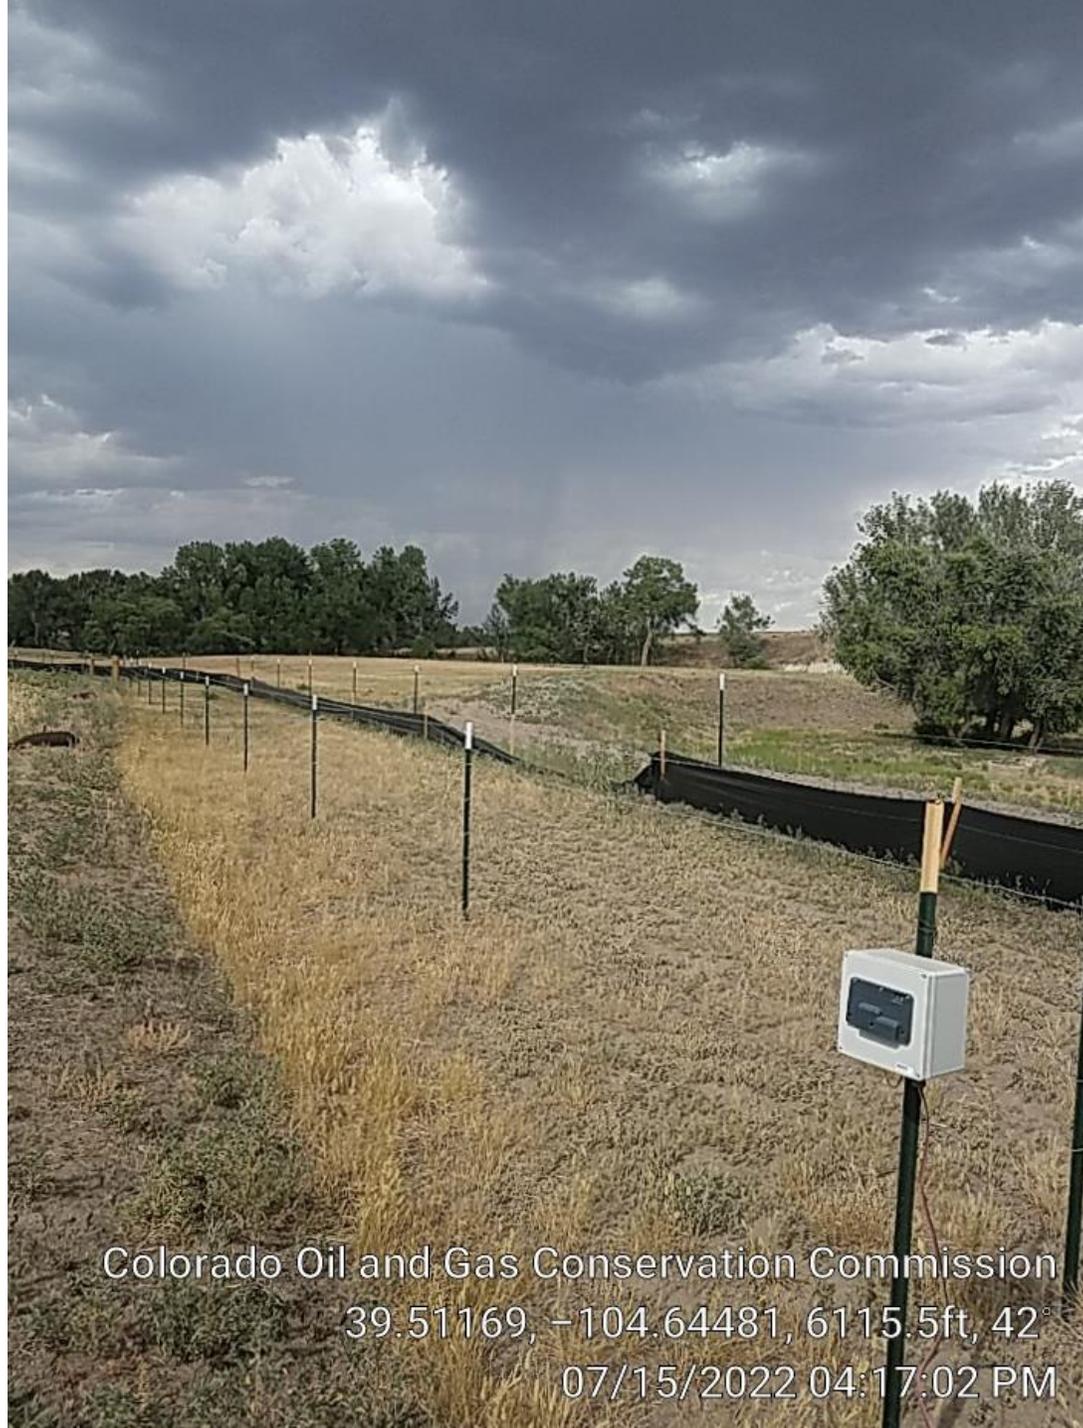
Colorado Oil and Gas Conservation Commission  
39.51169, -104.64481, 6115.5ft, 42°  
07/15/2022 04:17:02 PM

East side of location, frog fence down, inspector told consultant at frac to fix it.
