Location Name: RED ROCKS NO. 35-15, API #: 071-09919, Insp. #:69510645

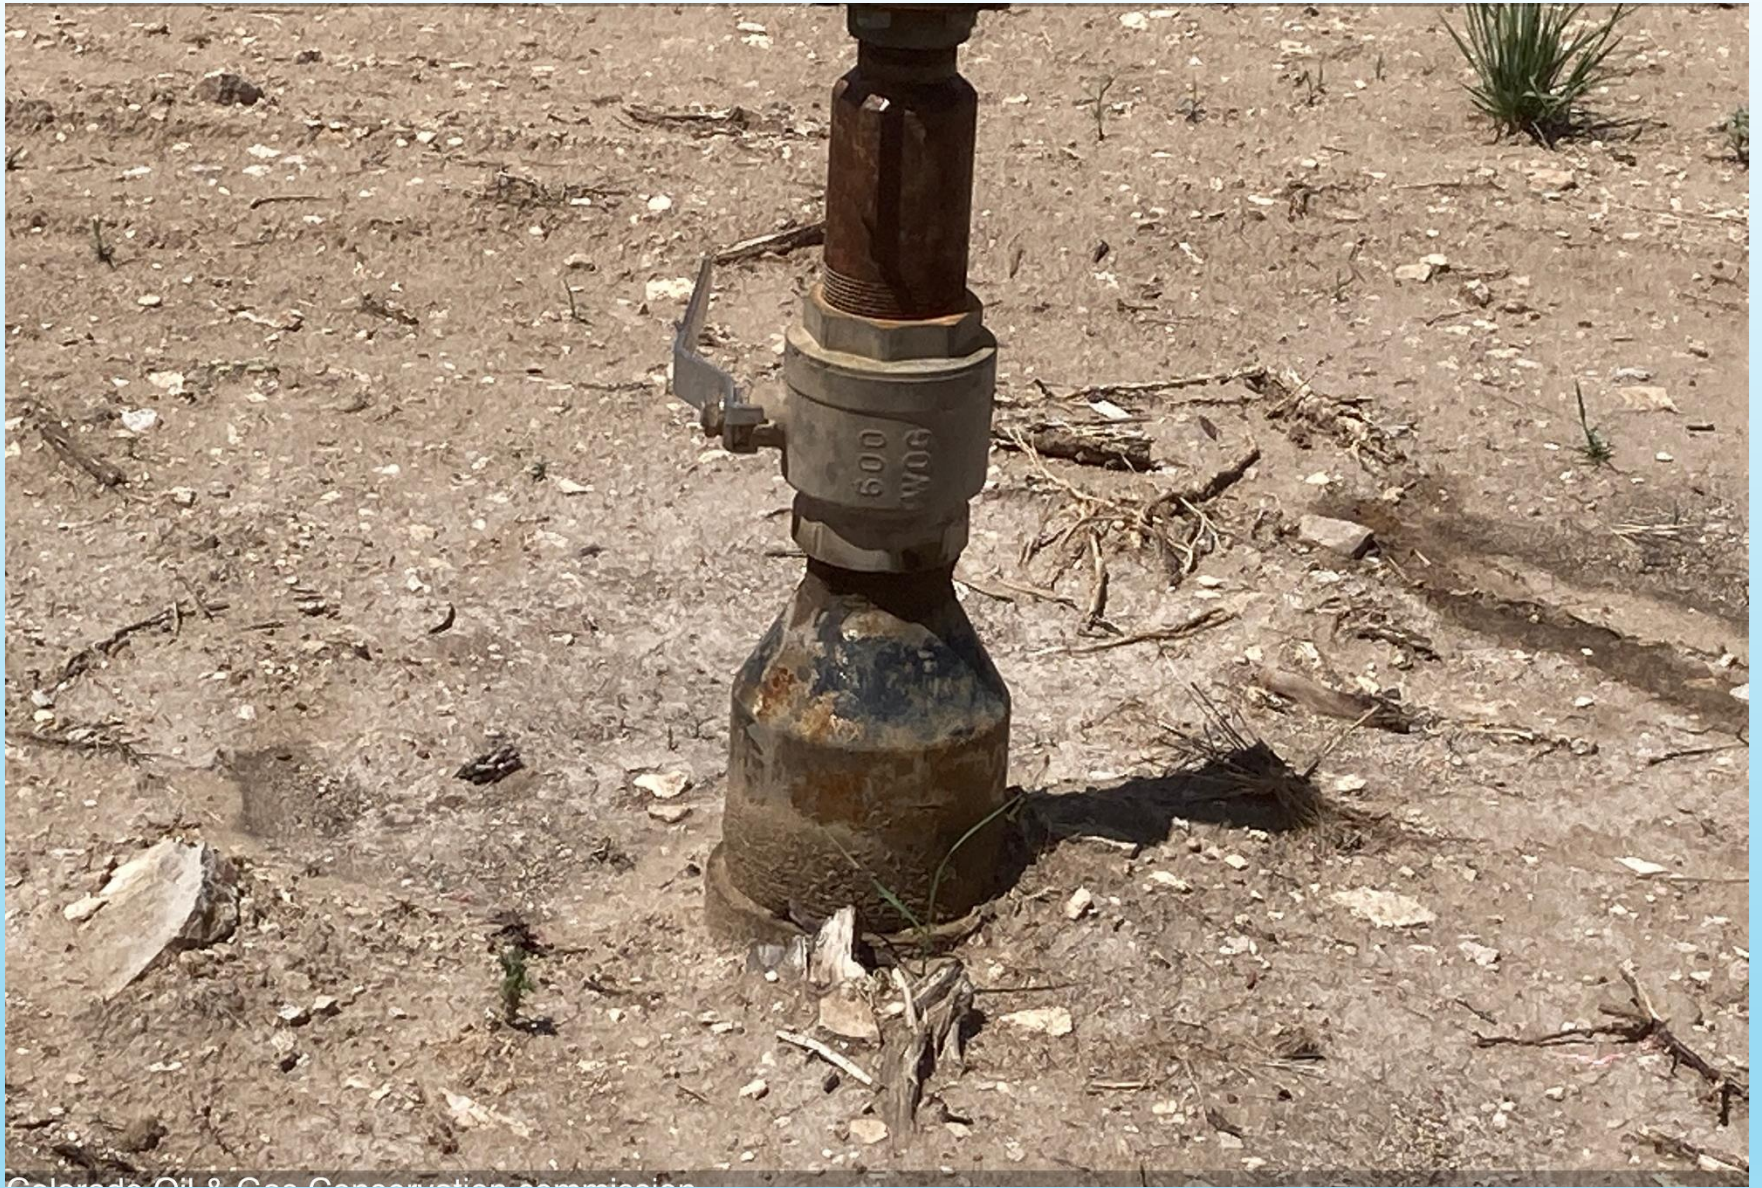
PHOTO 3: Bradenhead inaccessible or not visible. Install appropriate fittings to allow bradenhead visual inspection as per Rule 419.a.(1), (2). CA DATE 8-30-2022.
