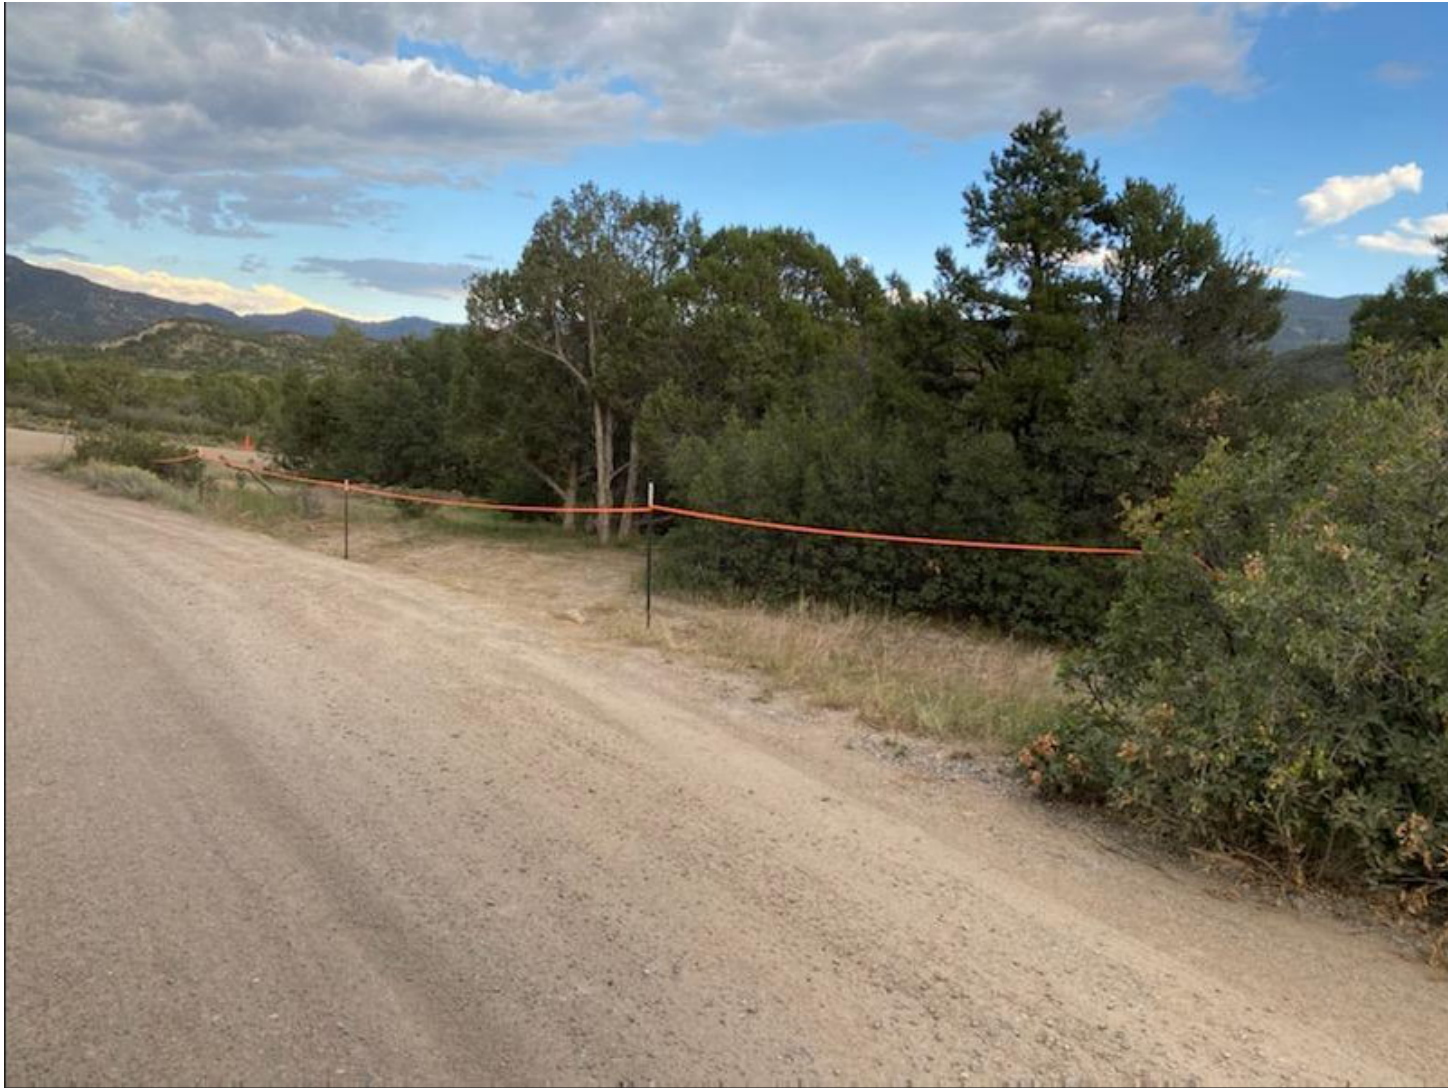
Vehicle parked off road in vegetated area (IMG 07). Sign at entrance states all vehicles must remain on designated roadways. Where feasible, vehicles must remain within access road per rule 1002.e.4

Instructed contractors to stop parking in vegetated areas and flagged off vegetated area.

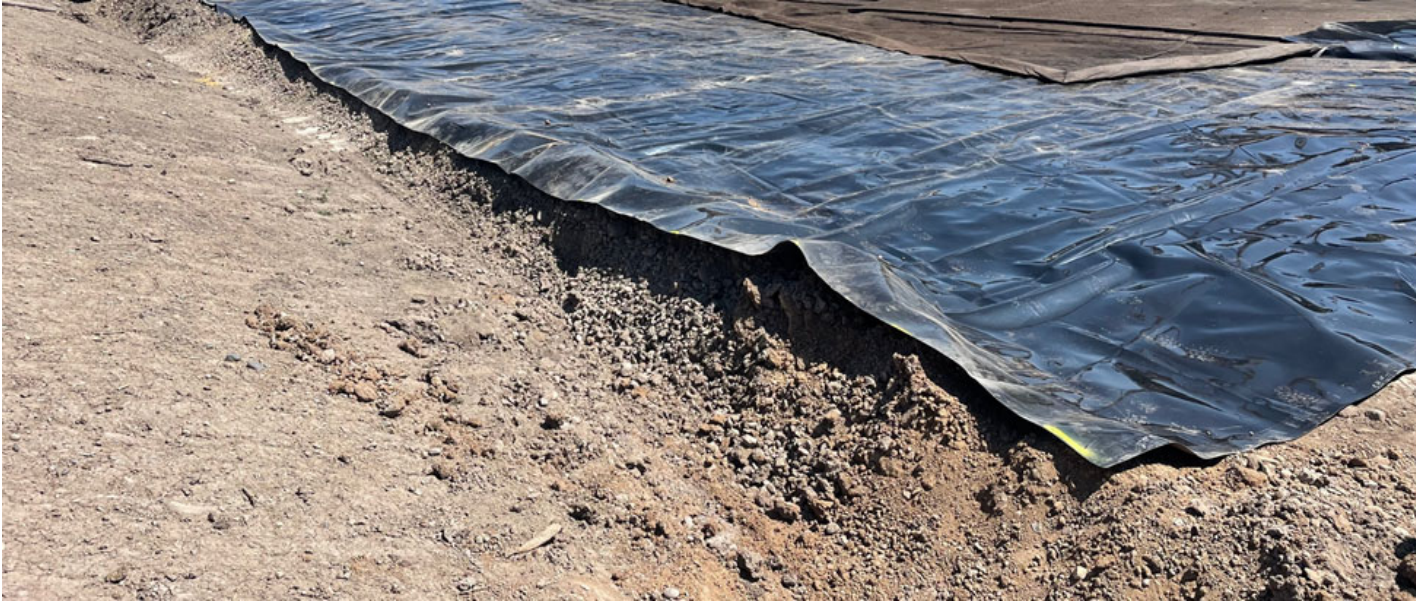
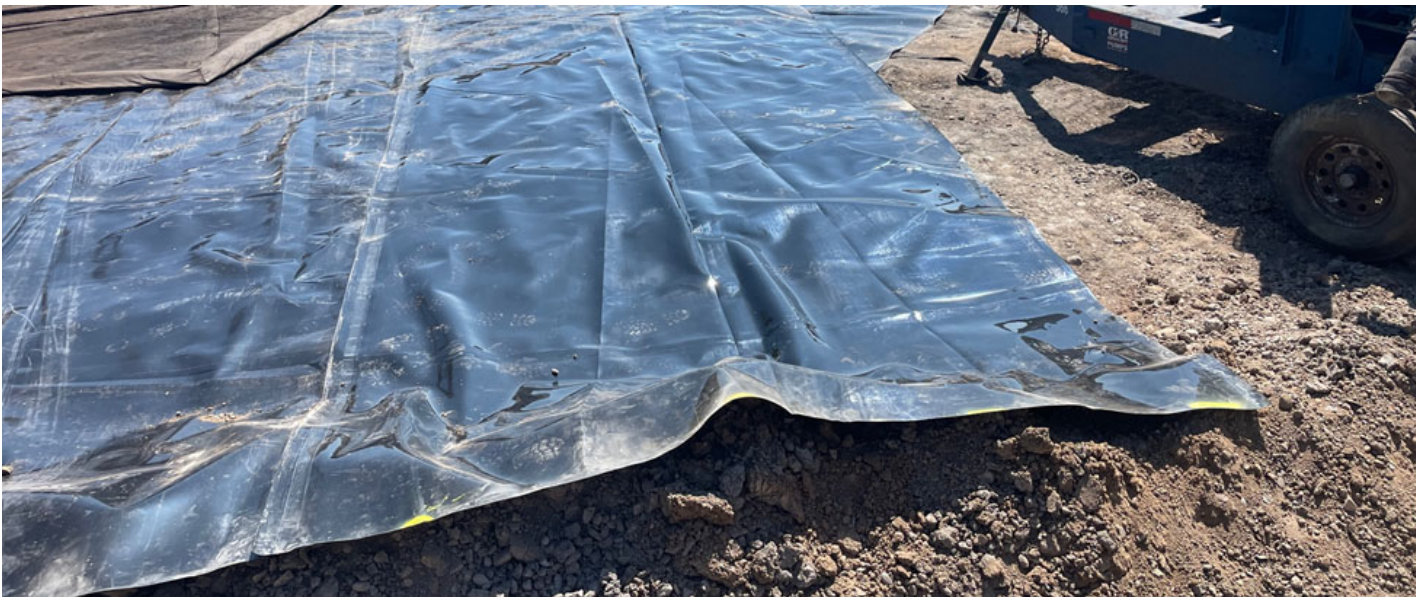
Liner material is creased, folded, driven over, and does not appear to be operated within manufacturers specifications (IMG 03). Operate all facility equipment within manufacturers specifications.

Replaced creased and folded liner

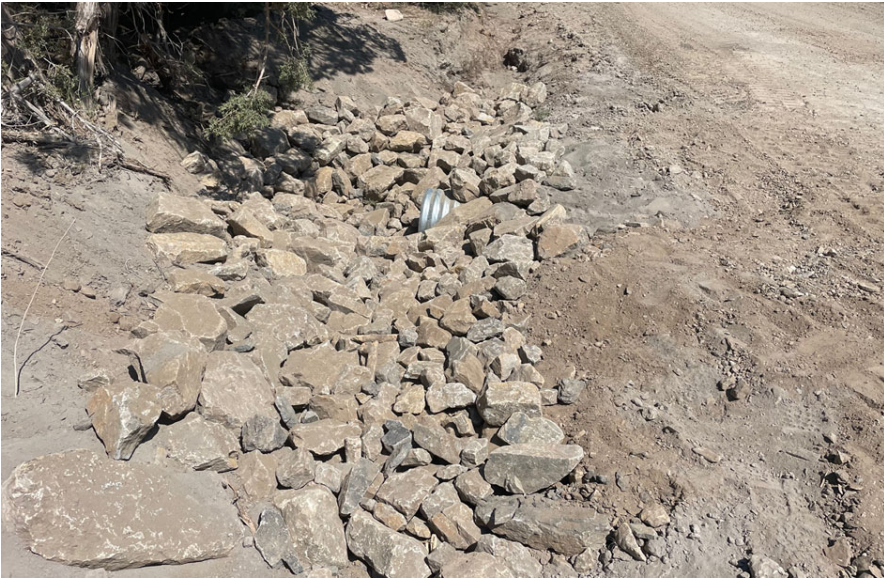
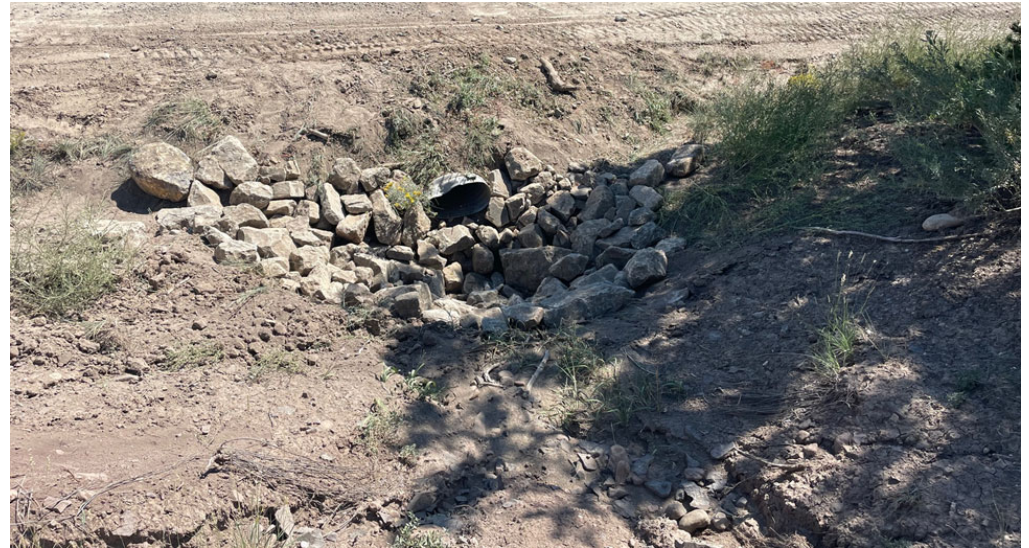
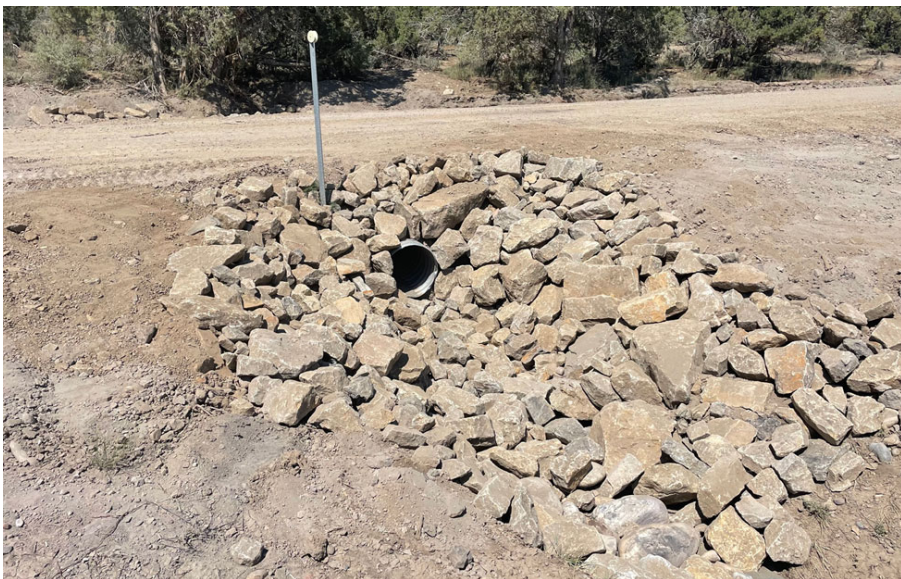
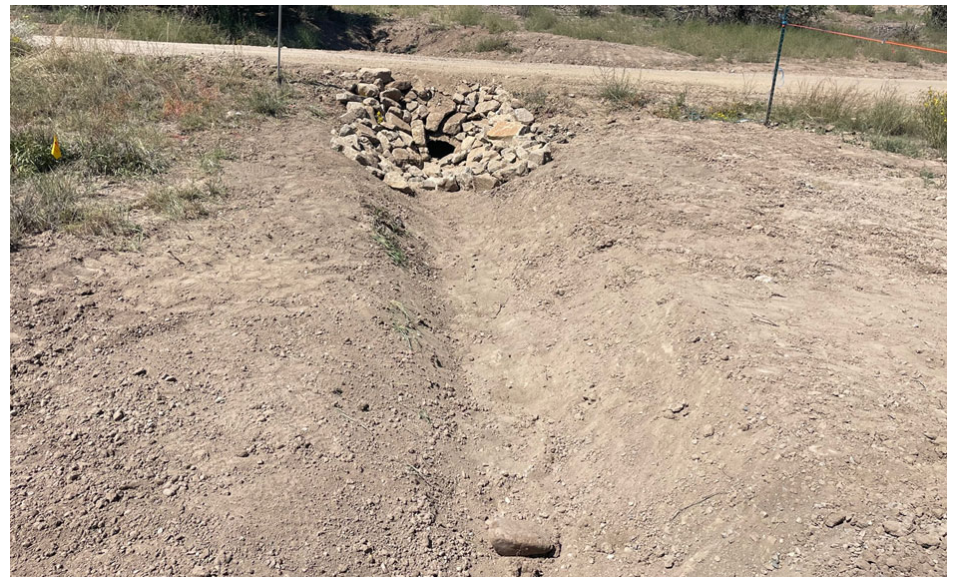
Erosion has occurred in drainage ditch near culvert on north of location (IMG 11).

Culvert has no inlet or outlet erosion. Install or repair/modify required BMPs per Rule 1002.f.(2)C

Installed new BMPs including rocked inlet/outlets on culverts on north of location.

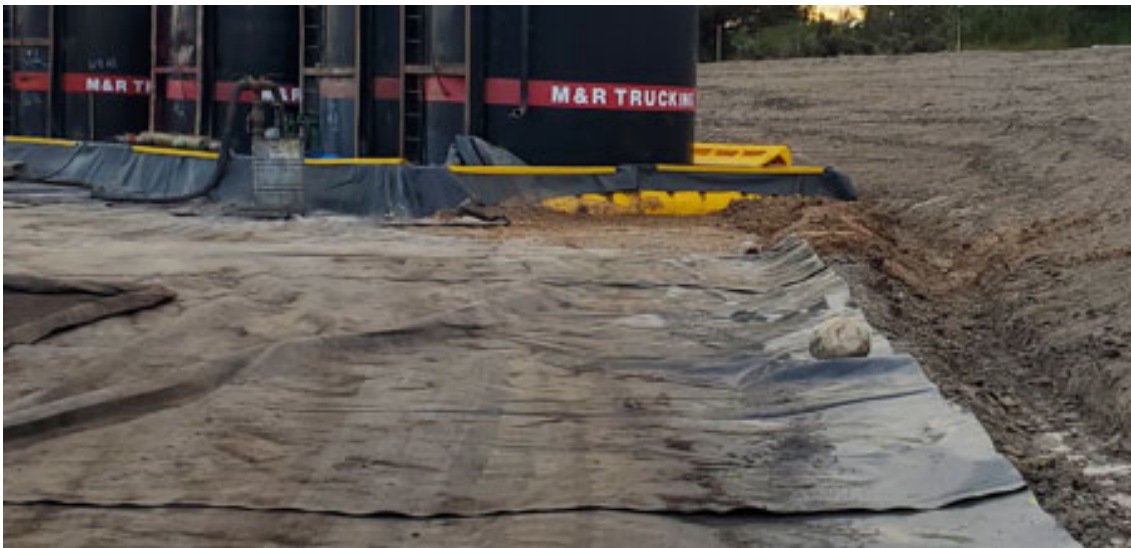
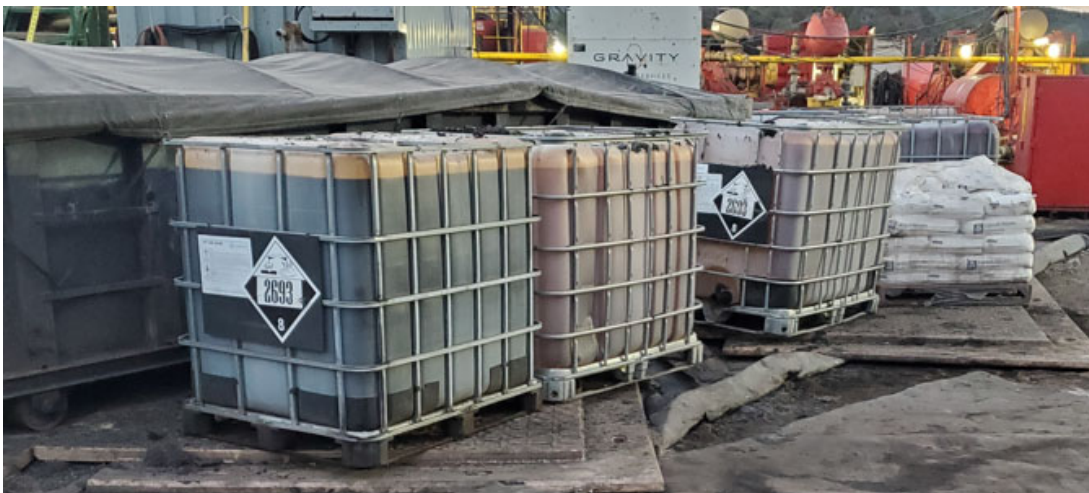
"Chemicals stored with no spill prevention (IMG 04). Implement or modify BMPs for improved material handling and spill prevention per rule 1002.f.(2)B."

Moved chemicals to containment and removed empty containers.

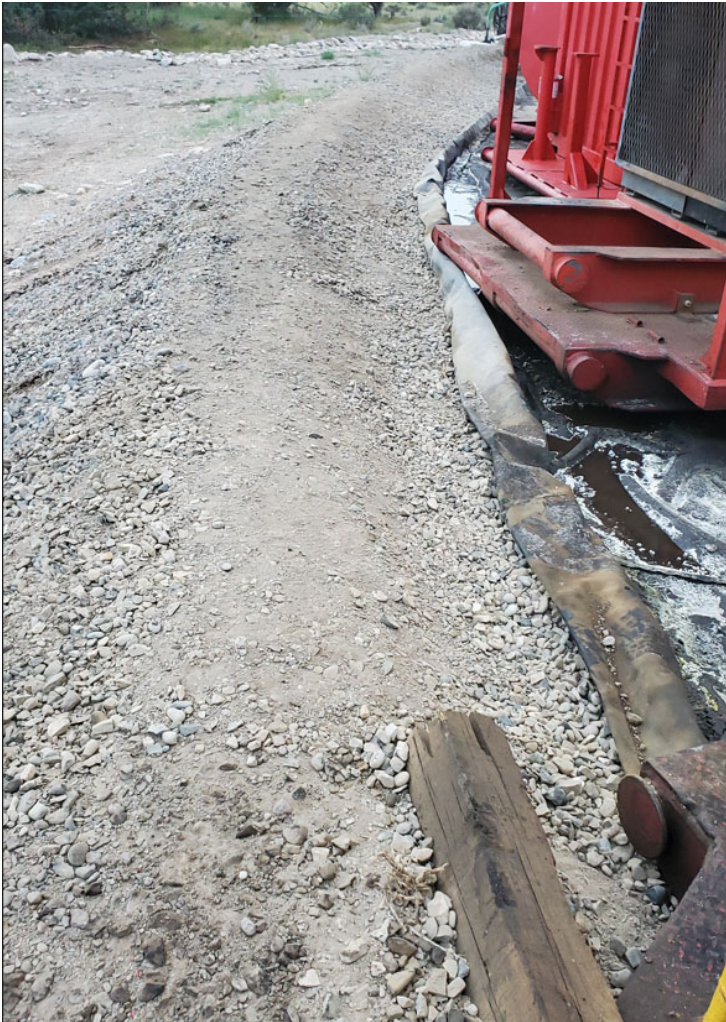
"2 Full cuttings bins on location, hauled to Bondad landfill. Wet cuttings and drilling fluid tracked off liner by forklift and vehicles (IMG 05). Impacts must be evaluated after drilling operations when liner is removed. Non E and P waste tracked off liner (IMG 06). Rig floor safety valve present, permit posted in dog house, fire extinguisher present in dog house, bear proof trash receptacle present, static discharge present on powered equipment, and storage tanks are contained within lined barriers. Remove all feasible impacted material. Improve cuttings management. Prevent E and P waste and non E and P waste from being tracked off liner. Notify COGCC at rig release."

Removed material off liner and will notify COGCC of rig release.
