Final Reclamation and Stormwater Inspection

Operator: KIMBARK OIL & GAS COMPANY - 47700

Location ID: 394559

Inspection Photos
Location Name: MCCLARNAN #2
Location ID: 394559

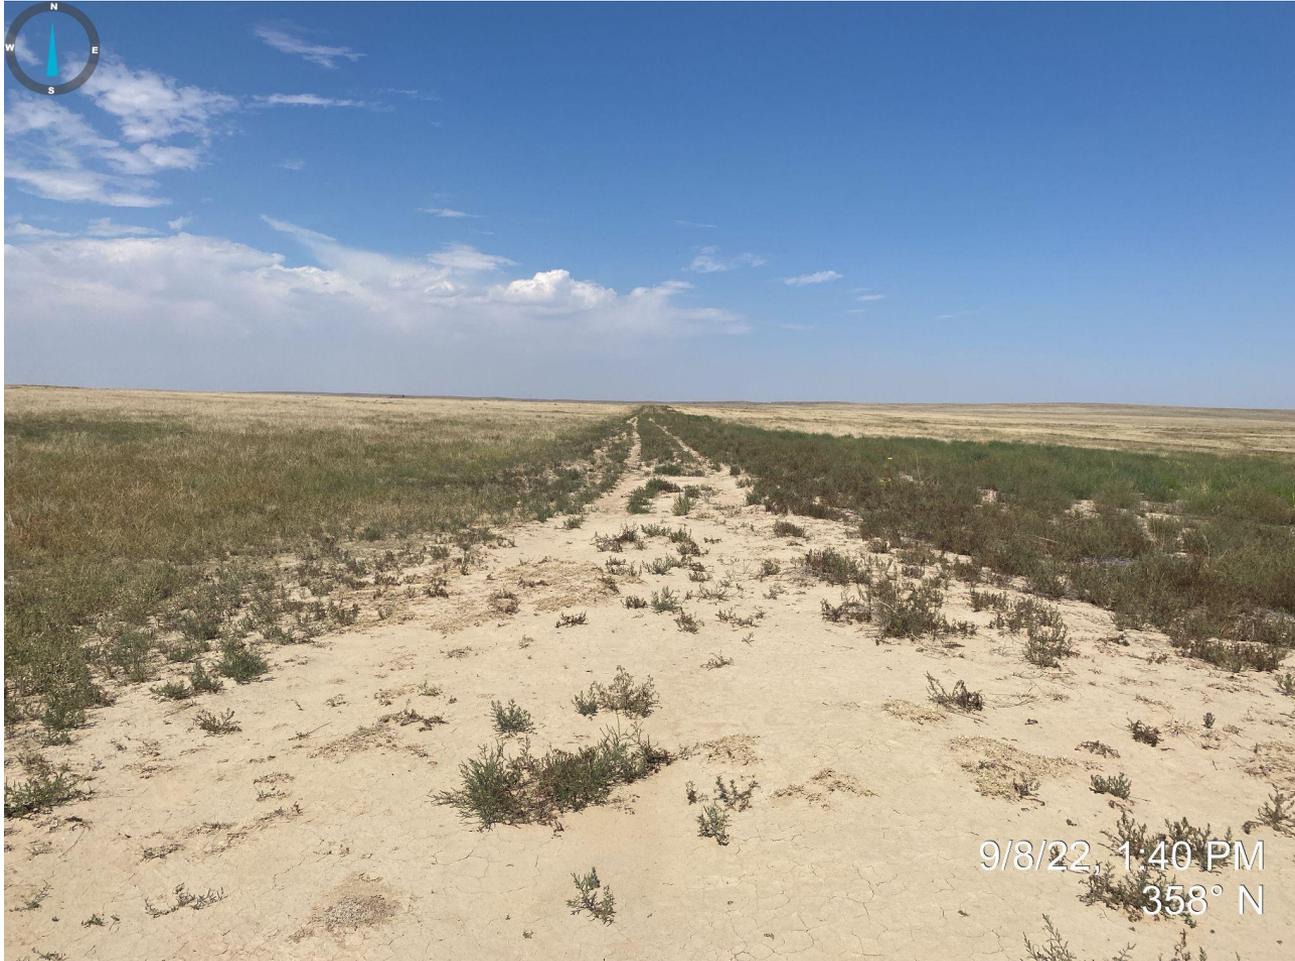
Photo 1. Access road photo taken south of location, facing north. Photo illustrates access road has not been reclaimed and presence of weedy annual vegetation (e.g. russian thistle, kochia).

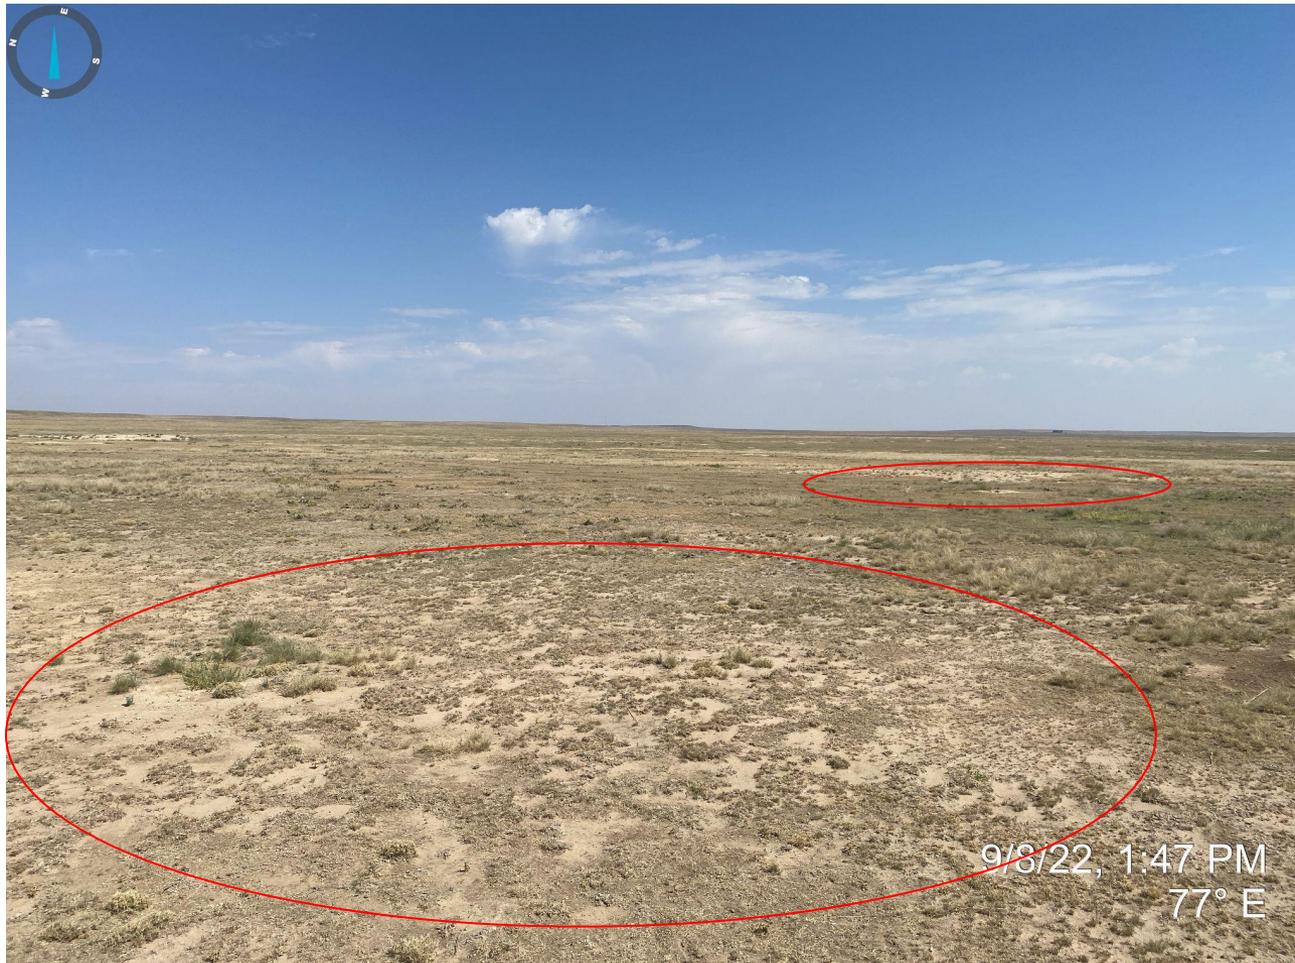
Photo 2. Location photo taken from western portion, facing east. Photo illustrates non-uniform vegetation cover resulting in bare soil, outlined in red.

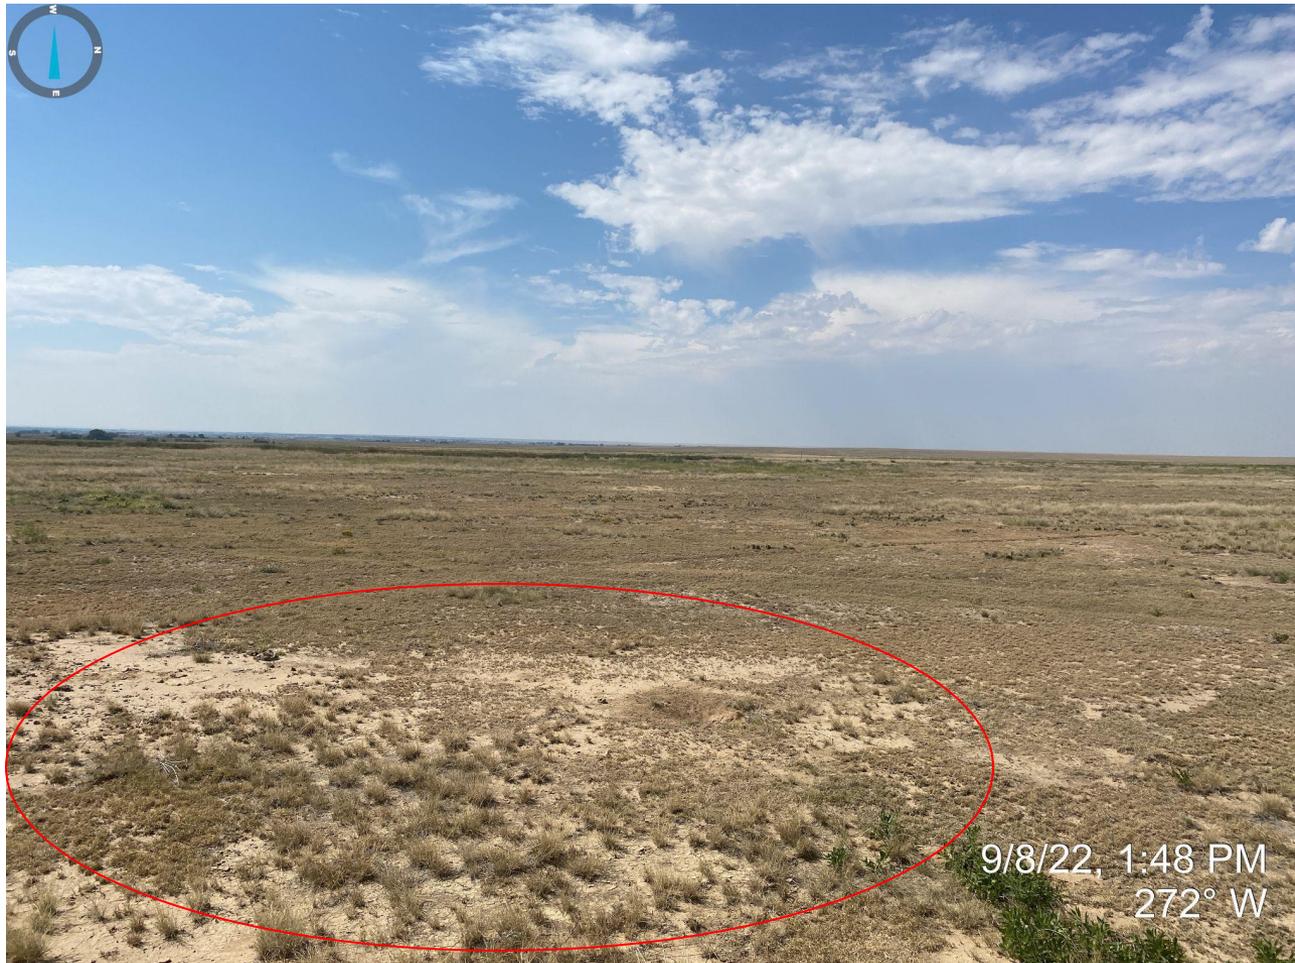
Photo 3. Facing west from eastern portion of location, see comments in photo 2.

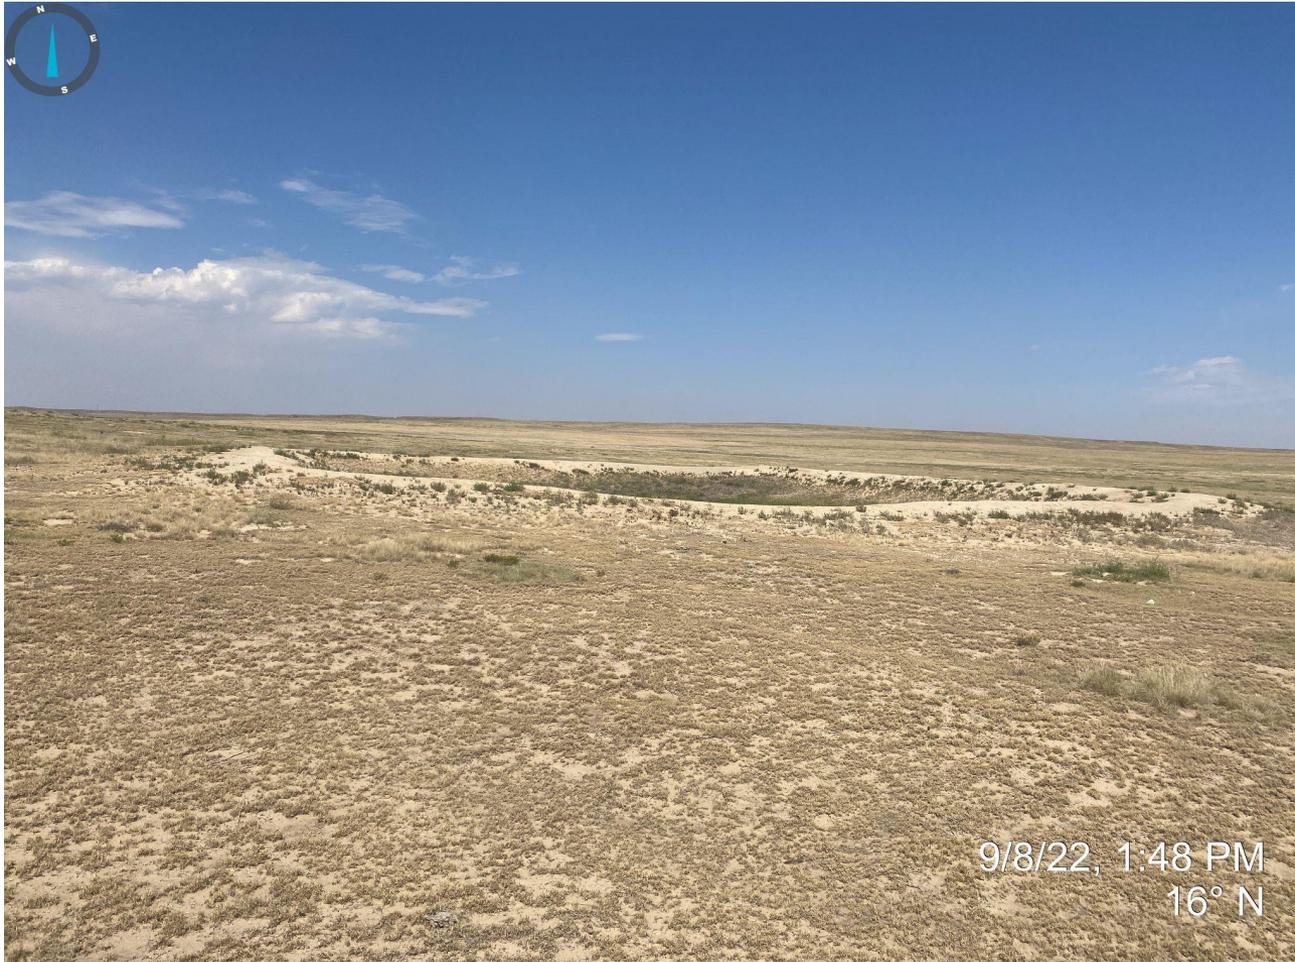
Photo 4. Taken from northeast portion of location, facing north. Photo illustrates a pit remains on location and has not been reclaimed.

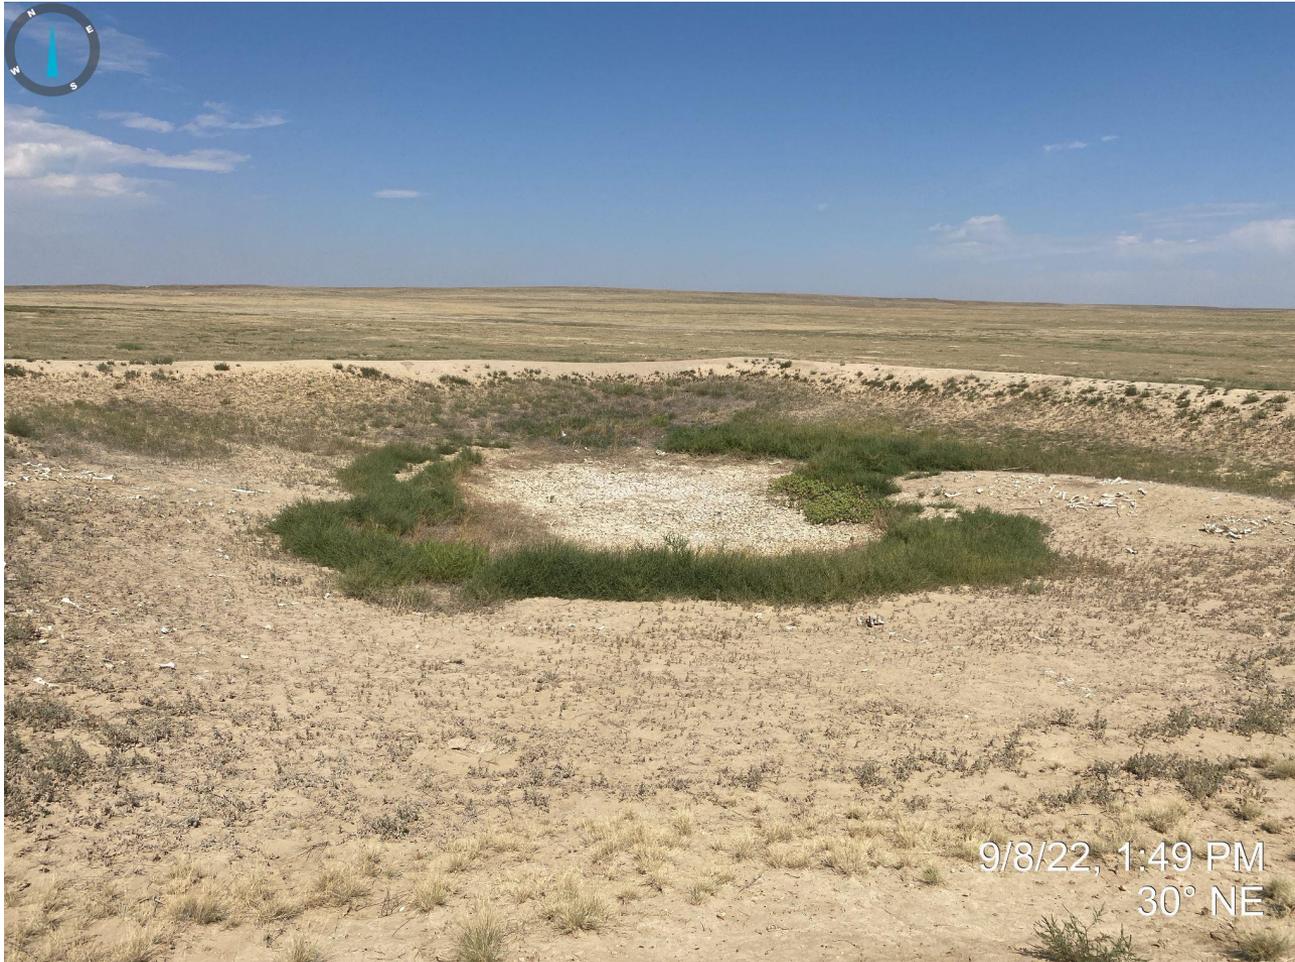
Photo 5. Close up photo of pit, see comments in photo 4.

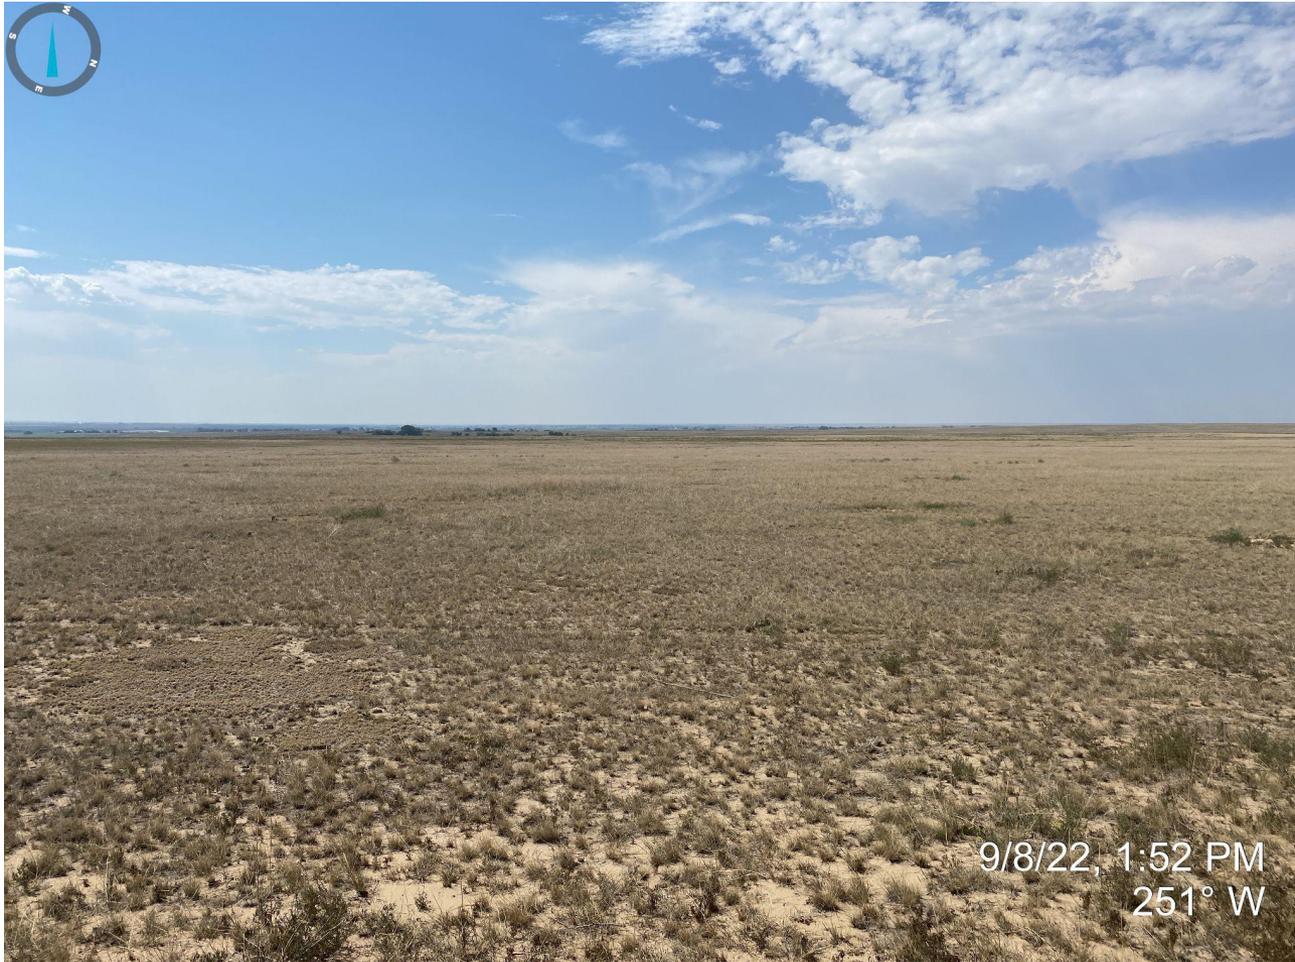
Photo 6. Reference area photo taken west of access road, facing west.
