Final Reclamation and Stormwater Inspection

Operator: CITATION OIL AND GAS - 17180

Location ID: 324935

Inspection Photos
Location Name: PFAFFLY FARMS #2
Location ID: 324935

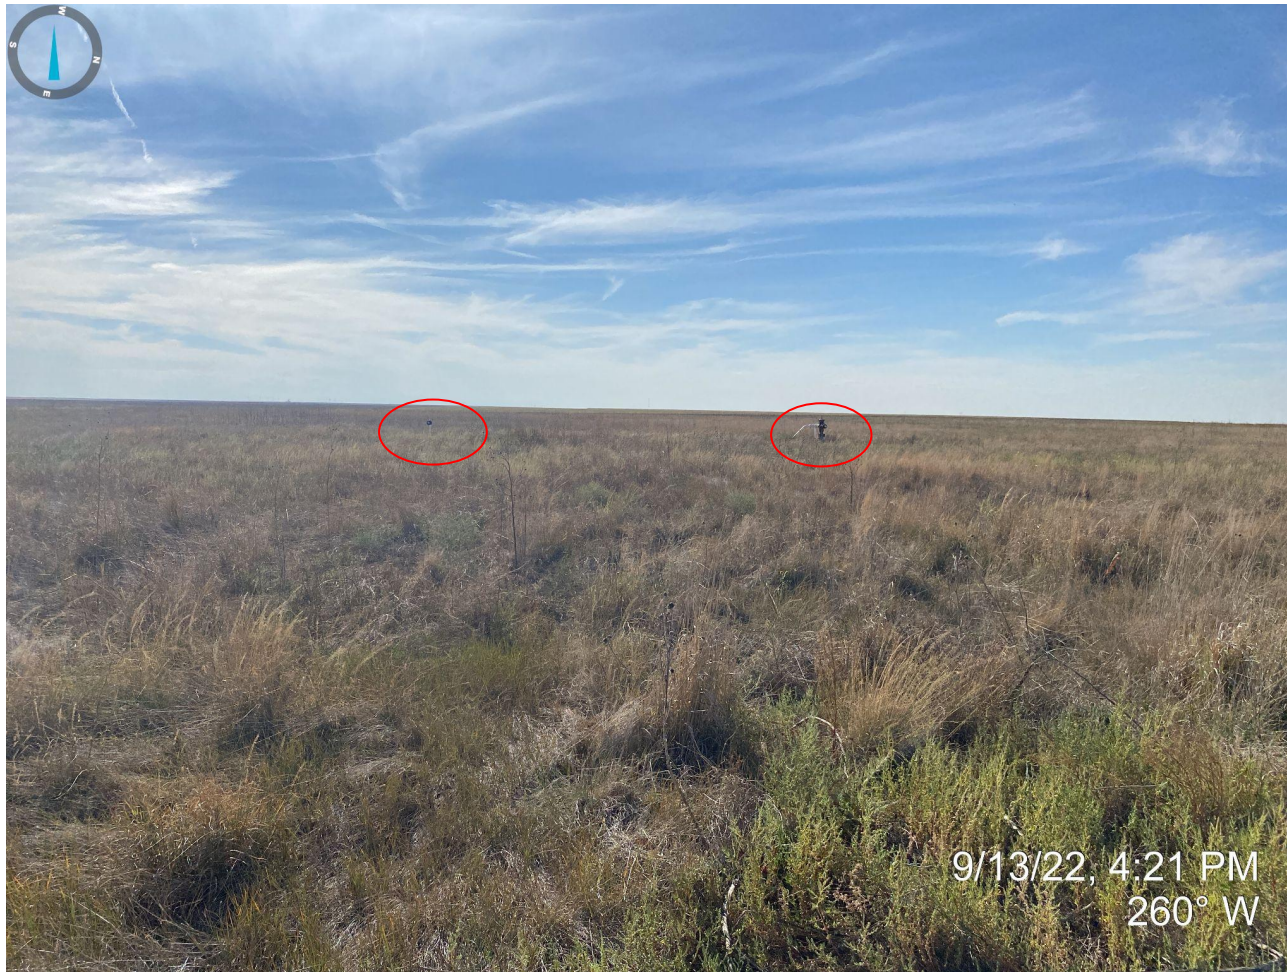
Photo 1. Taken from county road, facing west. Photo illustrates flow line riser and piggin station in background (outlined in red). This equipment should have been removed during P&A operations.

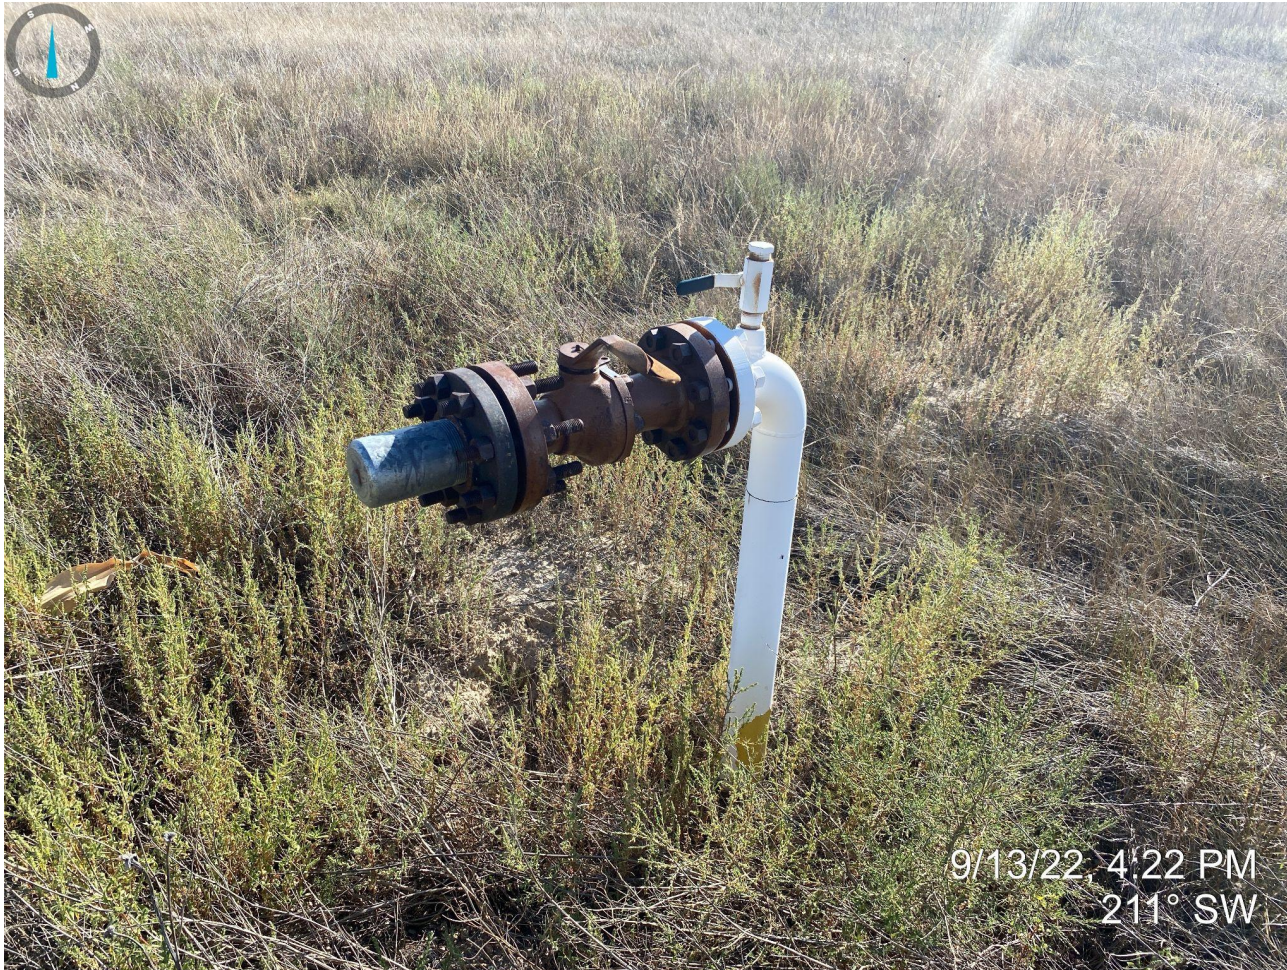
Photo 2. See comments in photo 1.

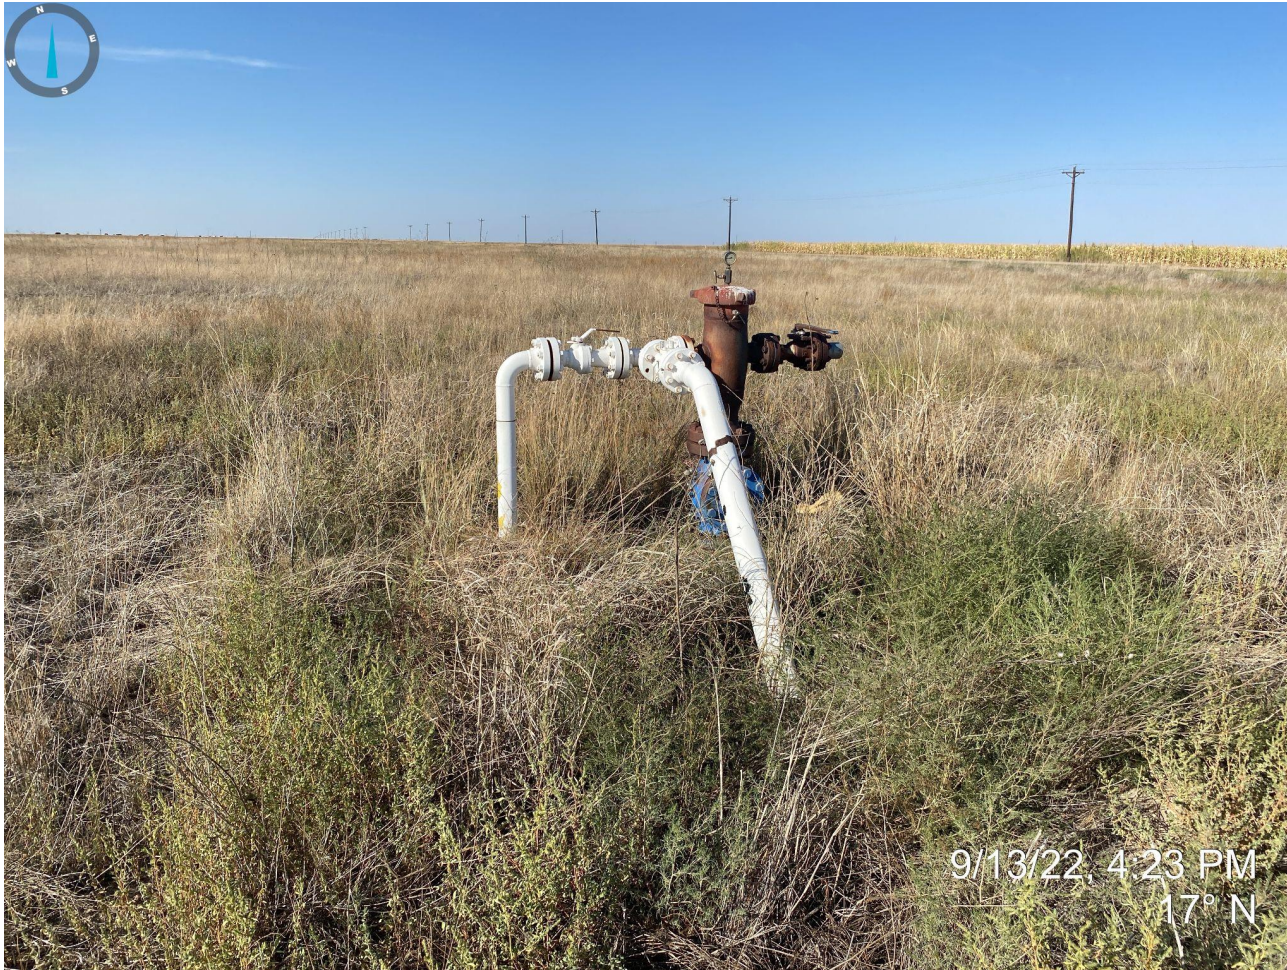
Photo 3. See comments in photo 1.

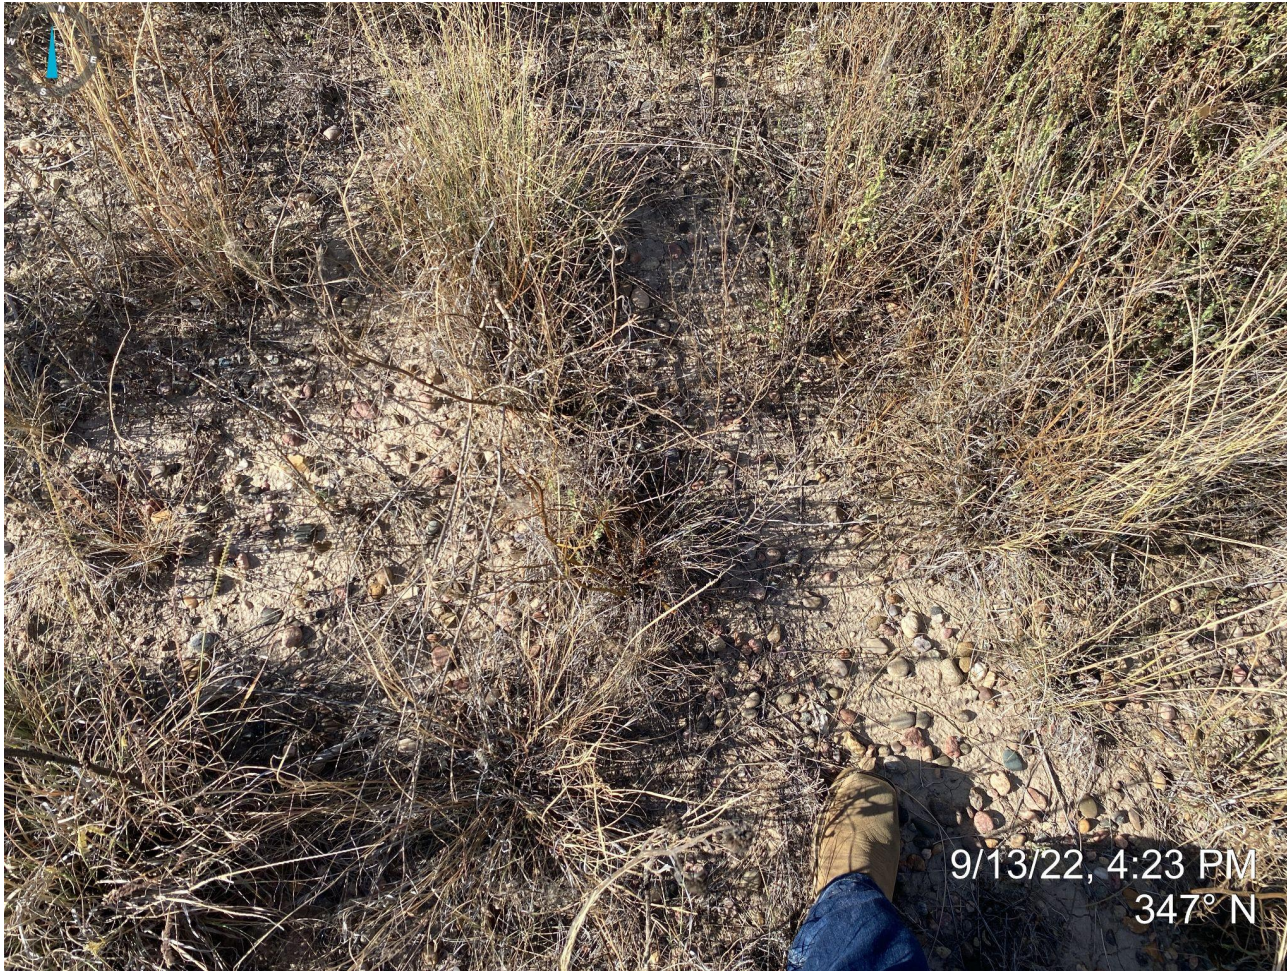
Photo 4. Close up photo of road base/gravel left on access road and location transition. The access road and location have not been reclaimed.

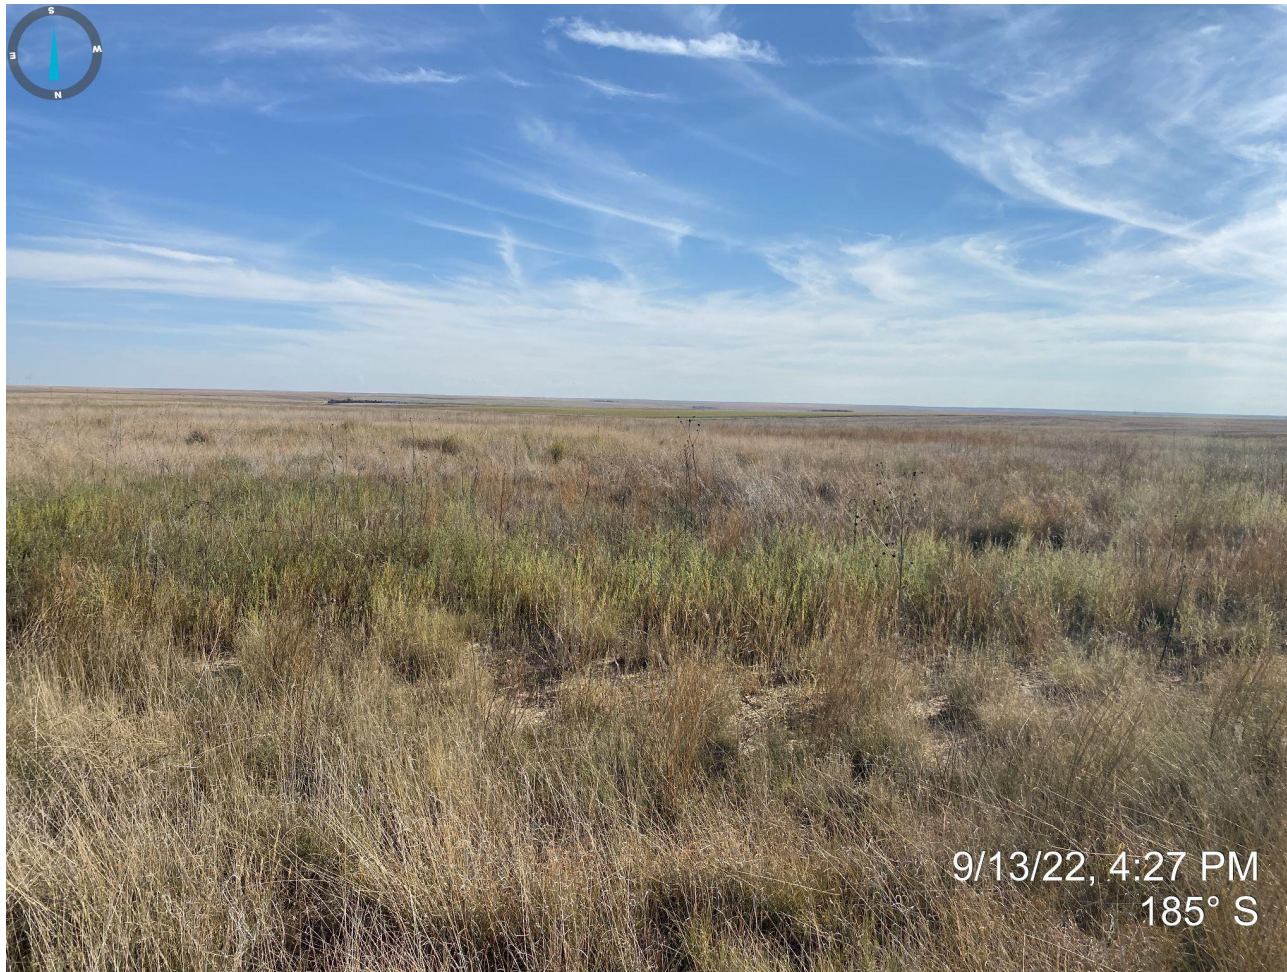
Photo 5. Location photo taken from northern portion, facing south. Photo illustrates that location has not been reclaimed with presence of annual weedy vegetation (russian thistle) that is not reflective of reference areas. Road base/gravel present at location, see comments/close up in photo 4.

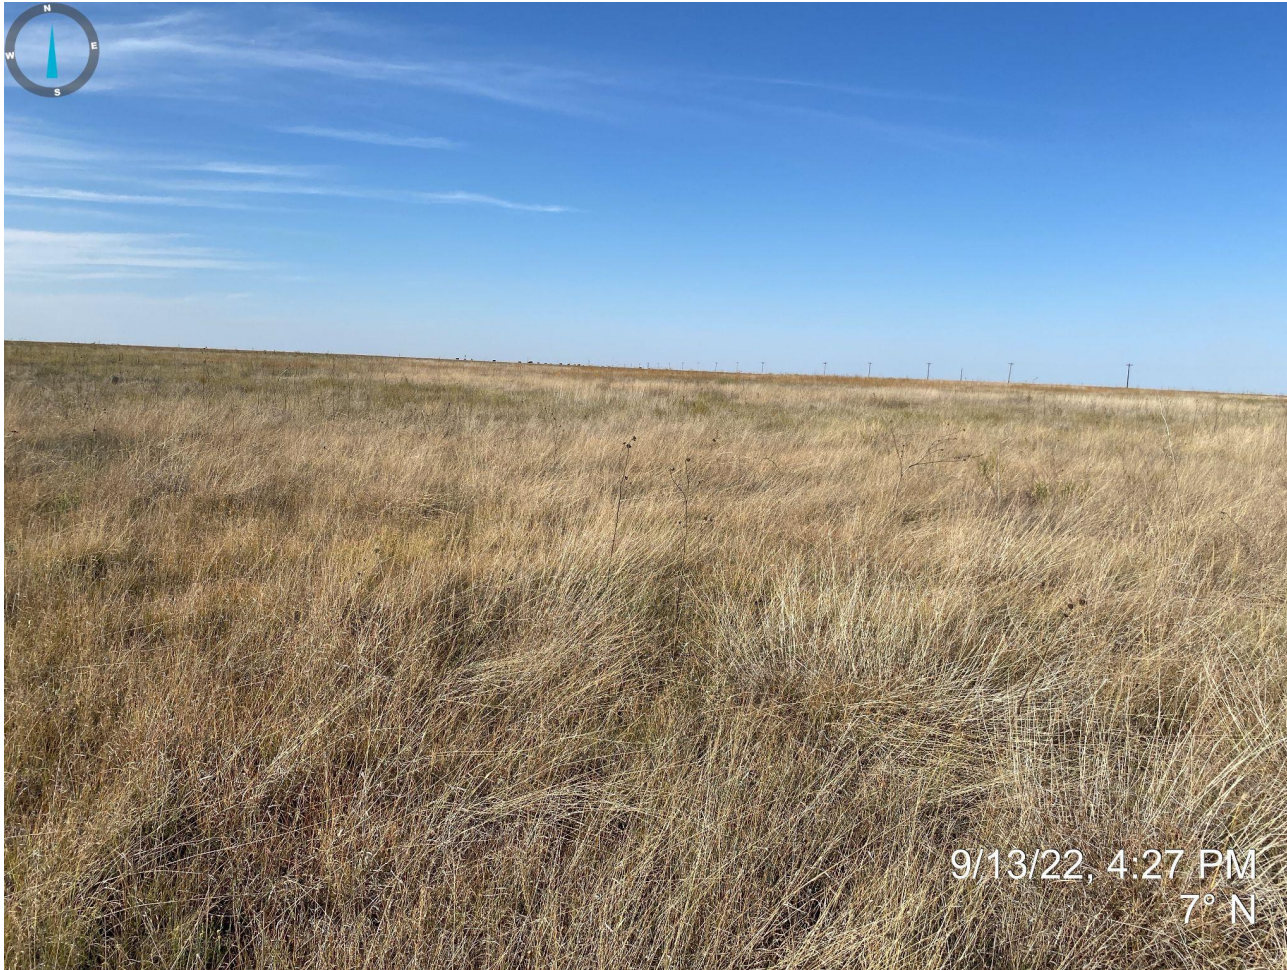
Photo 6. Reference area photo taken north of location, facing north. Predominantly sand drop seed and blue grama.
