APACHE CANYON 09-07 API# 05-071-06190 – OGRIS OPERATING  
COGCC OPERATOR NUMBER 10758 - DATE: OCTOBER 05, 2022  
CORRECTIVE ACTIONS COMPLETED REGARDING COGCC FIR DOCUMENT #690203380

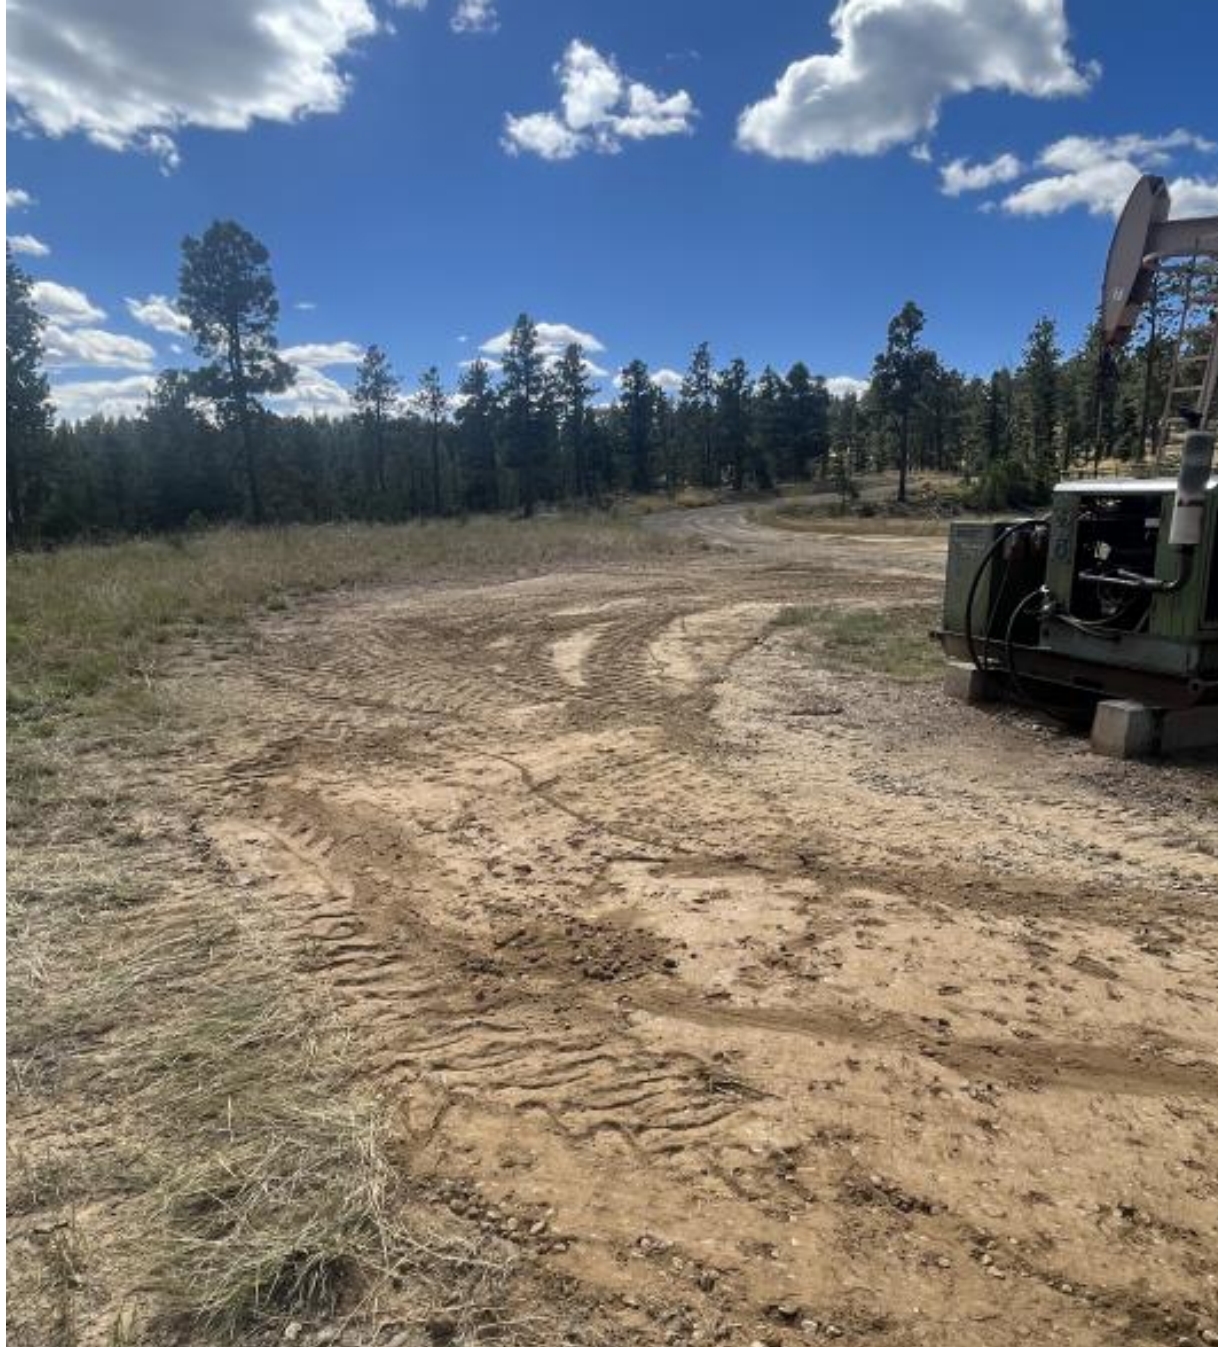
PHOTO 1: THE LEAKING PACKING BOLT HAS BEEN TIGHTENED AND MAINTENANCE HAS BEEN PERFORMED TO ENSURE ALL VALVES, PIPES, FITTINGS ARE SECURELY FASTENED. ALL PRODUCTION EQUIPMENT ARE IN GOOD MECHANICAL CONDITION. THE WELL PAD HAS BEEN BLADED AND GROOMED TO ELIMINATE THE VEHICLE RUTTING. DIVERSION DITCHES ALONG THE ACCESS LEADING TO THE LOCATION HAVE BEEN REDEFINED TO BETTER DIRECT STORMWATER OFF OF LOCATION.
