Final Reclamation and Stormwater Inspection

Operator: GULF OIL CORPORATION - 36600

Location ID: 394464

Inspection Document #: 696105586

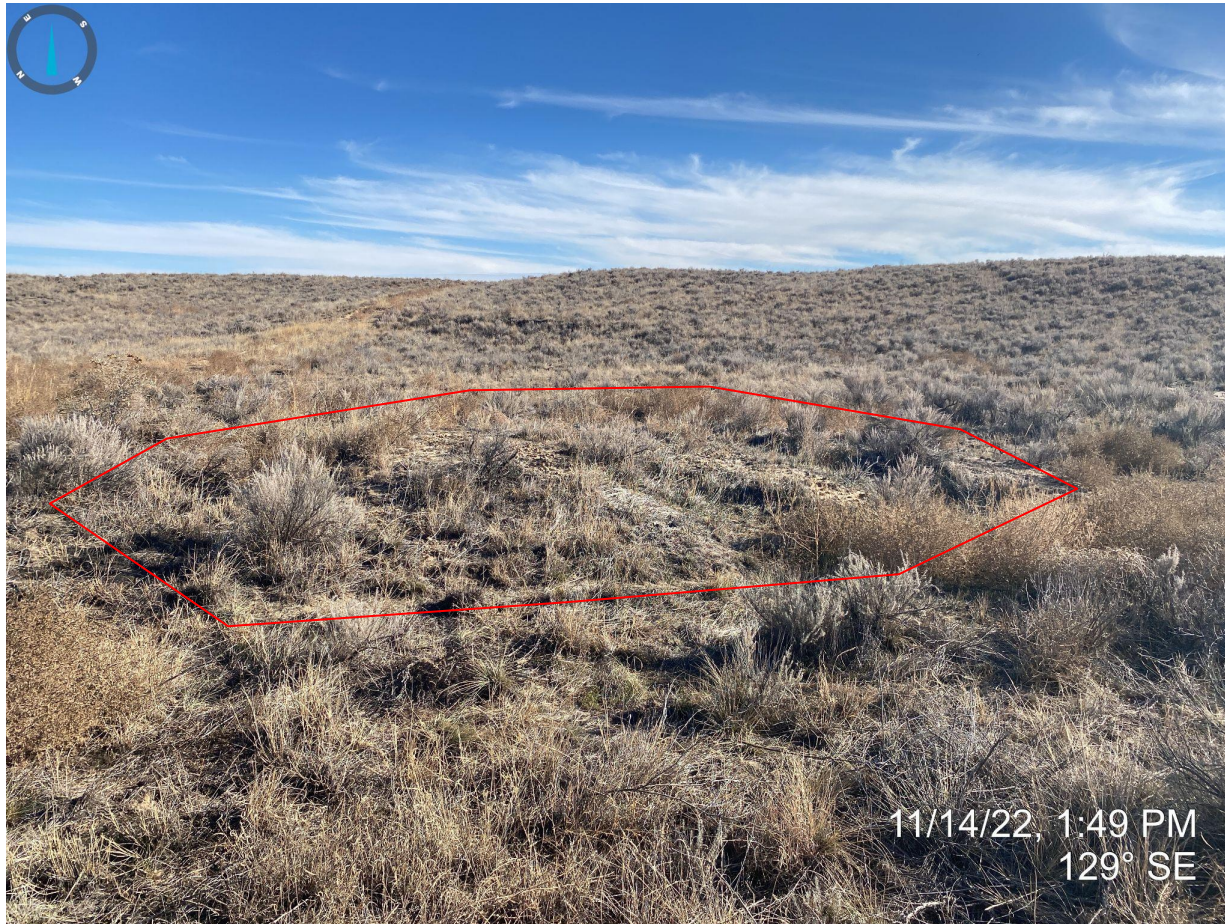
Photo 1. Taken from location, facing southeast. Photo illustrates a pile of road base/gravel approximately 20' x 20' in size, and about 2' above surface grade. This pile needs to be removed and the location needs to be recontoured and graded to reflect adjacent reference areas.

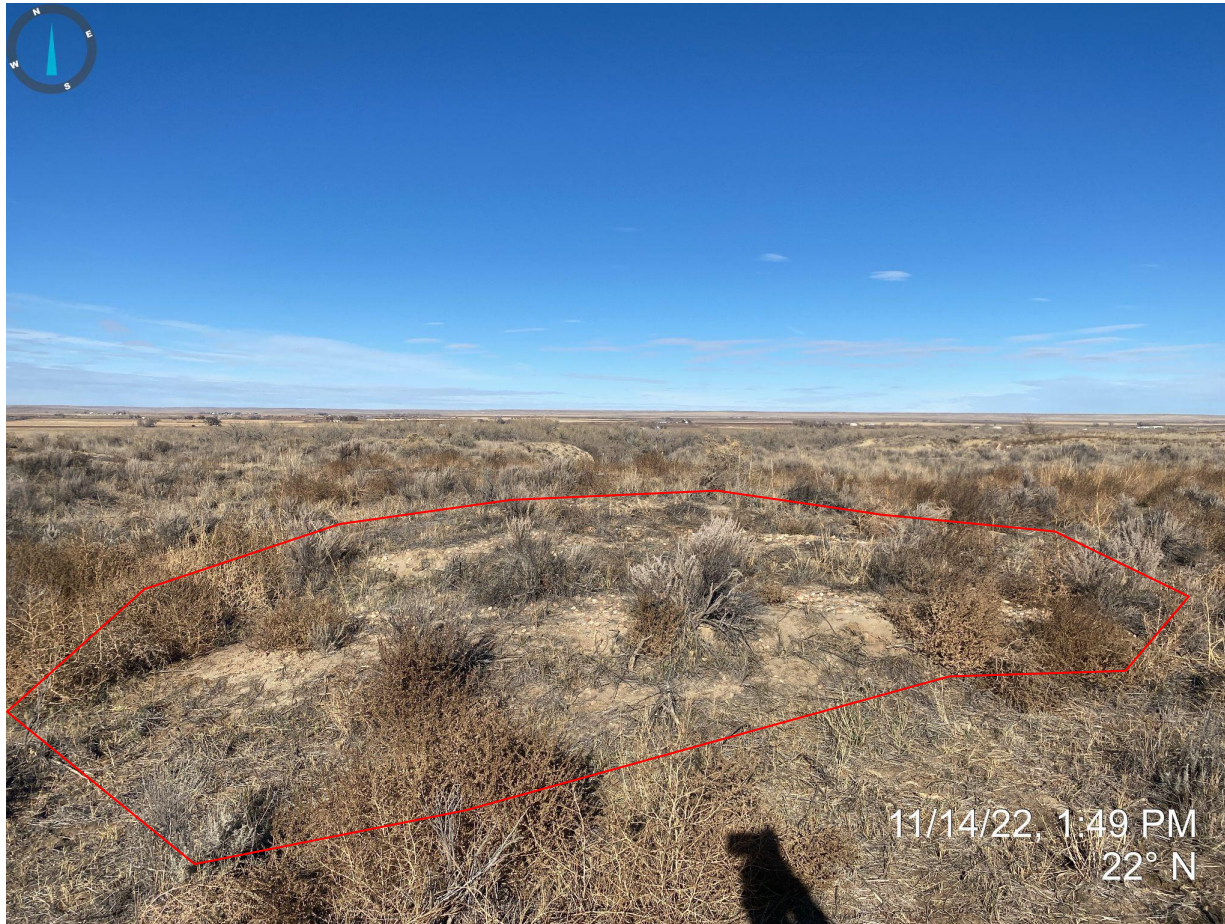
Photo 2. Facing north, see comments in Photo 1.

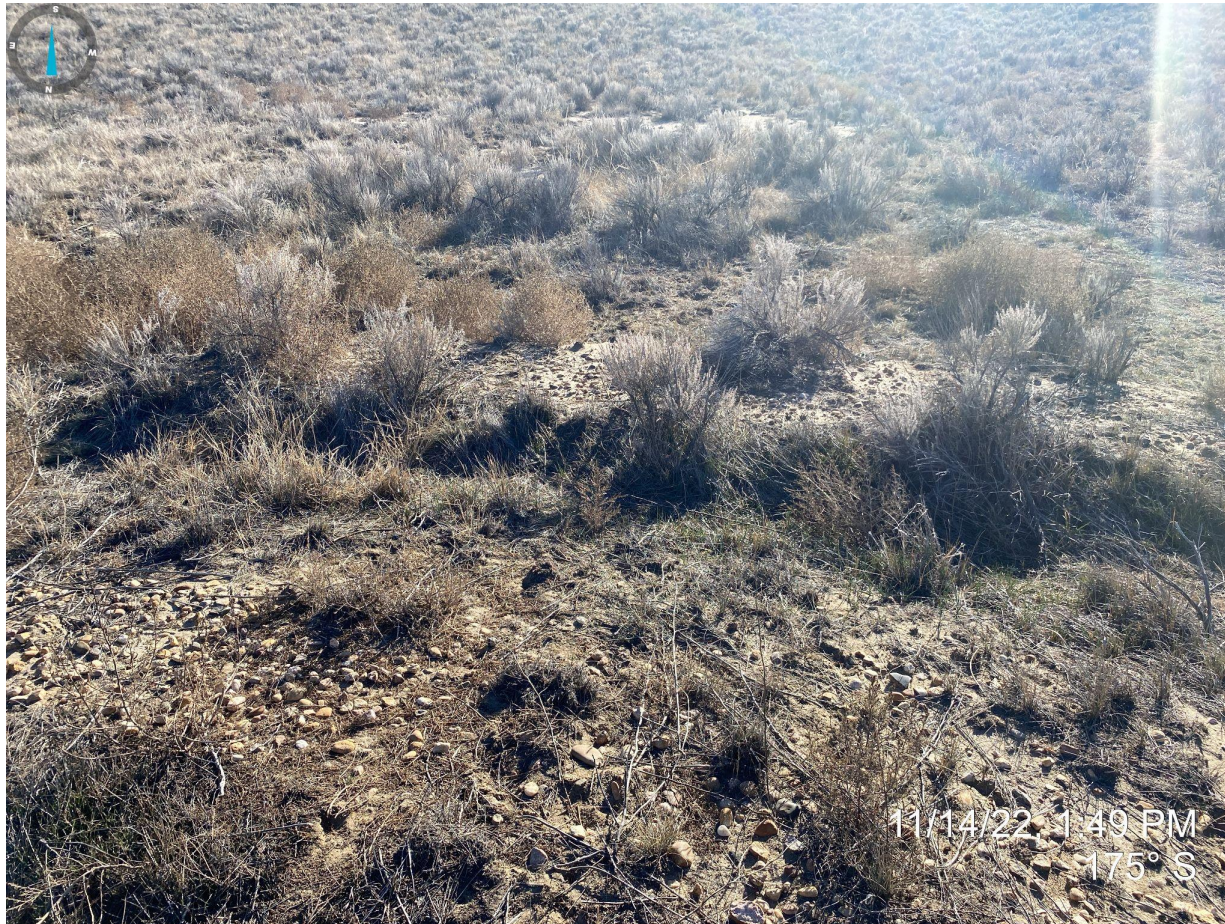
Photo 3. Close up photo of road base/gravel, see comments in photo 1.

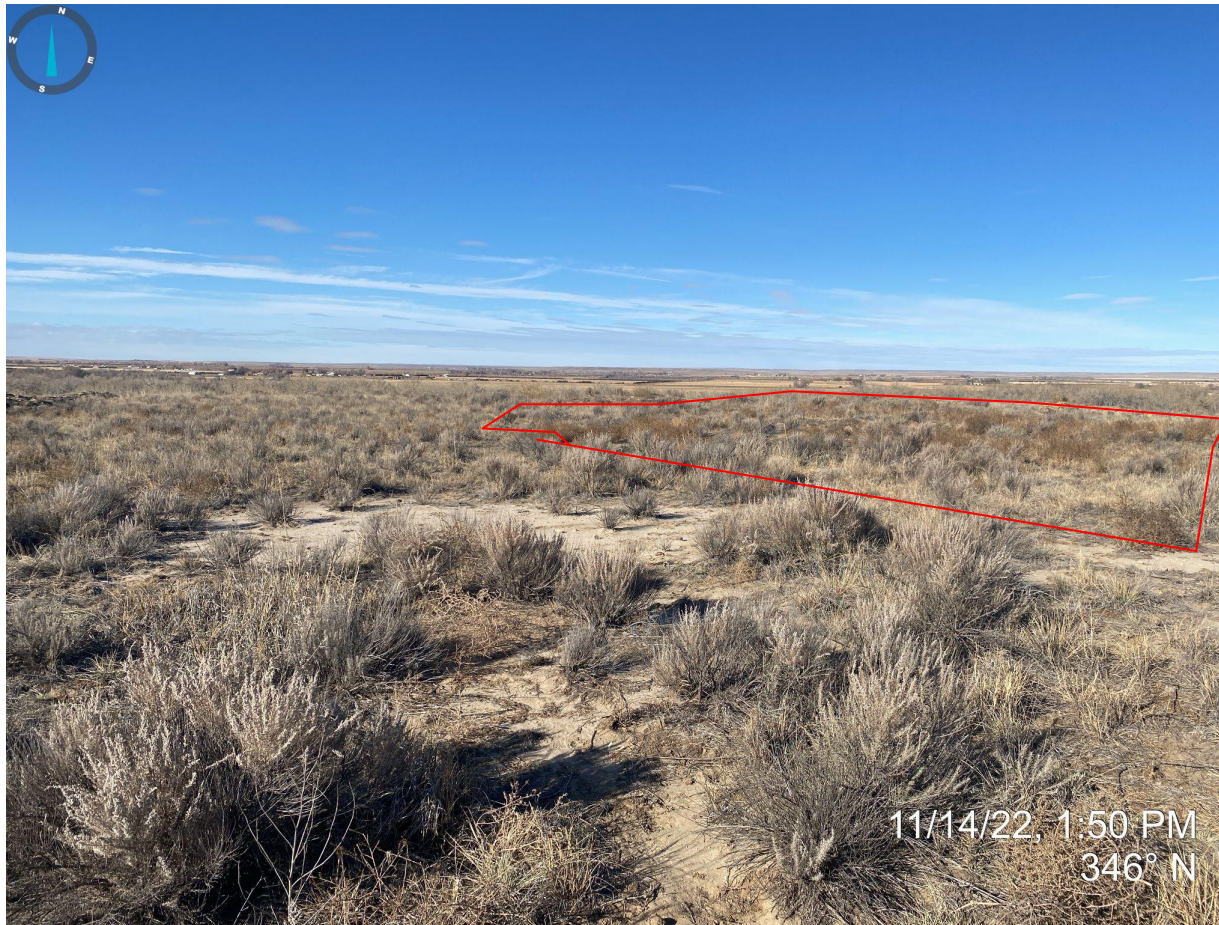
Photo 4. Taken from the southern portion of the location, facing north. Photo illustrates areas of bare soil within the location and undesirable vegetation (e.g. russian thistle and kochia) observed during the inspection, outlined in red.

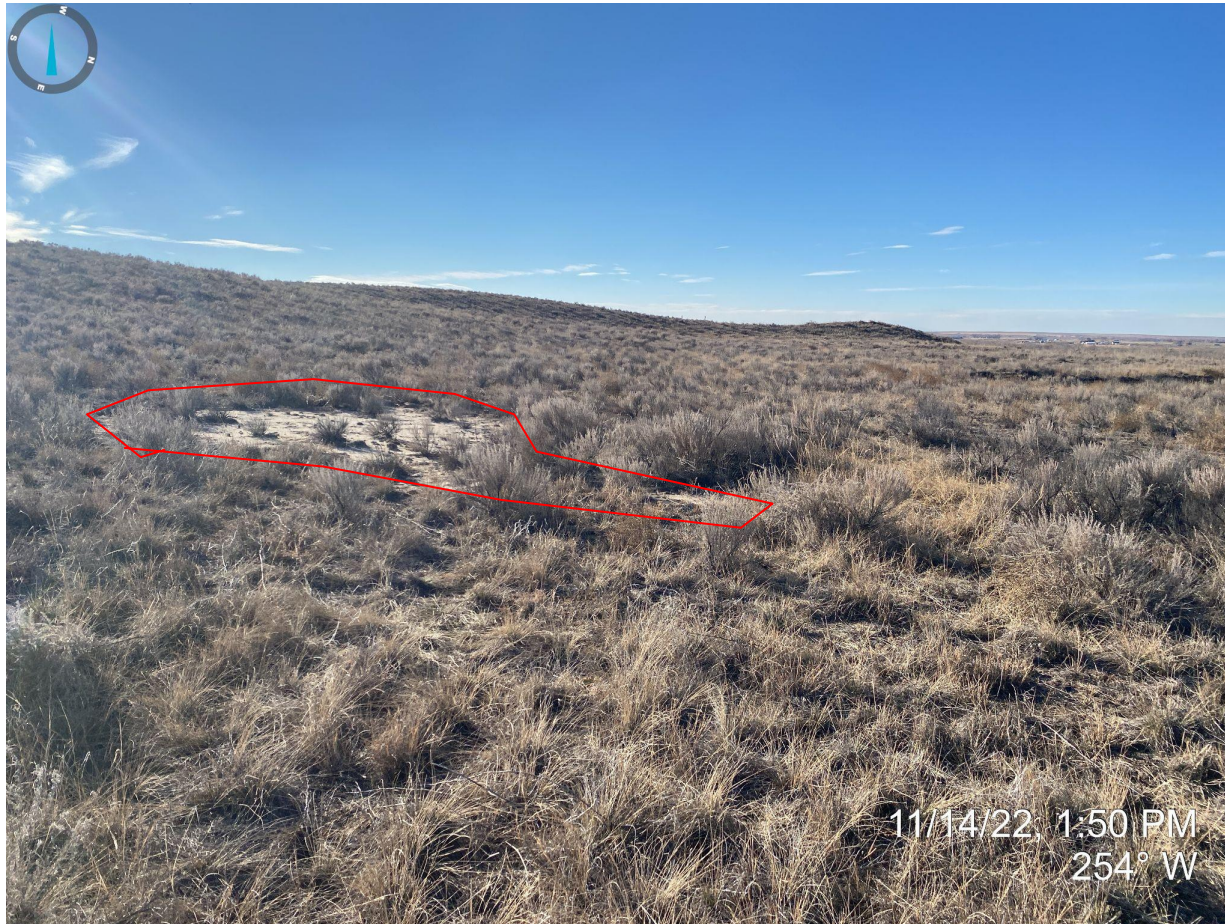
Photo 5. Taken from the southern portion of the location, facing west. Photo illustrates areas of bare soil observed within the location, outlined in red.

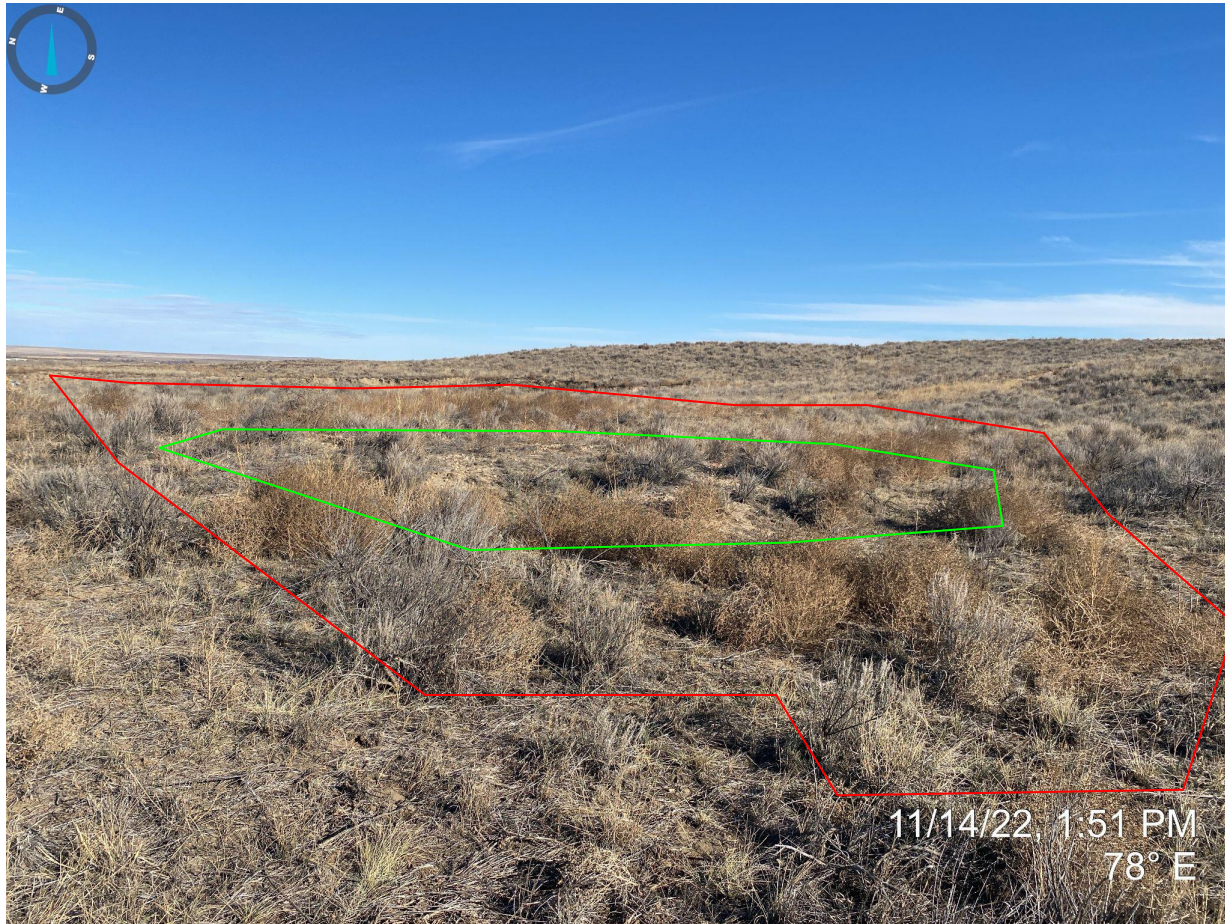
Photo 6. Taken from the northwestern portion of the location, facing east. Photo illustrates undesirable vegetation (outlined in red) and pile of road base/gravel (outlined in green).
