## Fwd: RW: North Carracas 32-4 #7F-5 & #7F-6 Drilling Courtesy Spill Report (2022-0037) (Fee Surface)

Late Sunday night/early Monday morning a release of approximately 50 bbl of drilling fluid (not oil-based or CaCl) was reported at our North Carracas 32-4 #7F-5 & #7F-6 drilling operations. A camlock fitting failed on the mud tank equipment allowing the drilling fluid out of its primary containment. The majority of the release remained on the liner under the rig equipment and will be cleaned/recovered (approximately 38 bbl); and approximately 10-12 bbl ran off of the liner to the pad surface and then ran down onto the interim reclaim a short distance but did not leave the footprint of the location. This portion of the release that was off of the liner will be cleaned up as soon as possible. Please review the attached courtesy spill report packet and let me know if there are any questions.

## Reportable Release Photographic Documentation

NC 32-4 #7F-5 & #7F-6 Drilling (2022-0037)

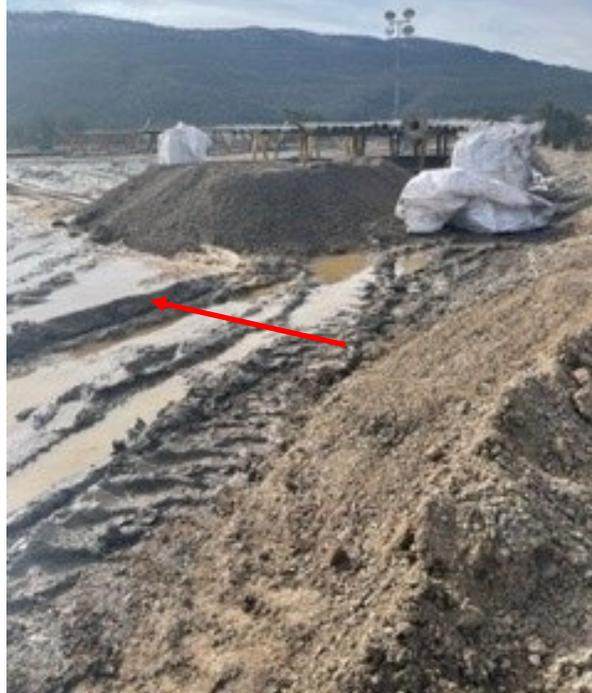
Looking West: Drilling fluid released outside of containment. Note where the liner is (red arrow).

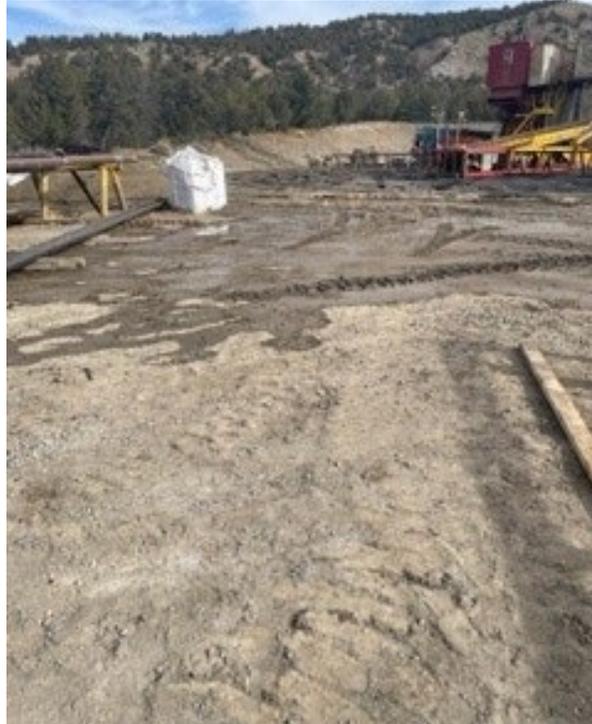
Looking East: Off-liner impacts to Northwest corner of pad surface.

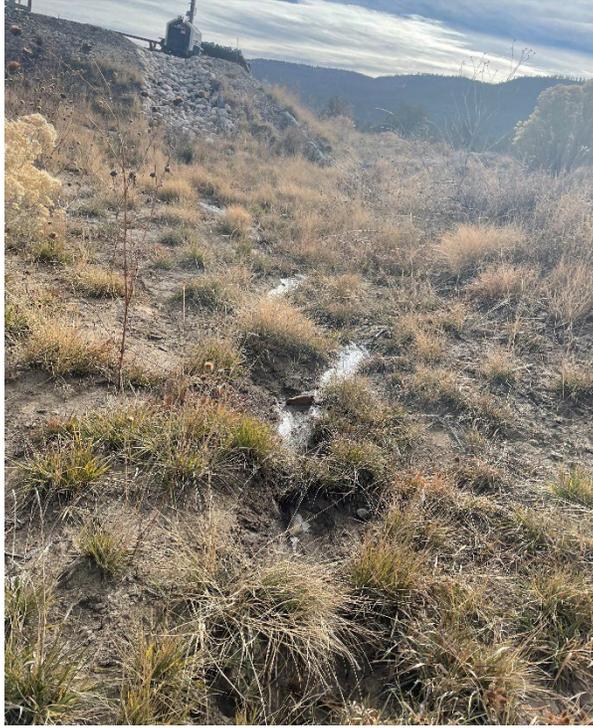
Looking South: Minor impacts off pad surface to interim reclamation.
