Inspection Photos

API: 071-08769

Operator: WAPITI OPERATING LLC

Inspection Date: 12/7/2022

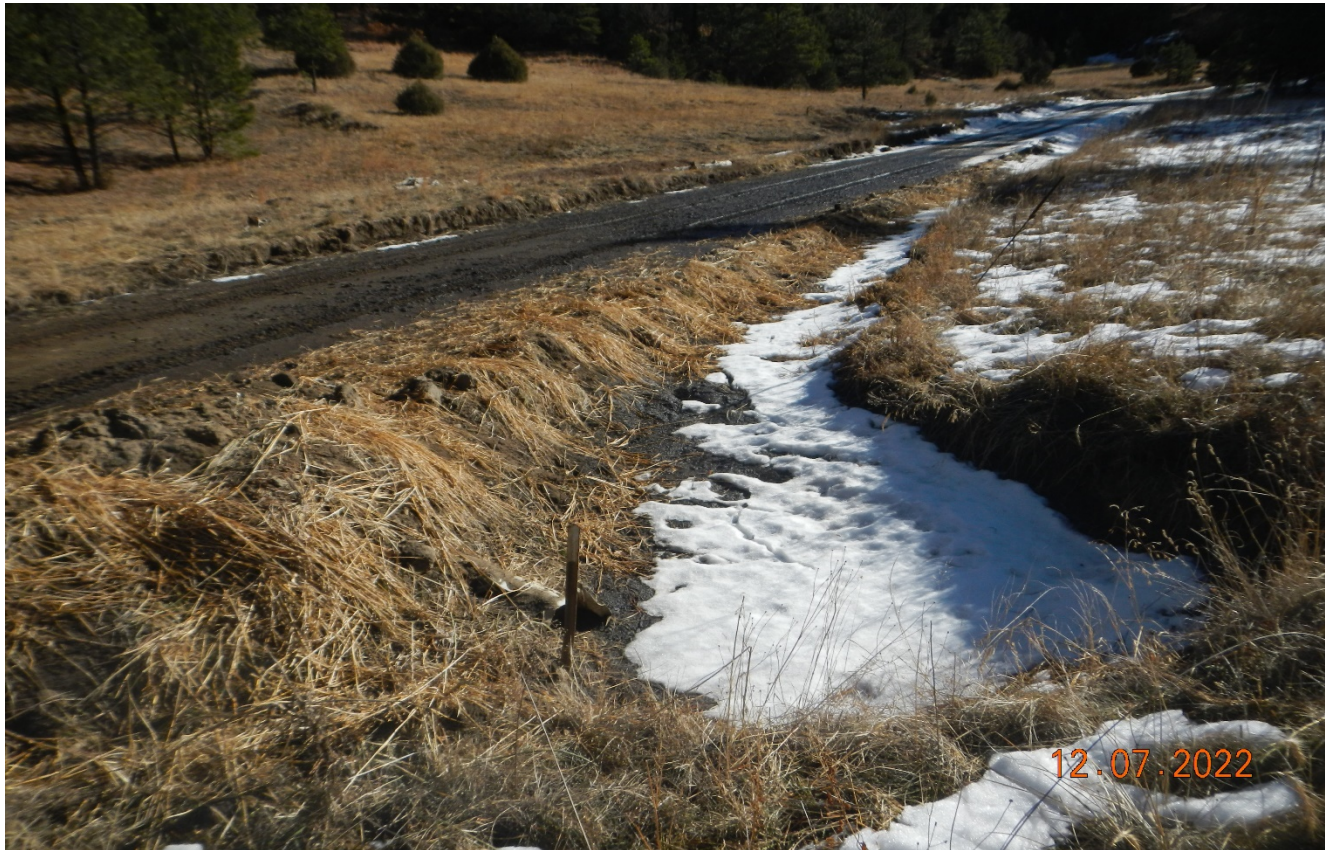
Photo 1. This culvert inlet was cleaned out however, the culvert is full of sediment. Previous corrective action was not completed. Lat/Long:37.00581,-104.83861.

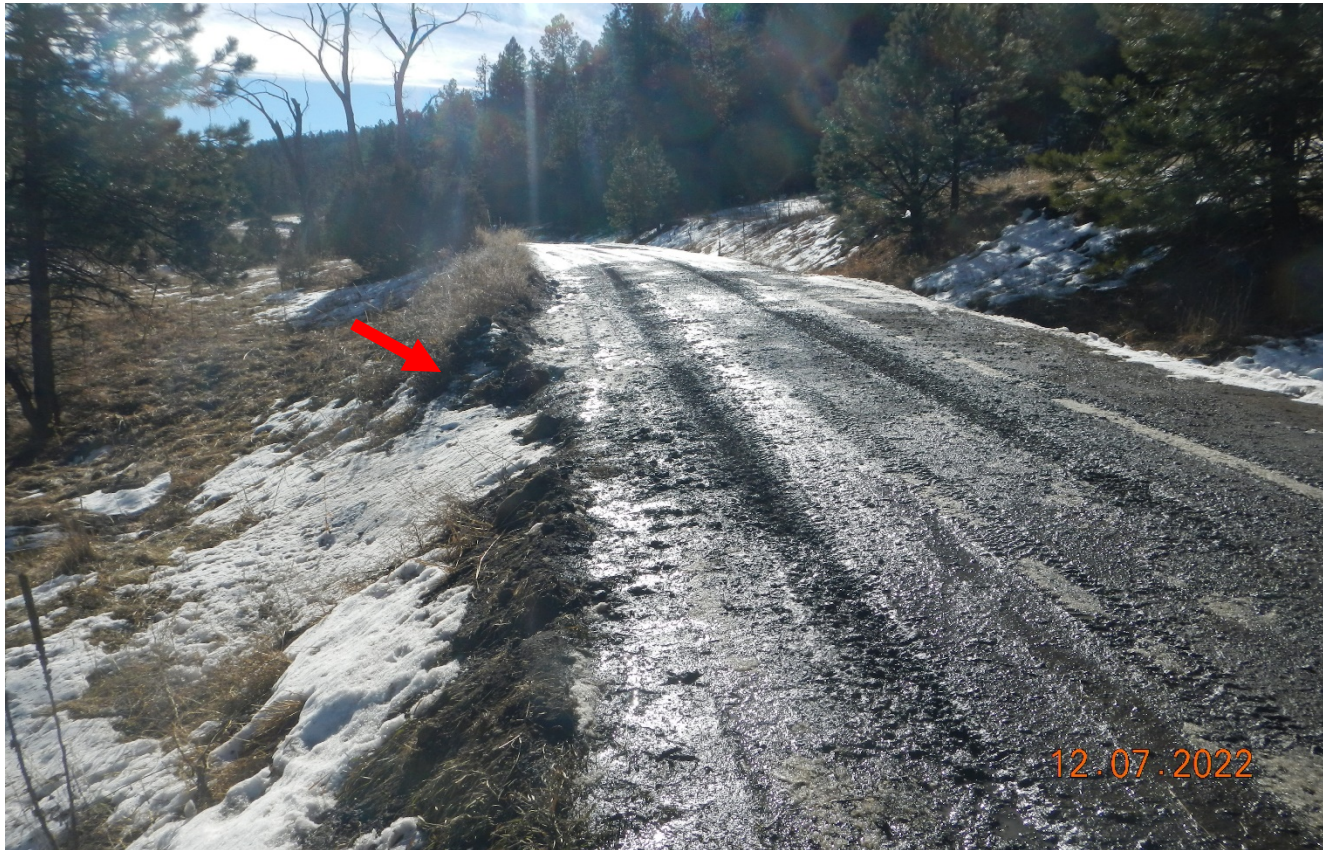
Photo 2. There is an erosion gully along the road that needs to be repaired and stabilized. It appears grading operations has partially filled in this gully however it still needs to be stabilized. Previous corrective action was not completed.

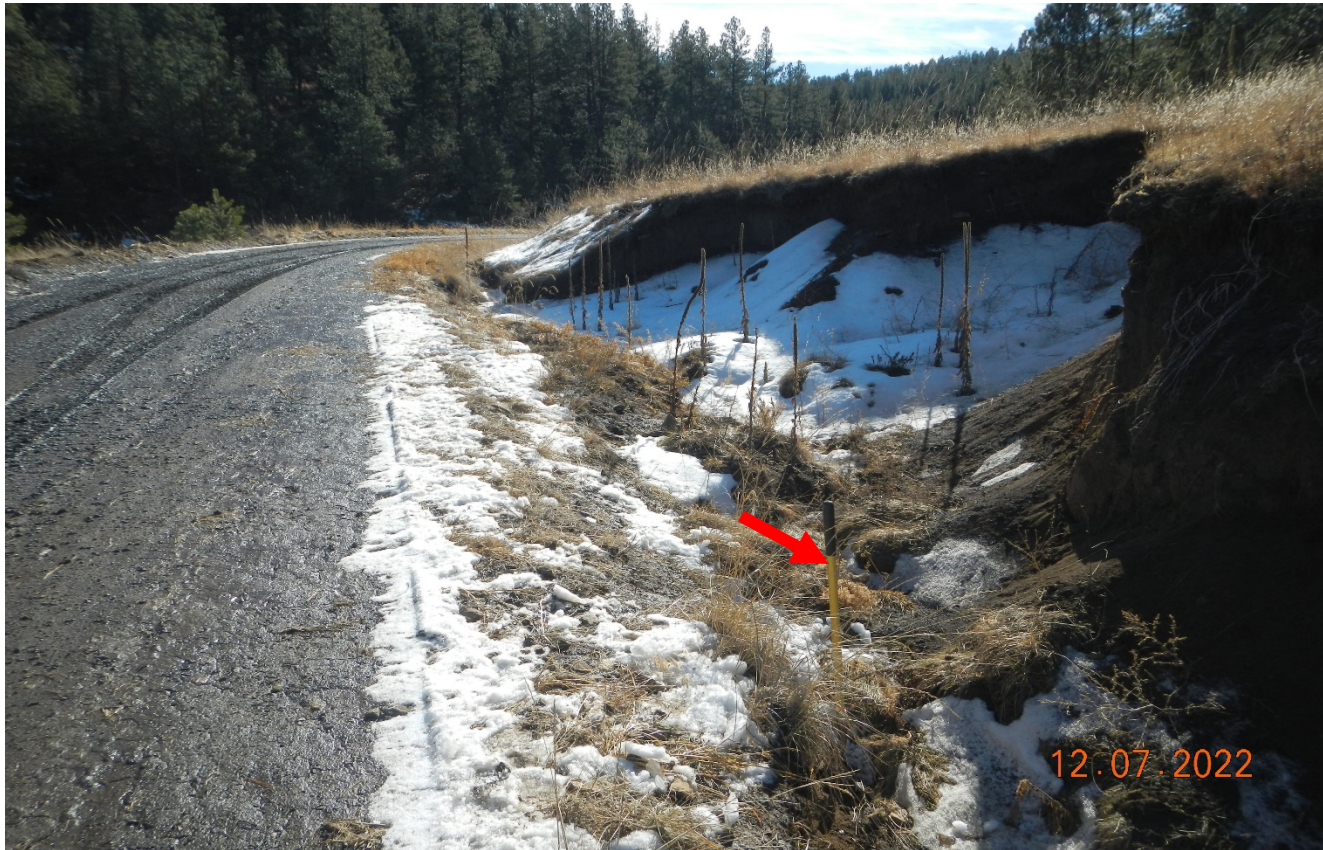
Photo 3. The side of the road is eroded and not stabilized. Erosion head cutting is continuing to occur further back. This area needs to be repaired and stabilized. Previous corrective action not completed. Red arrow points to 4.5 ft. shovel. Lat/Long:36.99952,-104.83425.

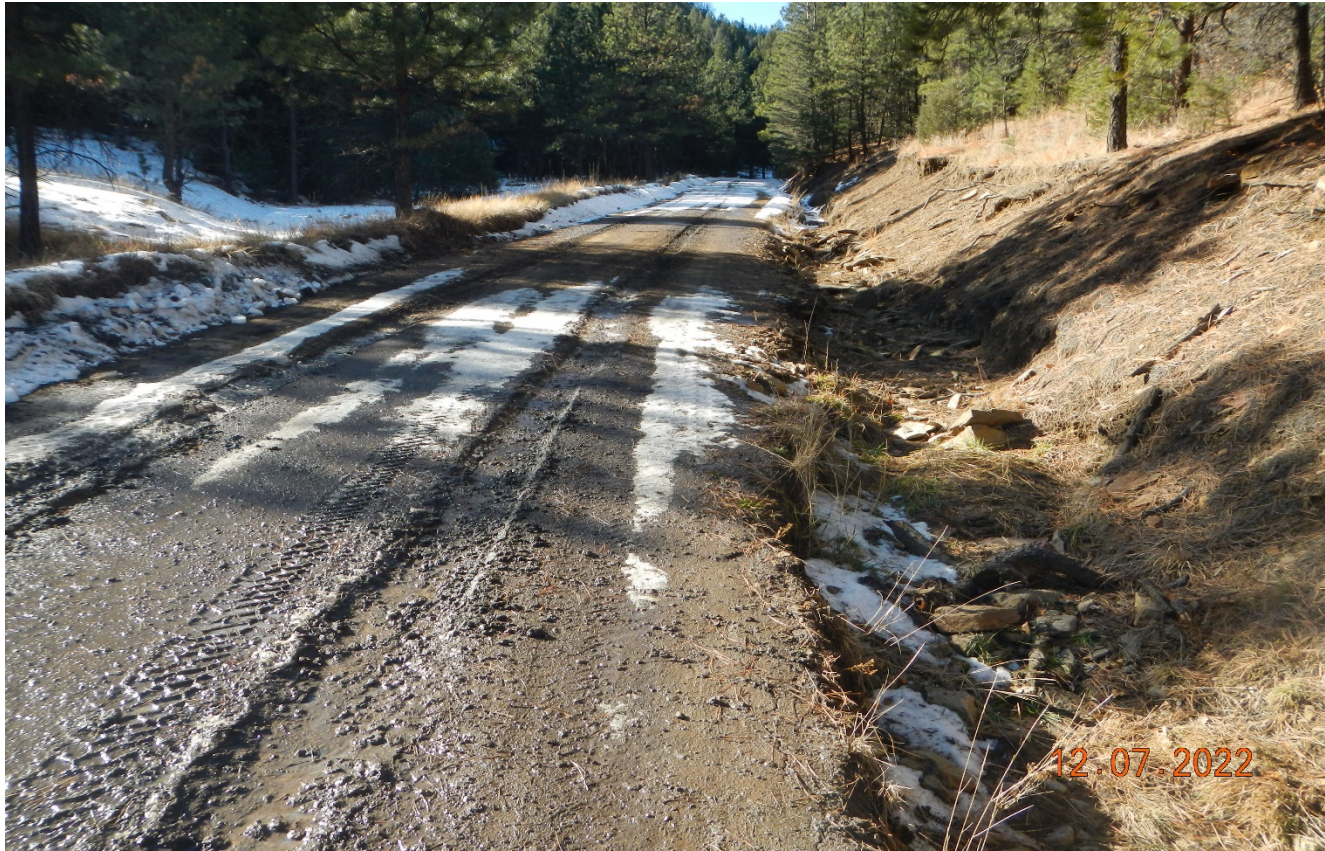
Photo 4. Further along the road near the Colorado line. The roadside and road is eroded and needs to be repaired and stabilized. Previous corrective action not completed.

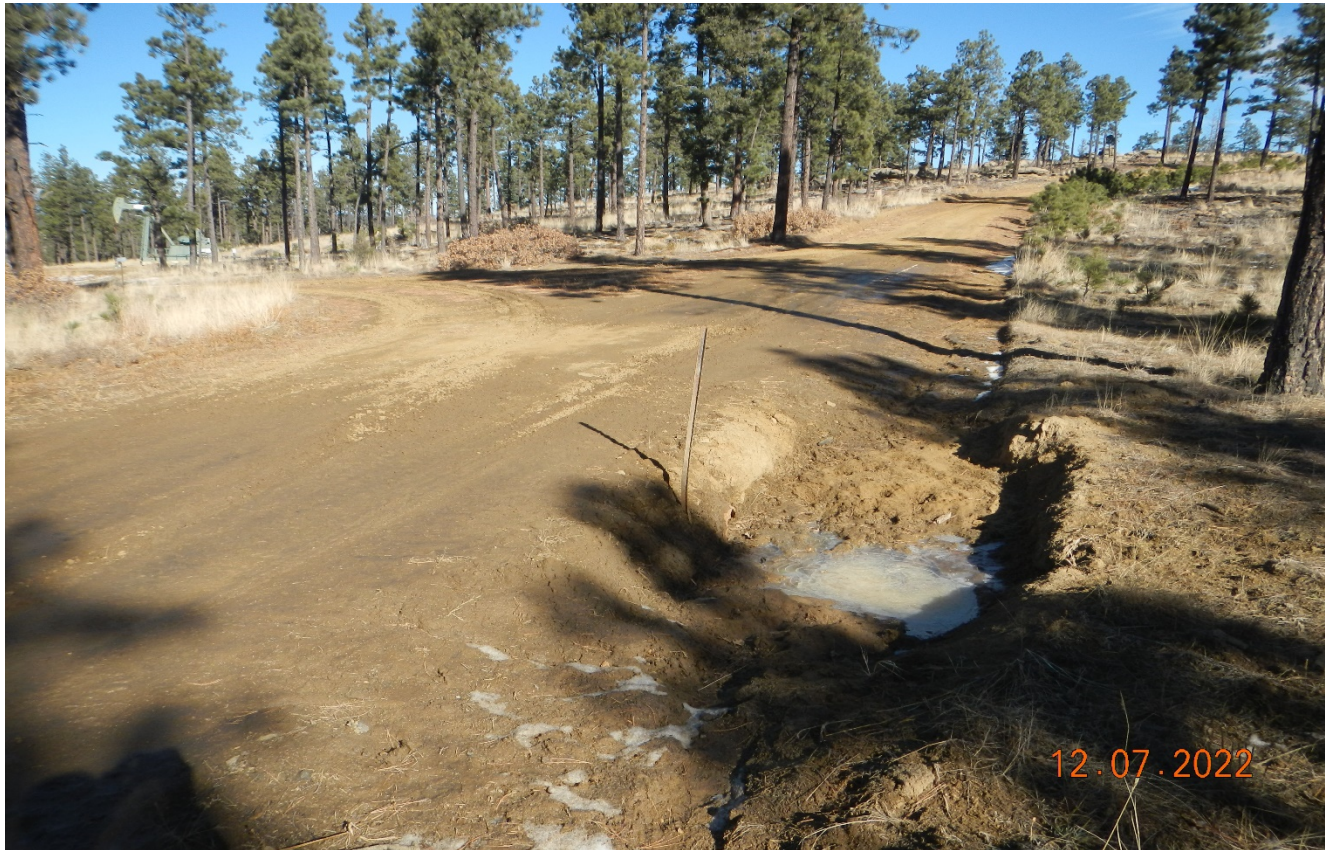
Photo 5. This culvert inlet was cleaned out however, the culvert is full of sediment which needs to be cleaned out. Lat/Long:36.99405,-104.84710.

Previous corrective action not completed.

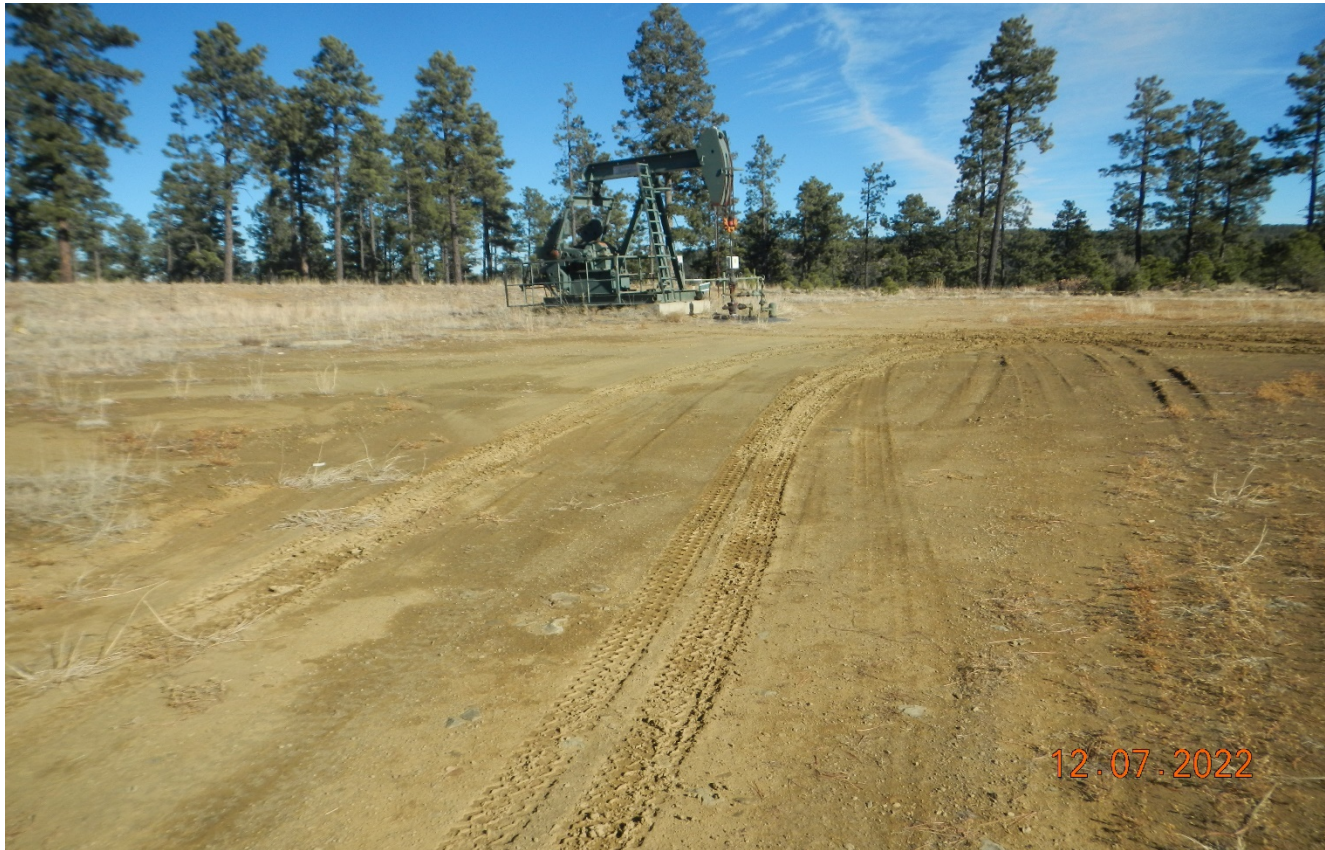
Photo 6. Facing northeast toward the well site.
