Manway 13-32 & Manway 13-32 TR

Pit Reconciliation

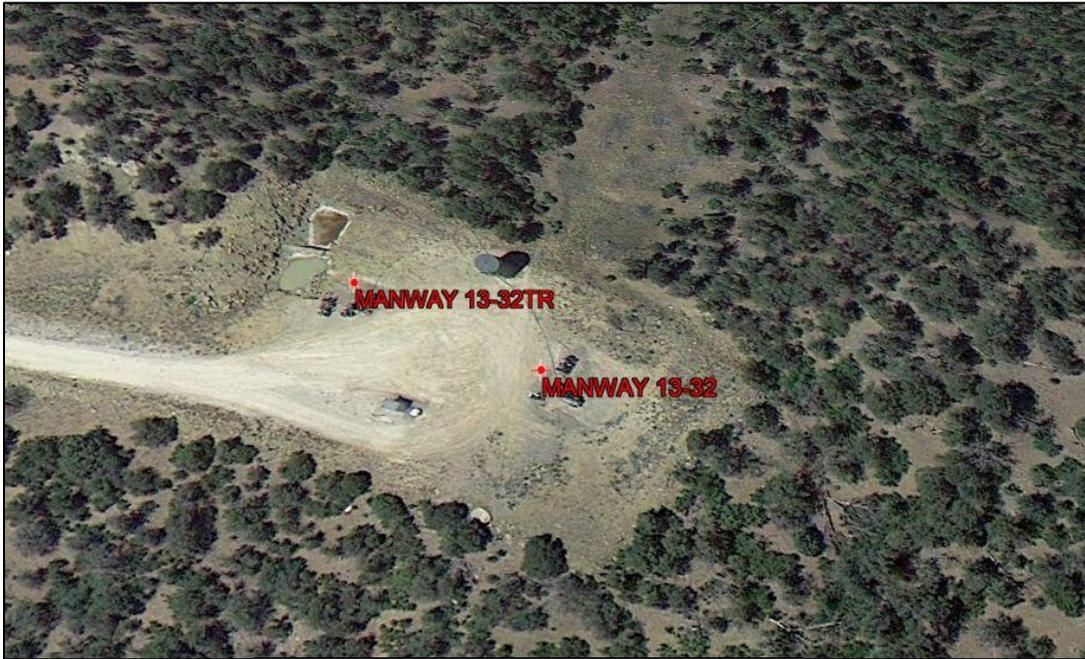
Facility #112900
Located by the TR
wellhead, but
named as OG pit

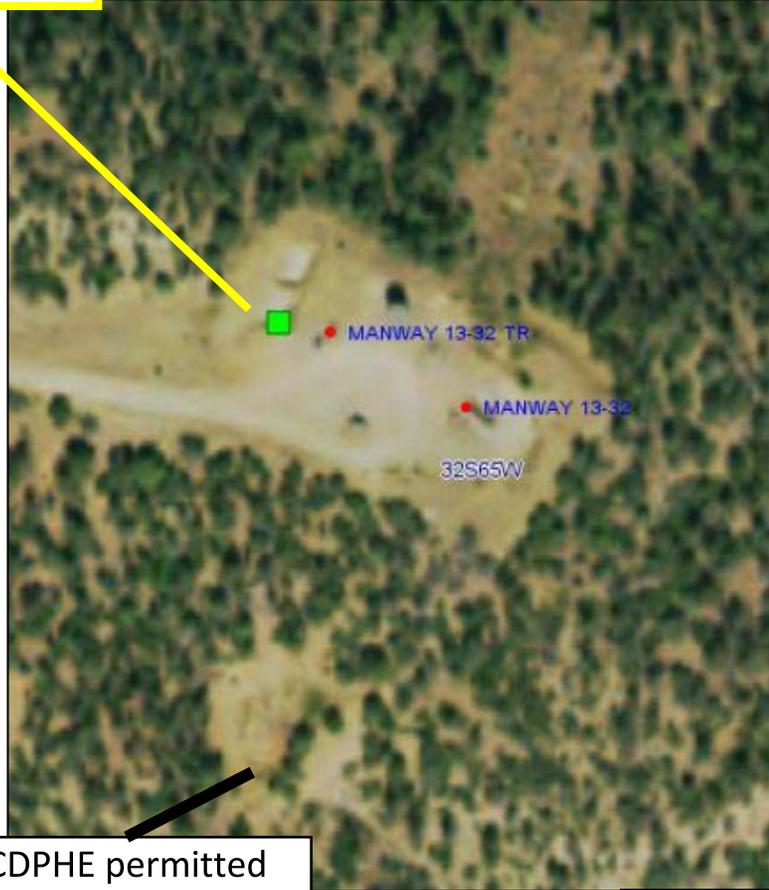
CDPHE permitted
discharge point, not
COGCC pit

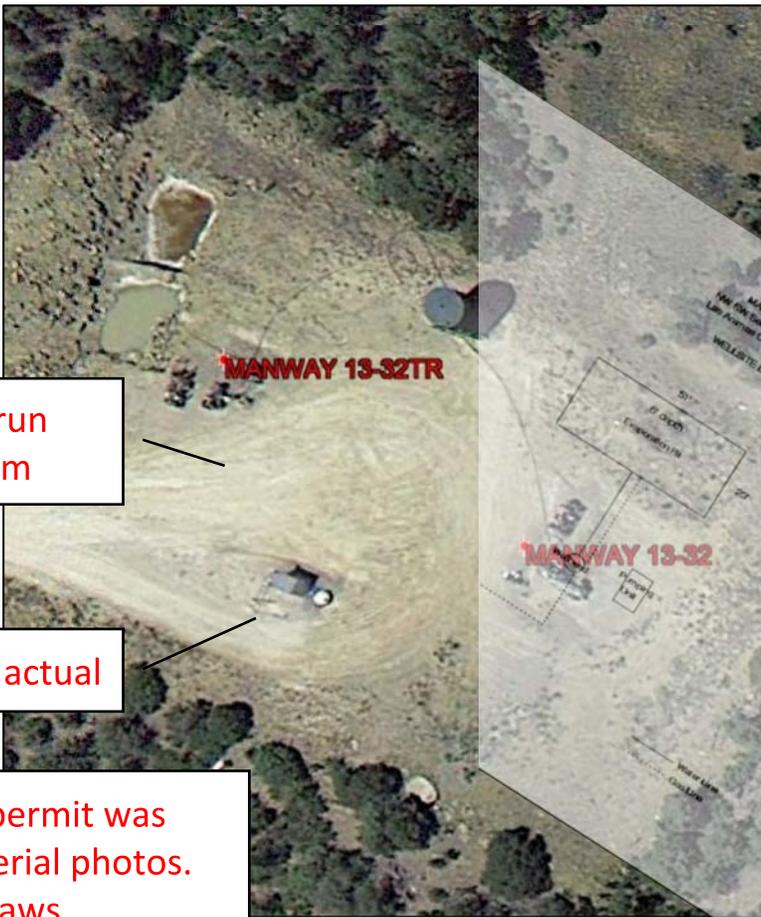
Meter run diagram

Meter run actual

Diagram from pit permit was overlaid on top of aerial photos. Both show flaws.

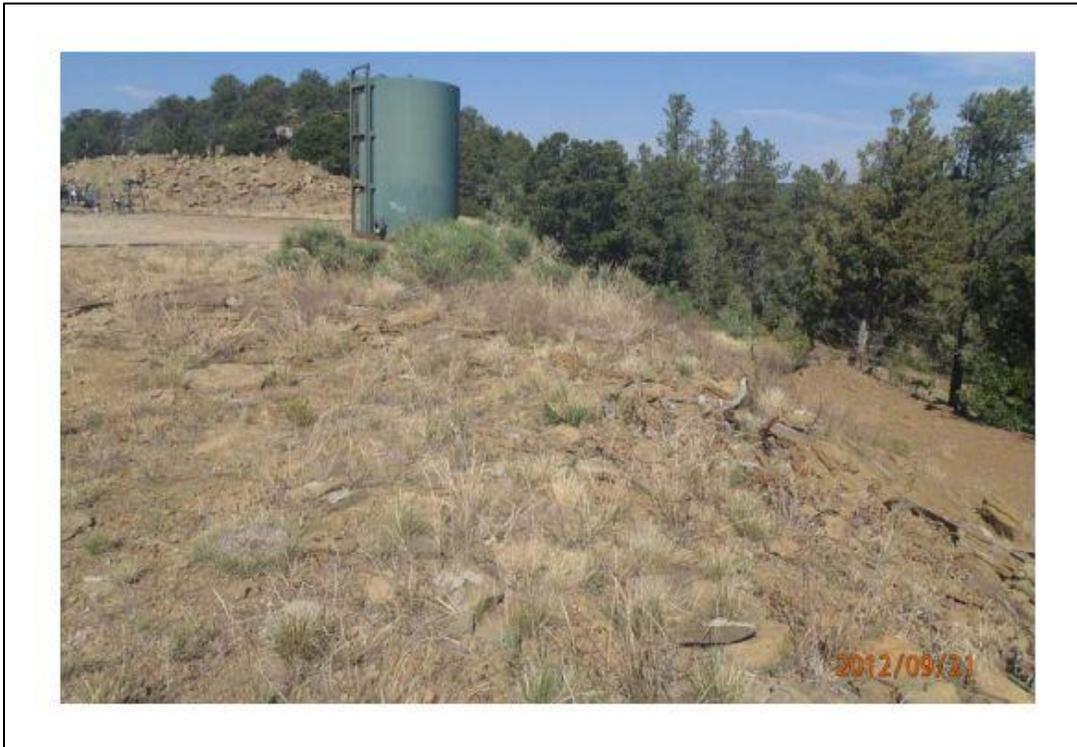
Internal Inspection Photos

Internal inspection photos from 2012 indicate that both a produced water storage tank, and a pit is found on the Manway OG/TR location. This matches the Doc #656647 comments

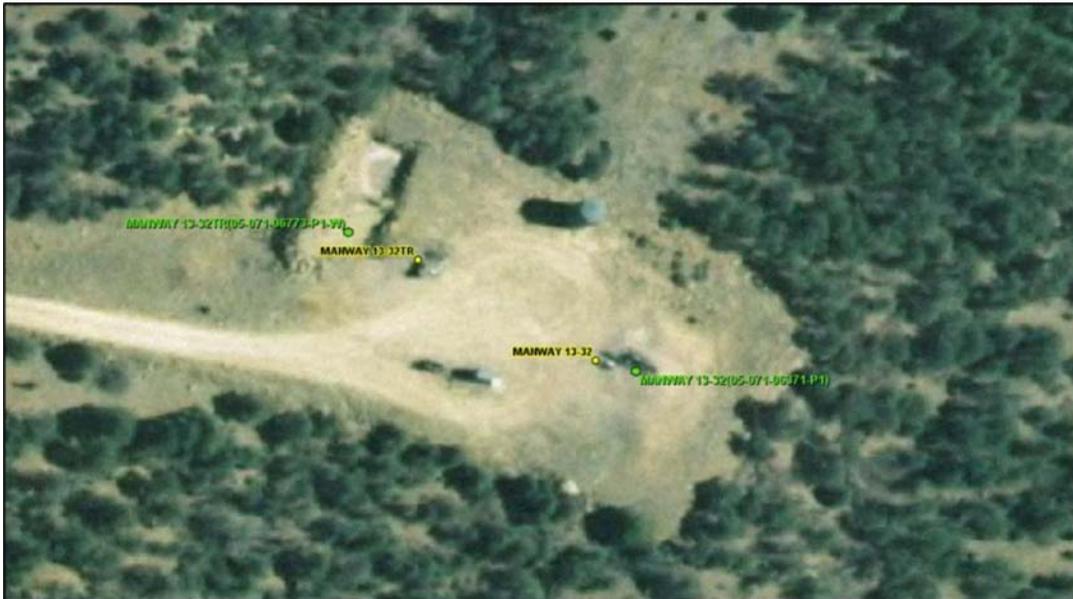
Internal GIS Database

- Internal GIS records indicate that there was a pit for both Manway OG and TR wells.
- **Manway OG pit indicates constructed, and is linked to ID #112900**
- **Manway TR pit indicates constructed, and is linked to ID#256702**
