# Interim Reclamation and Stormwater Inspection

Operator: UPLAND EXPLORATION LLC- #10701

Location ID: 456651

Inspection Photos  
Location Name: Salt Ranch Fee/18 East  
Location ID: 456651

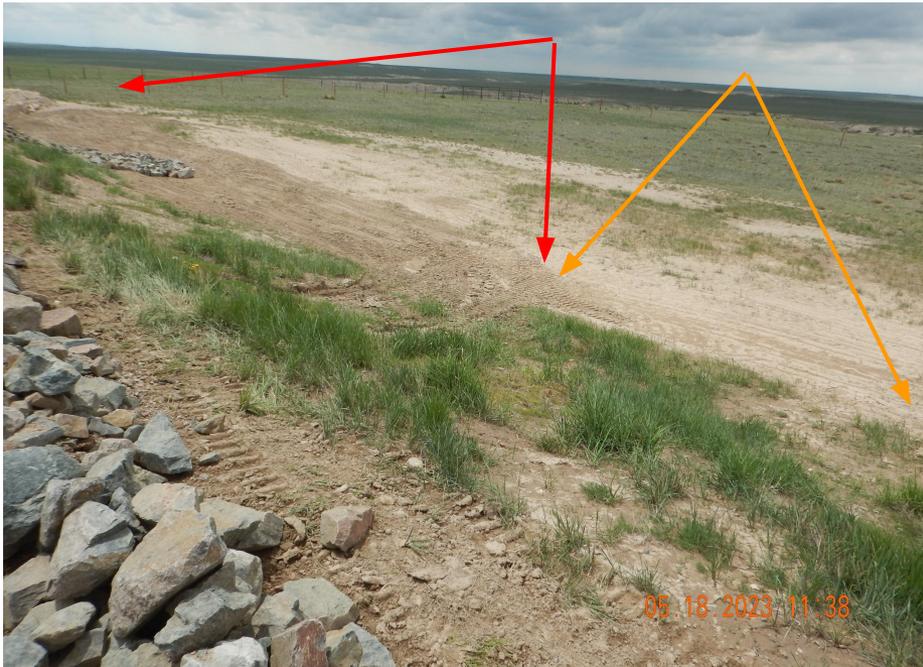
**Photo 1.** Photo taken from the southwestern fill slope, facing Southwest. Photo illustrates a stormwater BMP (ditch-red arrows) has been installed. At the time of this inspection, Operator believed that the BMP was sufficient to meet the stormwater requirements. COGCC disagreed and indicated that a significant portion (orange arrows) lacked any perimeter BMP. There is evidence of rill erosion along the fill slope within the orange arrows. See Photo 2 for additional areas lacking a perimeter BMP.

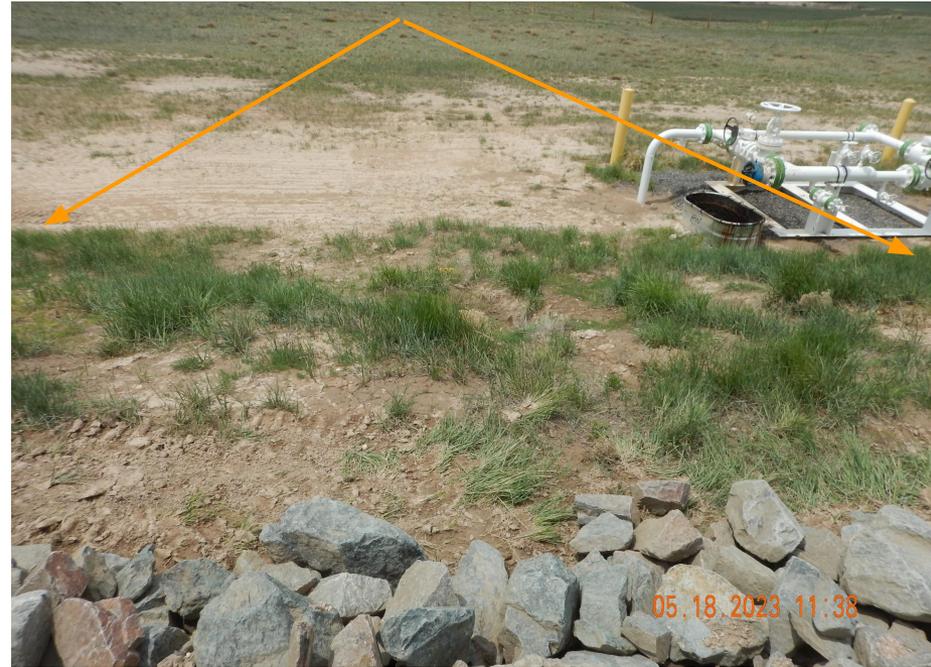
**Photo 2.** Photo taken from the southwestern fill slope, facing West. Photo illustrates a lack of any perimeter BMP. There is evidence of rill erosion along the fill slope within the orange arrows.

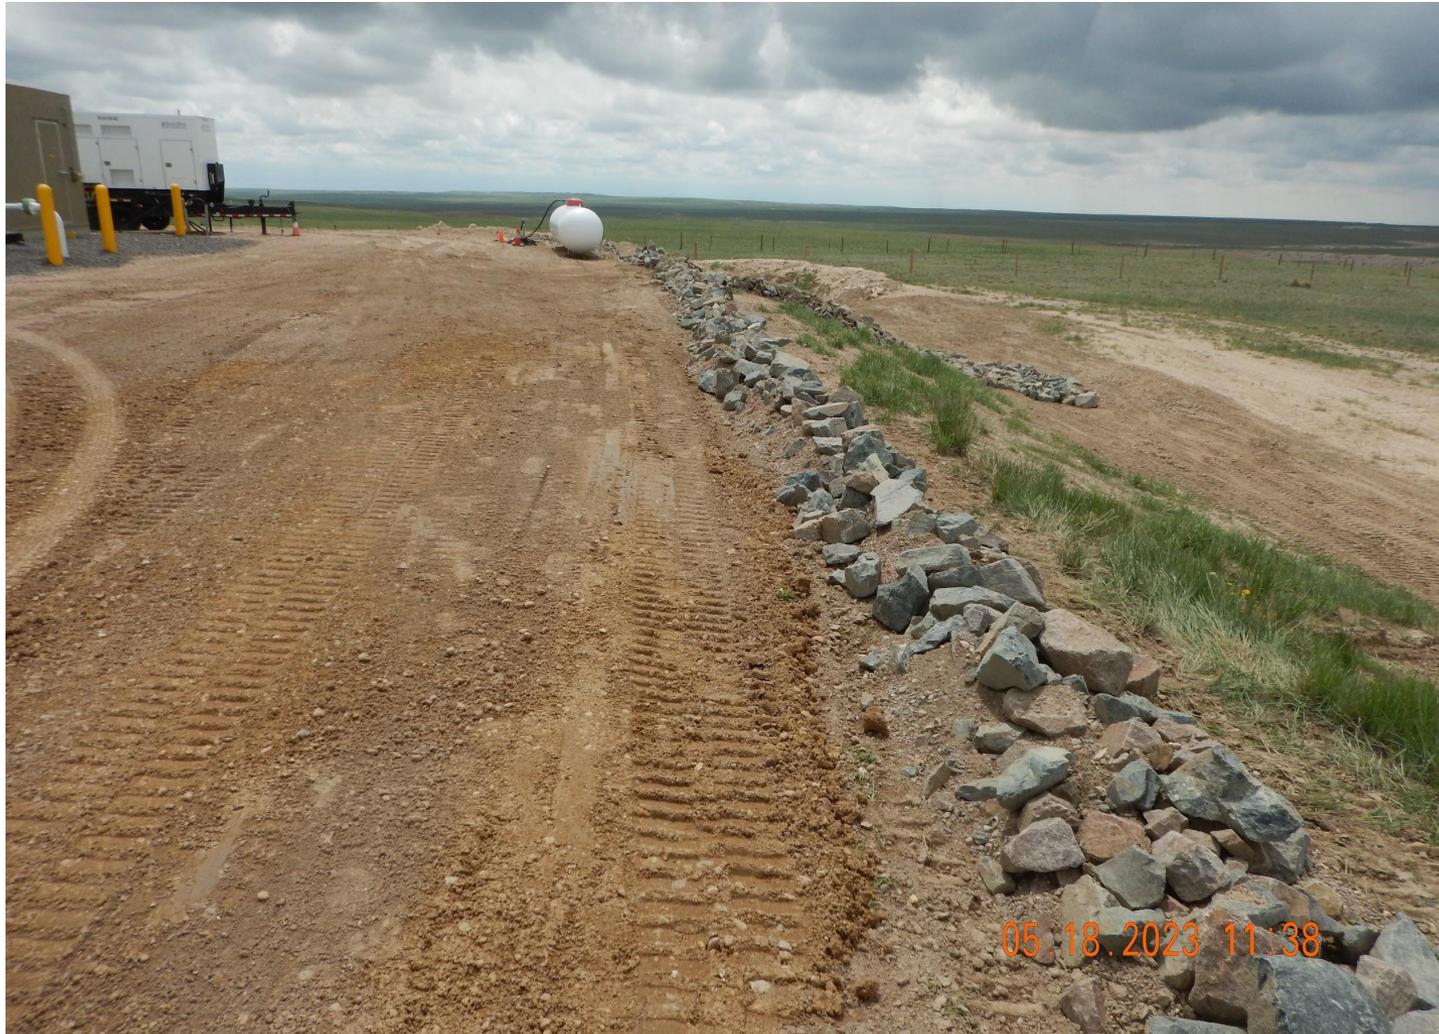
**Photo 3.** Photo taken from the southwestern fill slope, facing South. Photo illustrates a rocked BMP along the top of the fill slope to act as a check dam to slow stormwater runoff before it reaches the down gradient fill slope.

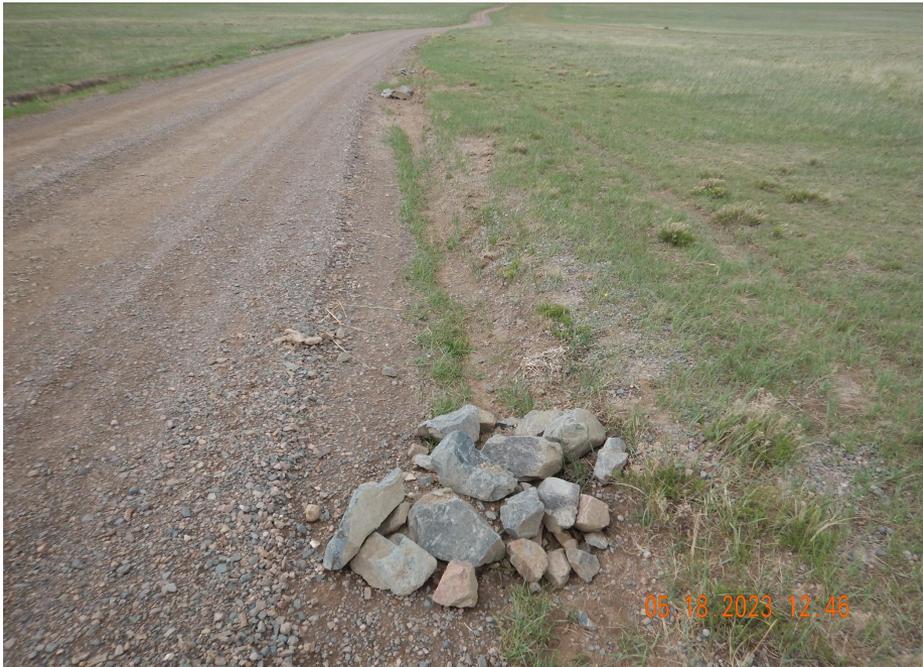
**Photo 4.** Photo taken from a portion of the access road, facing East. Photo illustrates check dams have been installed since the May 11th inspection. However, not all the check dams have been installed and reclamation repairs along the access road are in-process.

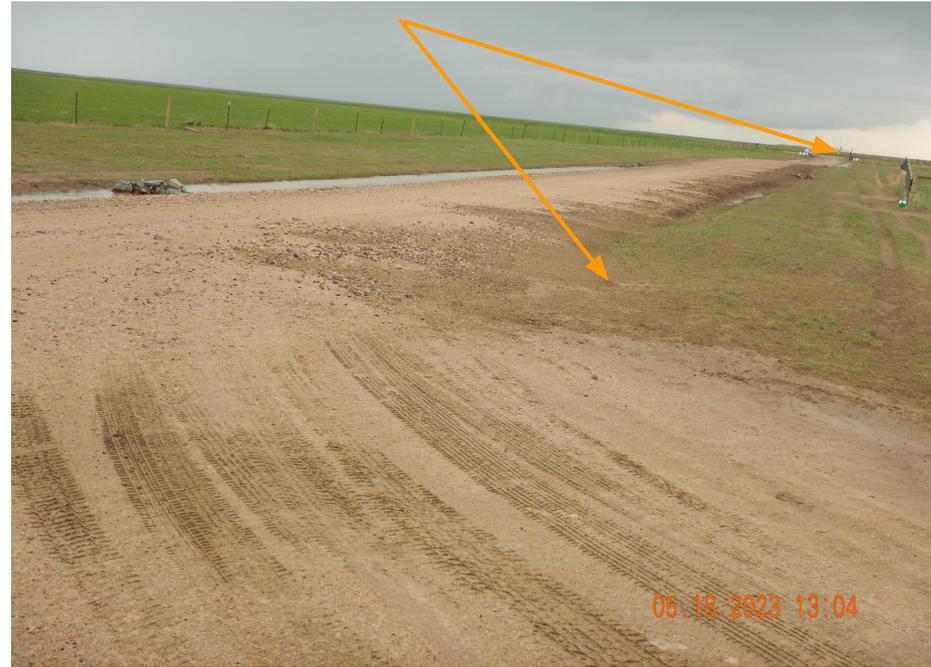
**Photo 5.** Photo taken from a portion of the access road near the entrance of location, facing East. Photo illustrates crews have initiated rock removal from pasture areas.
