Operator: Crestone Peak Resources

Location Name: GRENEMEYER WAGNER C UNIT-61N67W 34NWNW

Loc ID: 319014

Inspection: 709400134

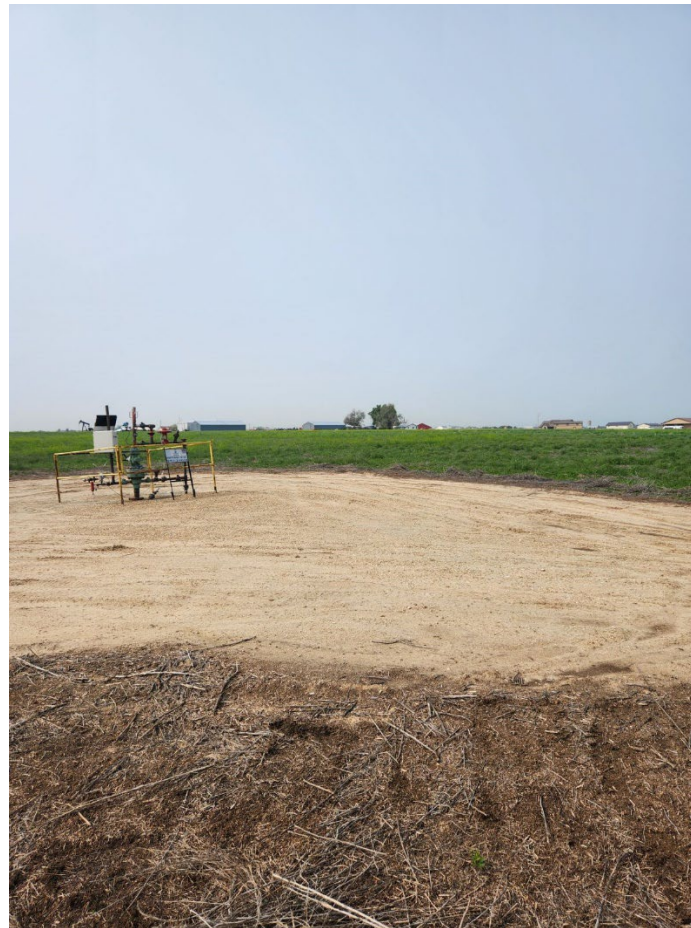
Exhibit A

CA: Weeds and weed debris in the reclamation area around site. Operator failed to control and manage weeds to prevent weed waste and prevent the spread of seeds onto adjacent lands. Comply with Rule 606 to remove weed debris.

CA Resolution: Weeds and weed debris have been removed in compliance with Rule 606. (See Exhibit A)
