Inspection Photos

Operator: SCOUT ENERGY MANAGEMENT LLC
- 10779

Location Number: 314536
Rio Blanco County, CO

Aaron Trujillo
NW Reclamation Specialist
COGCC

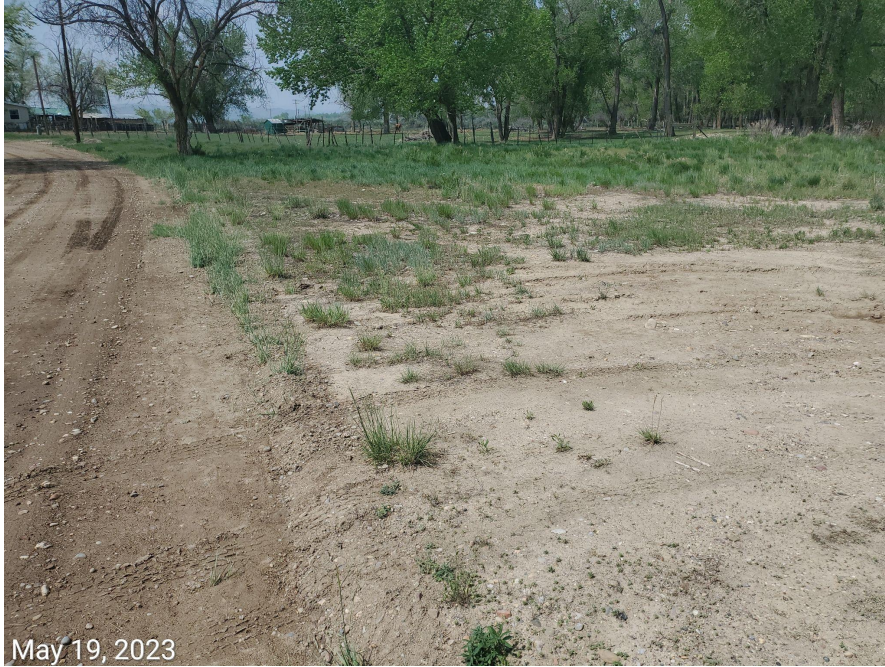
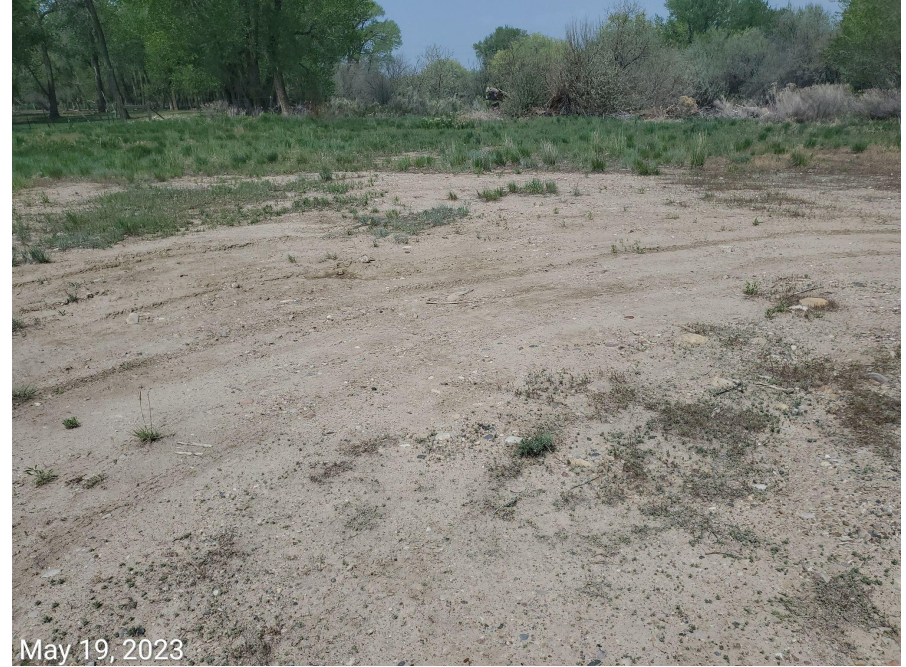
Photo 1: Photos 1-2 taken from the southeast end of the Location. Photos provide an overview of the Location from southwest, west, north, to northeast. Photos show large areas of the Location that remains bare/unvegetated. Location has not achieved a uniform desirable perennial vegetative cover. Compaction issues remain apparent.

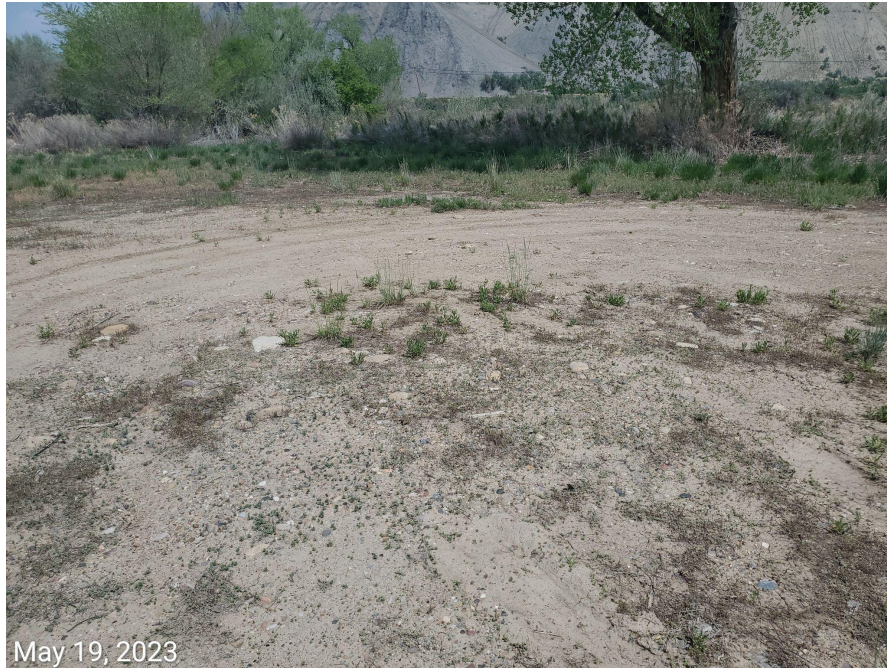
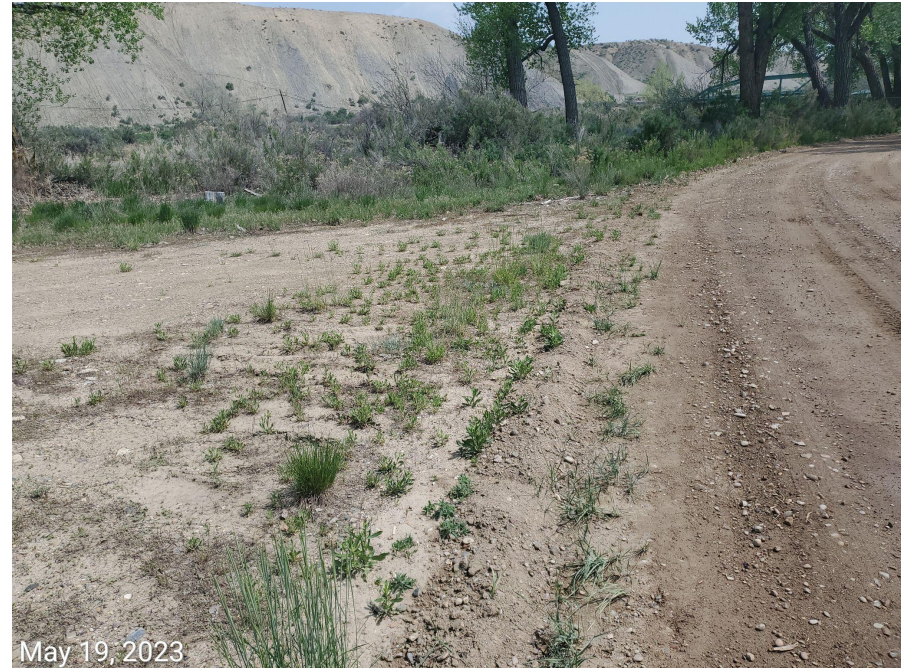
Photo 2: See comments under photo 1.

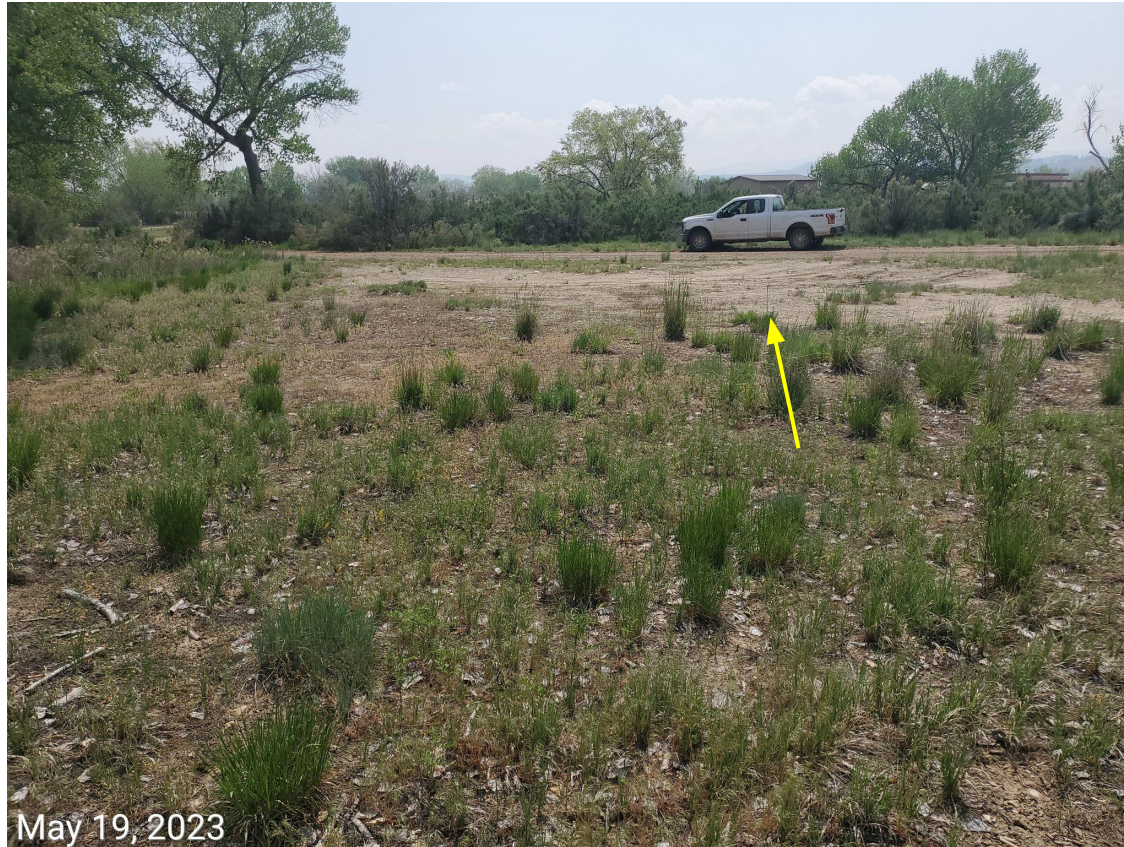
Photo 3: Photo taken from the interim areas on the northwest end of Location, facing southeast. Photos provide an overview of the Location from east, southeast, south to southwest. Arrows show areas of the Location that remains bare/unvegetated. Location has not achieved a uniform desirable perennial vegetative cover.
