Issue of Concern:

Corrective actions taken.

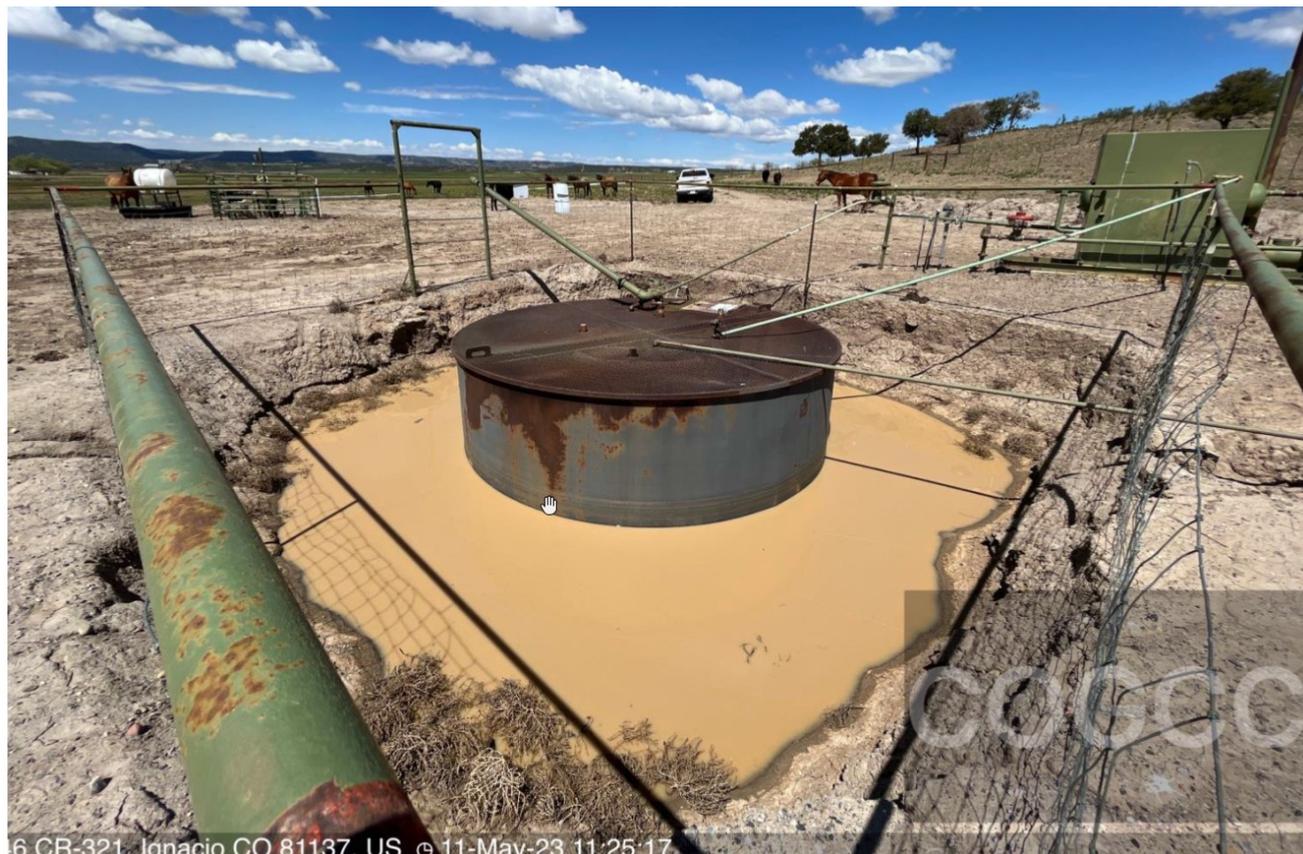
COMMENTS: Tank containment berm holding fluid. See Photo #2.

Picture from INC showing the containment around the pit with water in it.

CORRECTIVE ACTION: Rule 912.d.(1) Maintain tank berm by removing fluid, confirm tank integrity and confirm that fluid is not E&P waste. If E&P waste is suspected, fluid must be disposed of in accordance with 900 Series rules.

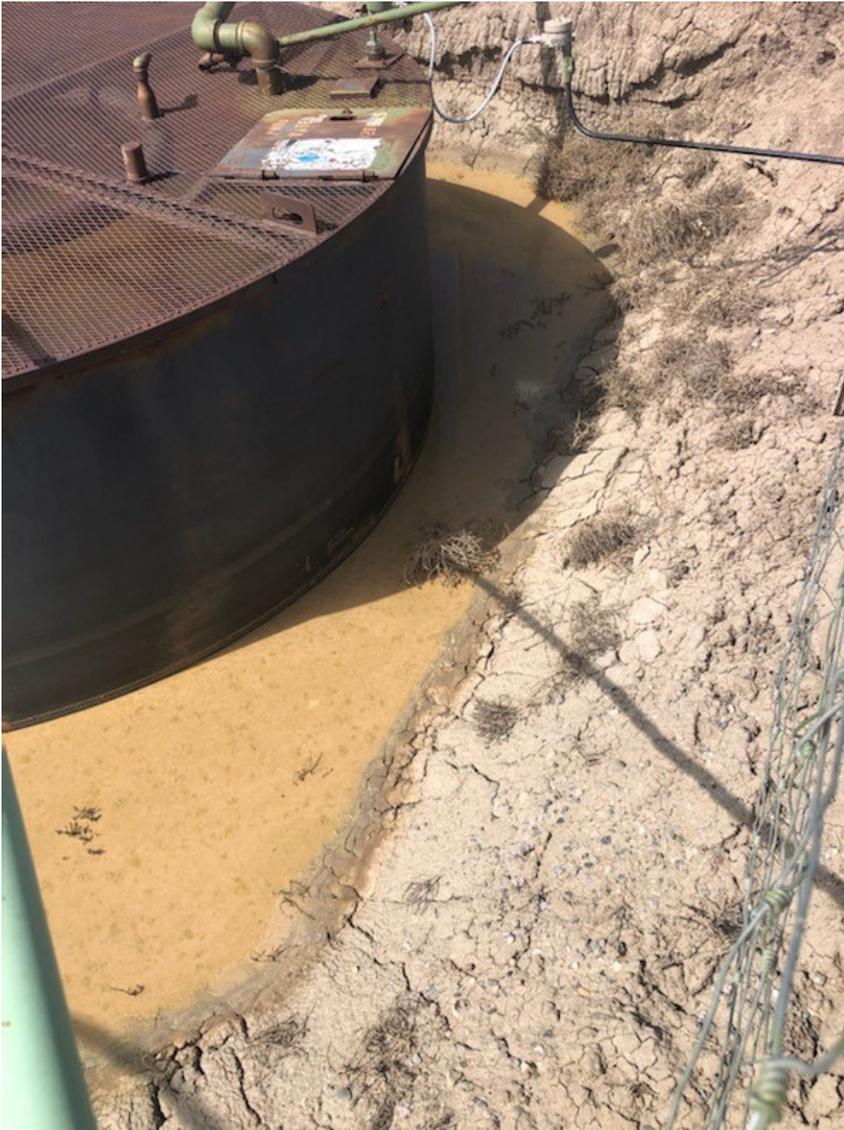
Pictured is the remaining water in the containment area. We have been monitoring this water level since pumping out what we could. It is slowly decreasing as it evaporates and should be completely dry soon provided when continue with drier weather.
