Operator: 8 NORTH LLC

Location Name: FABRIZIUS 33-14

Loc ID: 413933

Inspection: 696304950

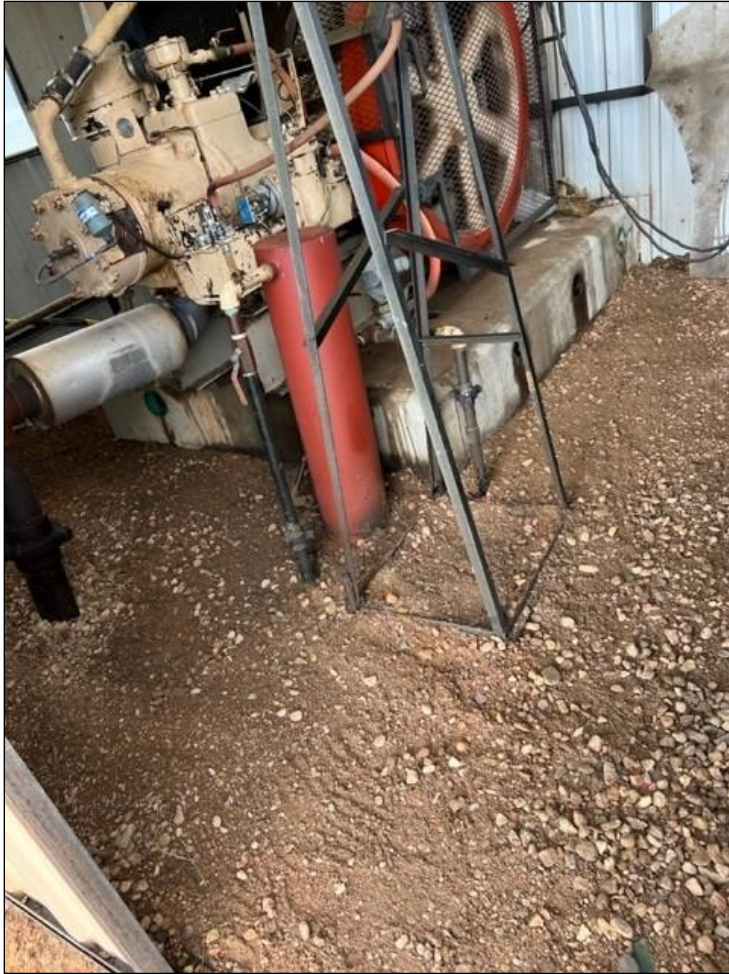
Exhibit A

CA: Stained Soil at Wellhead, Gas Engine, and Exhaust. For localized stained soils or oily waste - "Properly dispose of oily waste in accordance with 905.e."

CA Resolution: Identified stained soil at Wellhead, Gas Engine, and Exhaust has been properly addressed. Operator has disposed of stained soil and replaced it with fresh soil to comply with Rule 905.e.
