**FIGURE 1**  
**TABLE 915 ORGANICS ASSESSMENT MAP**  
**DRAGON COMPRESSOR STATION**  
**NENE SEC 8-T5S-R62W**  
**ARAPAHOE COUNTY, COLORADO**  
**KERR MCGEE GATHERING, LLC**

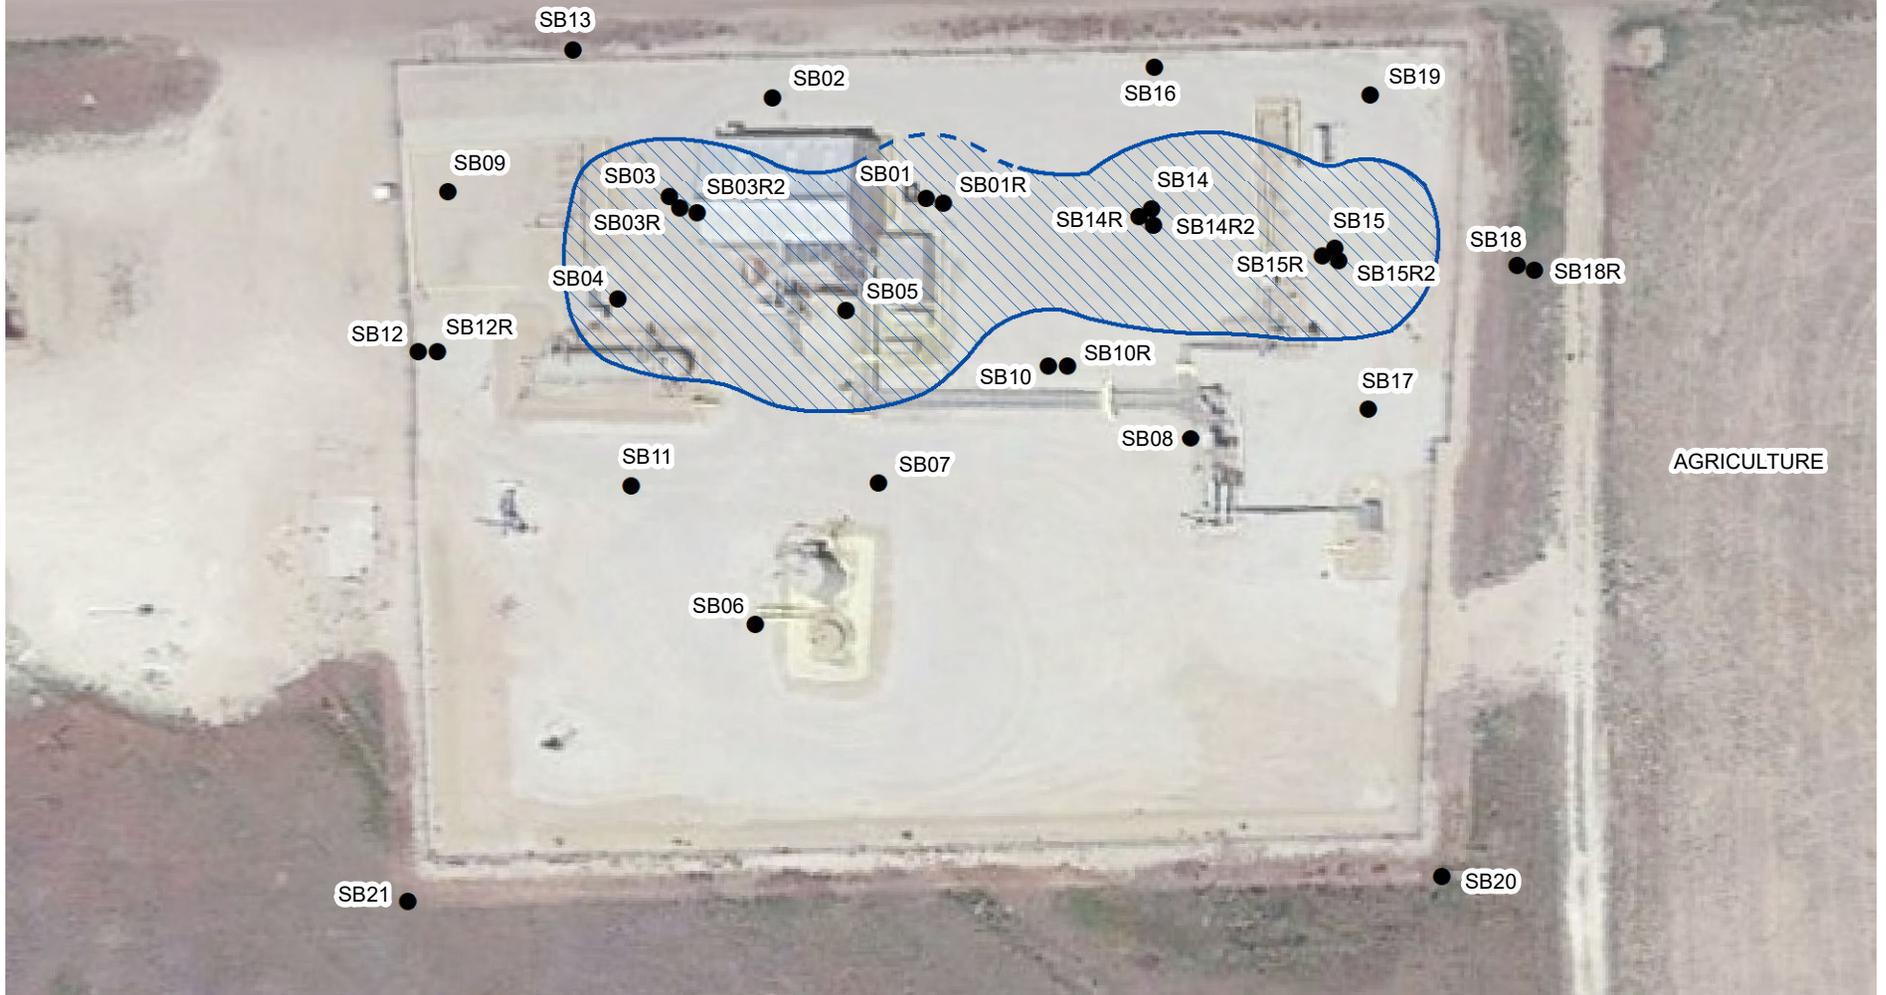
- SOIL BORING
- IMPACTED SOIL IN-PLACE BOUNDARY
- - - DASHED WHERE INFERRED
- /// ESTIMATED EXTENT OF SOIL NON-COMPLIANT WITH TABLE 915 ORGANIC SOIL STANDARDS

NOTE: ALL INFRASTRUCTURE ON SITE IS FORMER.
