Operator: CRESTONE PEAK RESOURCES OPERATING LLC

Location Name: SELTZER-61N67W 34SESW

Loc ID: 317673

Inspection: 709400295

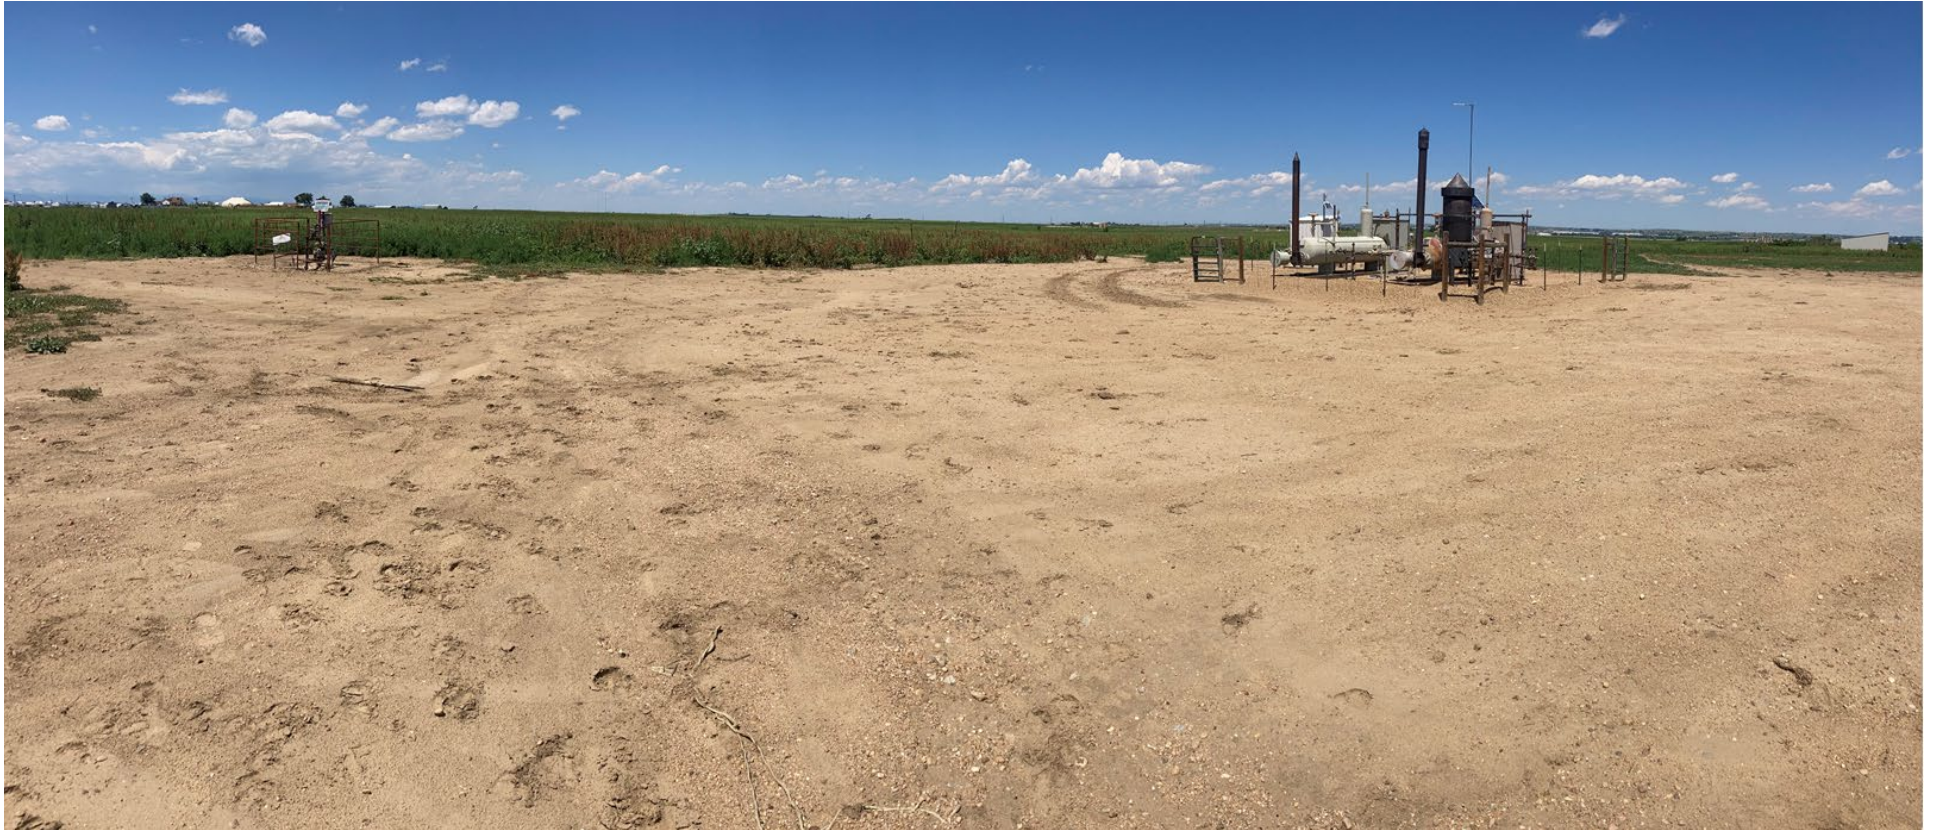
Exhibit A

CA: Failure to control and manage weeds to prevent weed waste and prevent the spread of seeds onto adjacent lands. Comply with Rule 606.c.

CA Resolution: Weeds have been sprayed by property owner to comply with Rule 606. Area will be monitored and maintained moving forward.
