# Interim Reclamation and Stormwater Inspection

June 30, 2023

Operator: NOBLE ENERGY INC - #100322

Location ID: 332789

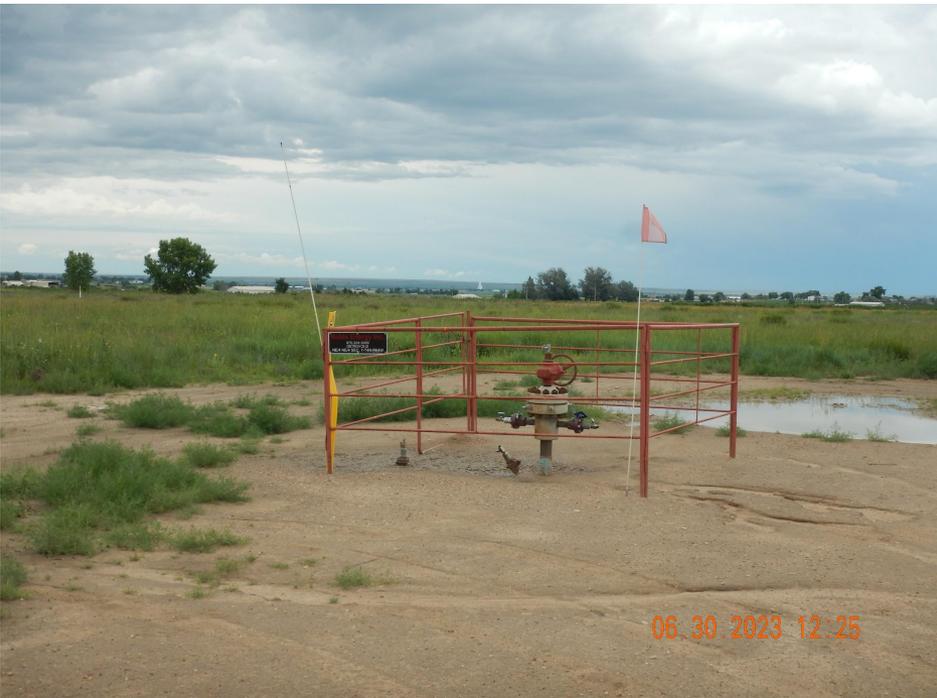
**Photo 1.** Photo taken from the well location, facing East. Photo illustrates Operator has plugged and abandoned 5 of the 6 wells.

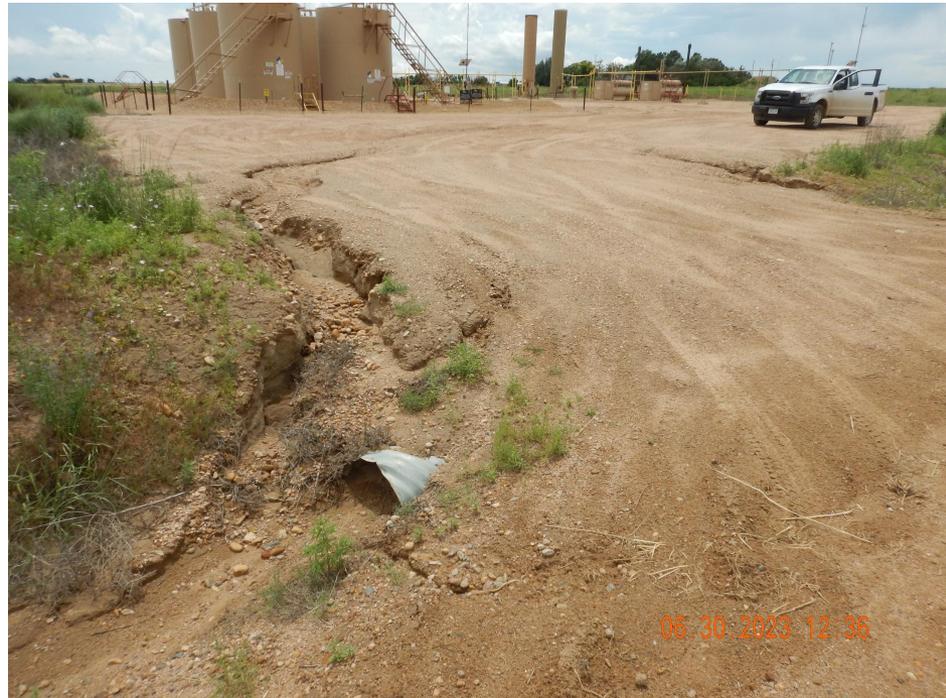
**Photo 2.** Photo taken from the associated offsite tank battery, facing Southwest. Photo illustrates gully erosion without sufficient stormwater BMPs. Also, the culvert is in need of repair.

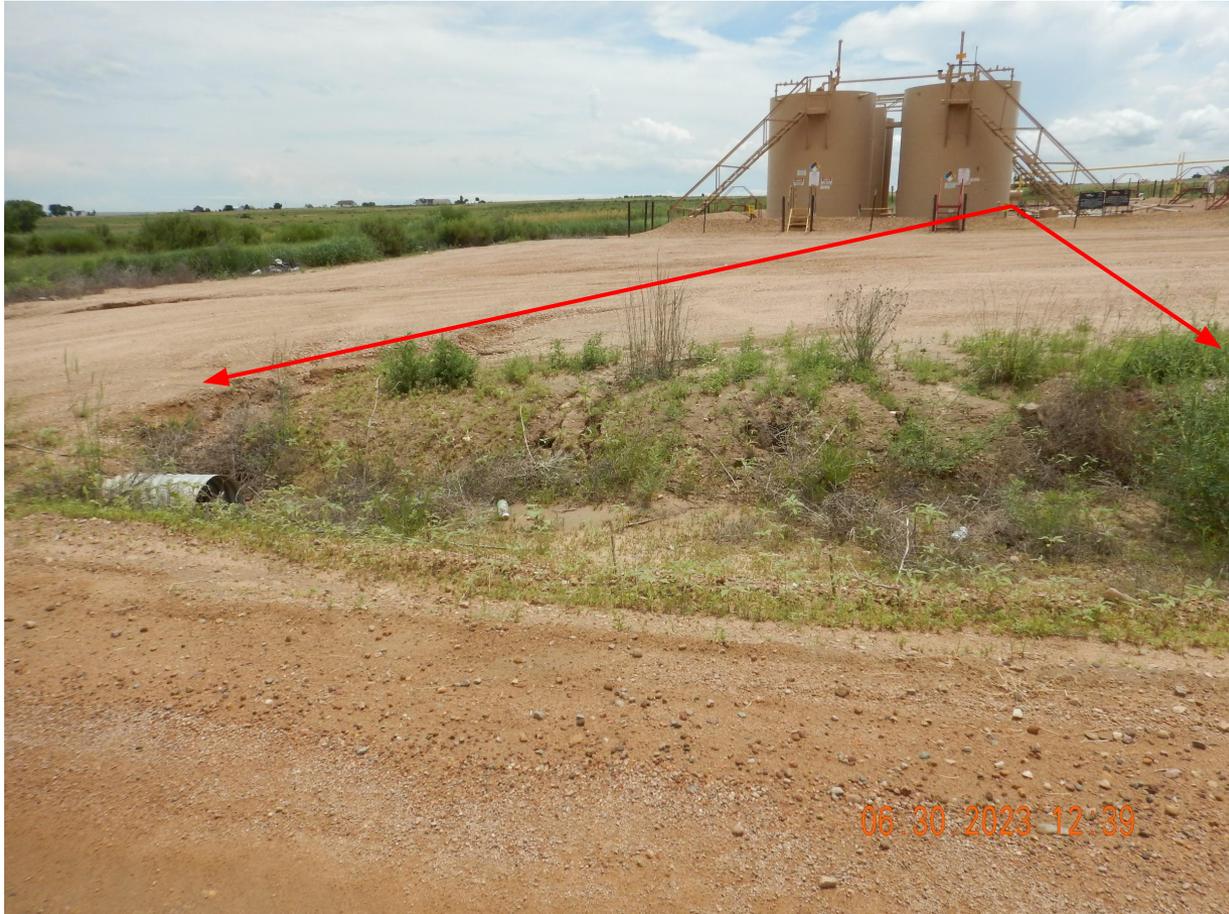
**Photo 3.** Photo taken from the associated offsite tank battery, facing South. See comments under Photo 2.
