Inspection Photos

Operator: GUNNISON ENERGY LLC - 10515

Location Number: 412922

Gunnison County, CO

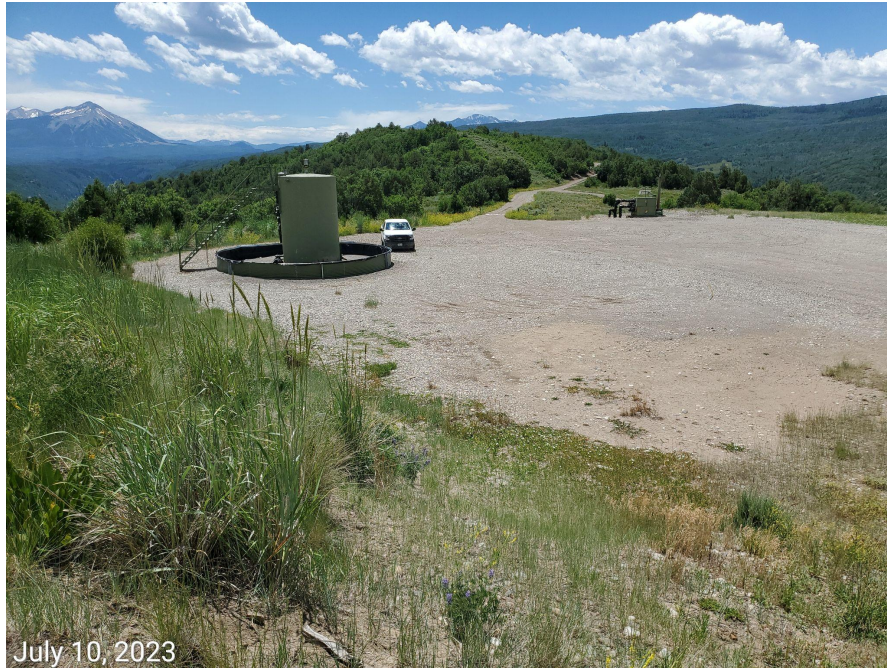
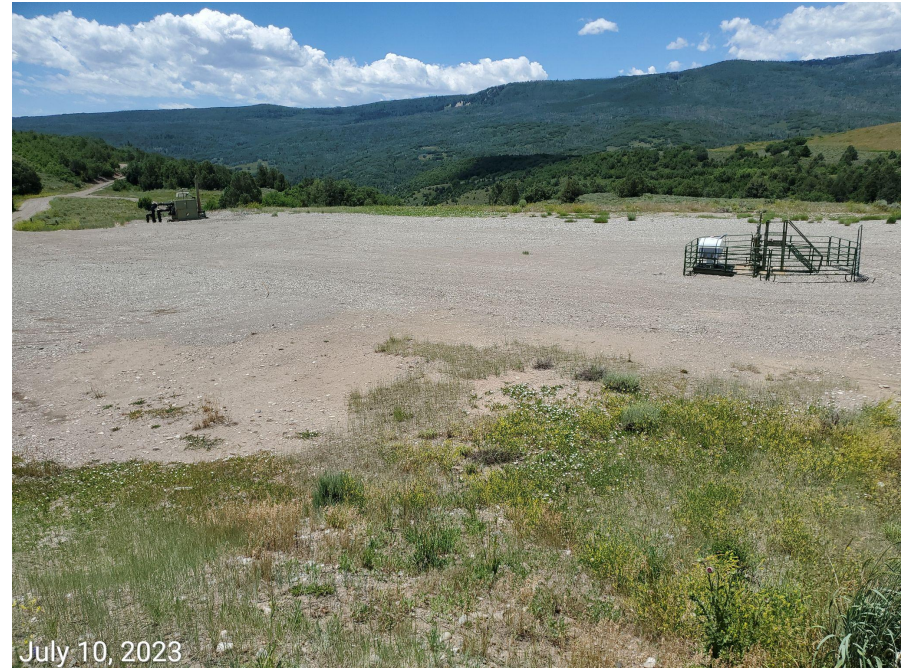
Photo 1: Photos 1-2 taken from the east end of the Location. Photos provide an overview of the Location from southeast, south, southwest to west. Photos show interim reclamation of areas not needed for production have not been conducted in accordance with Rule 1003.b.

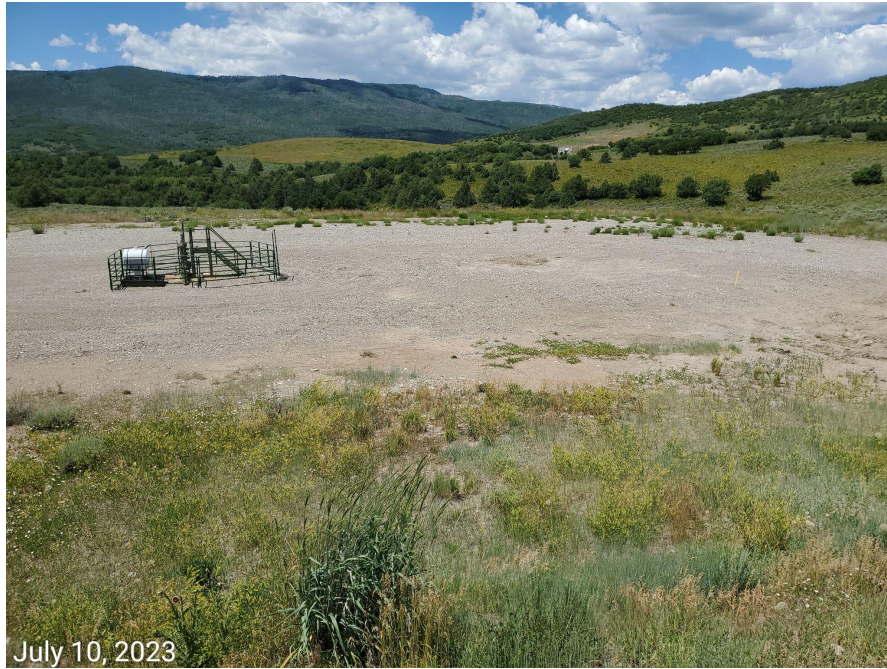
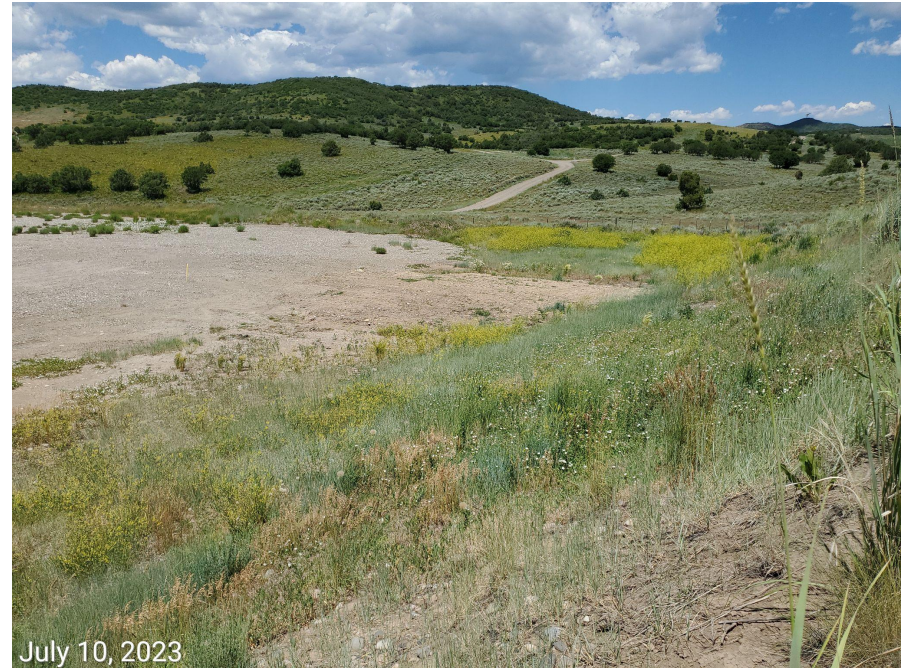
Photo 2: See comments under photo 1.

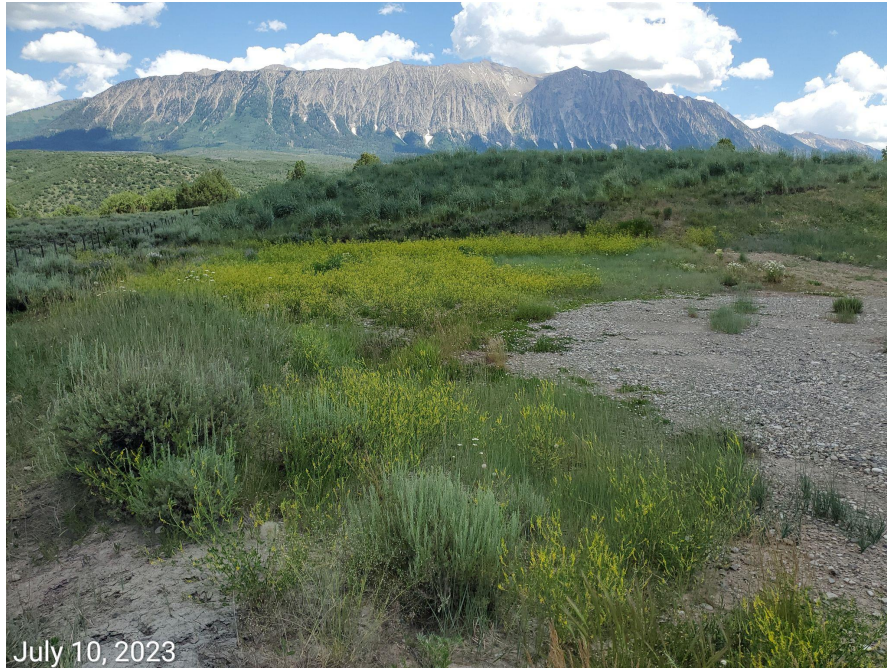
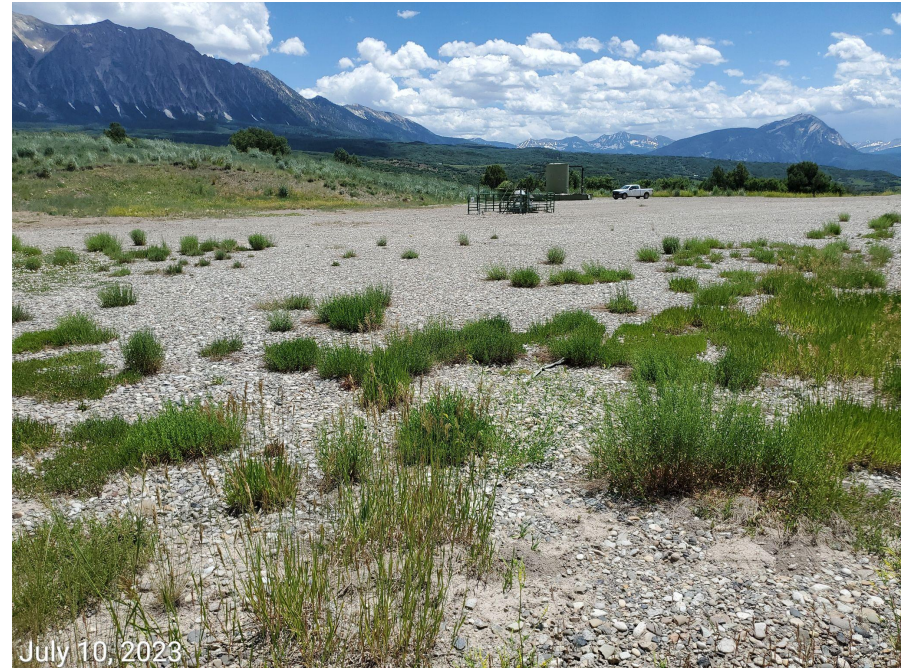
Photo 3: Photos 3-4 taken from the north end of the Location. Photos provide an overview of the Location from east, southeast, southwest to west. facing east and south. Photos show interim reclamation of areas not needed for production have not been conducted in accordance with Rule 1003.b.

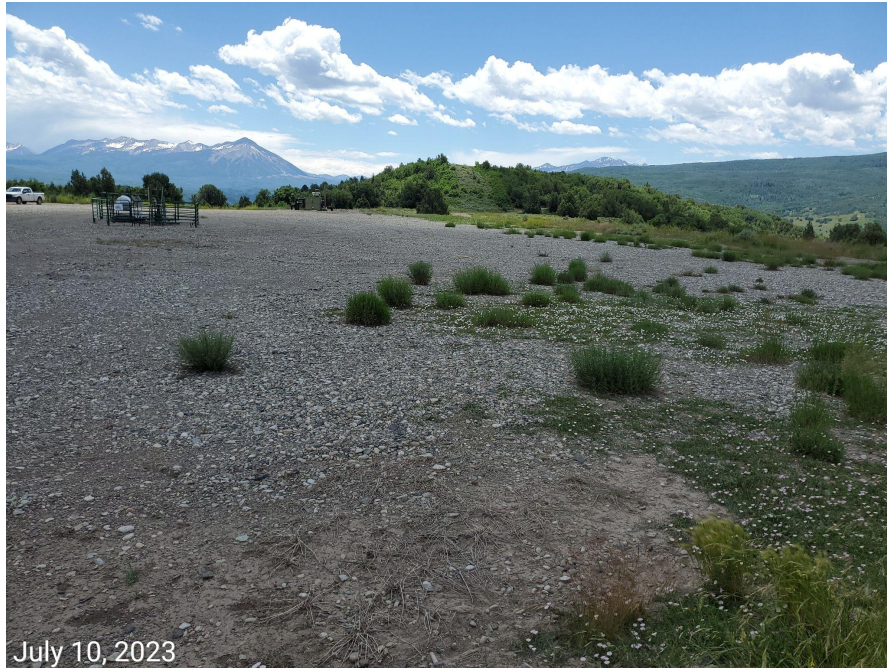
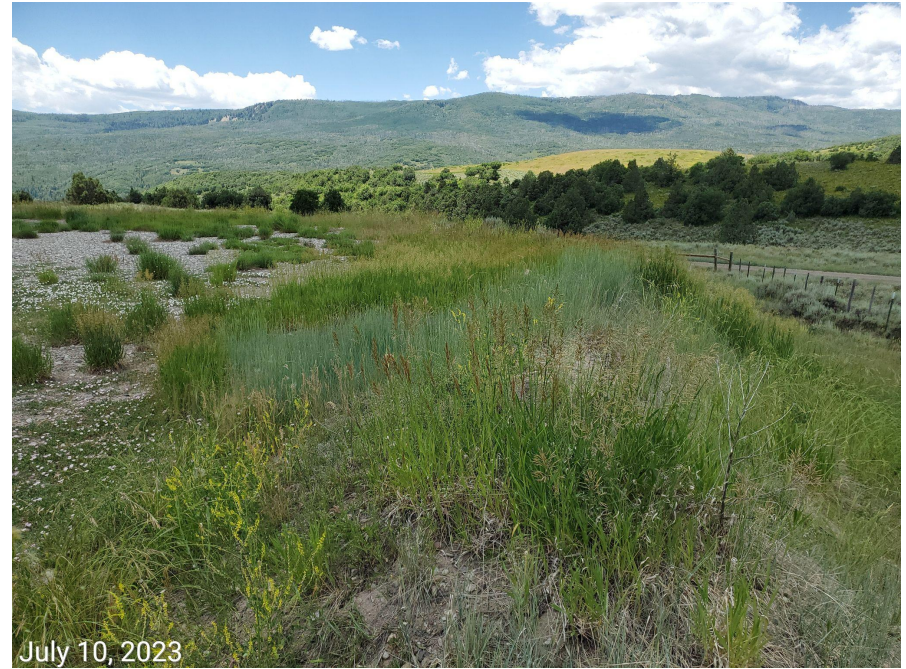
Photo 4: Photos taken from the northwest corner of the Location, facing east and south. Photos show areas on the west end of the Location, not needed for production, have not been reclaimed in accordance with 1003 Rules.

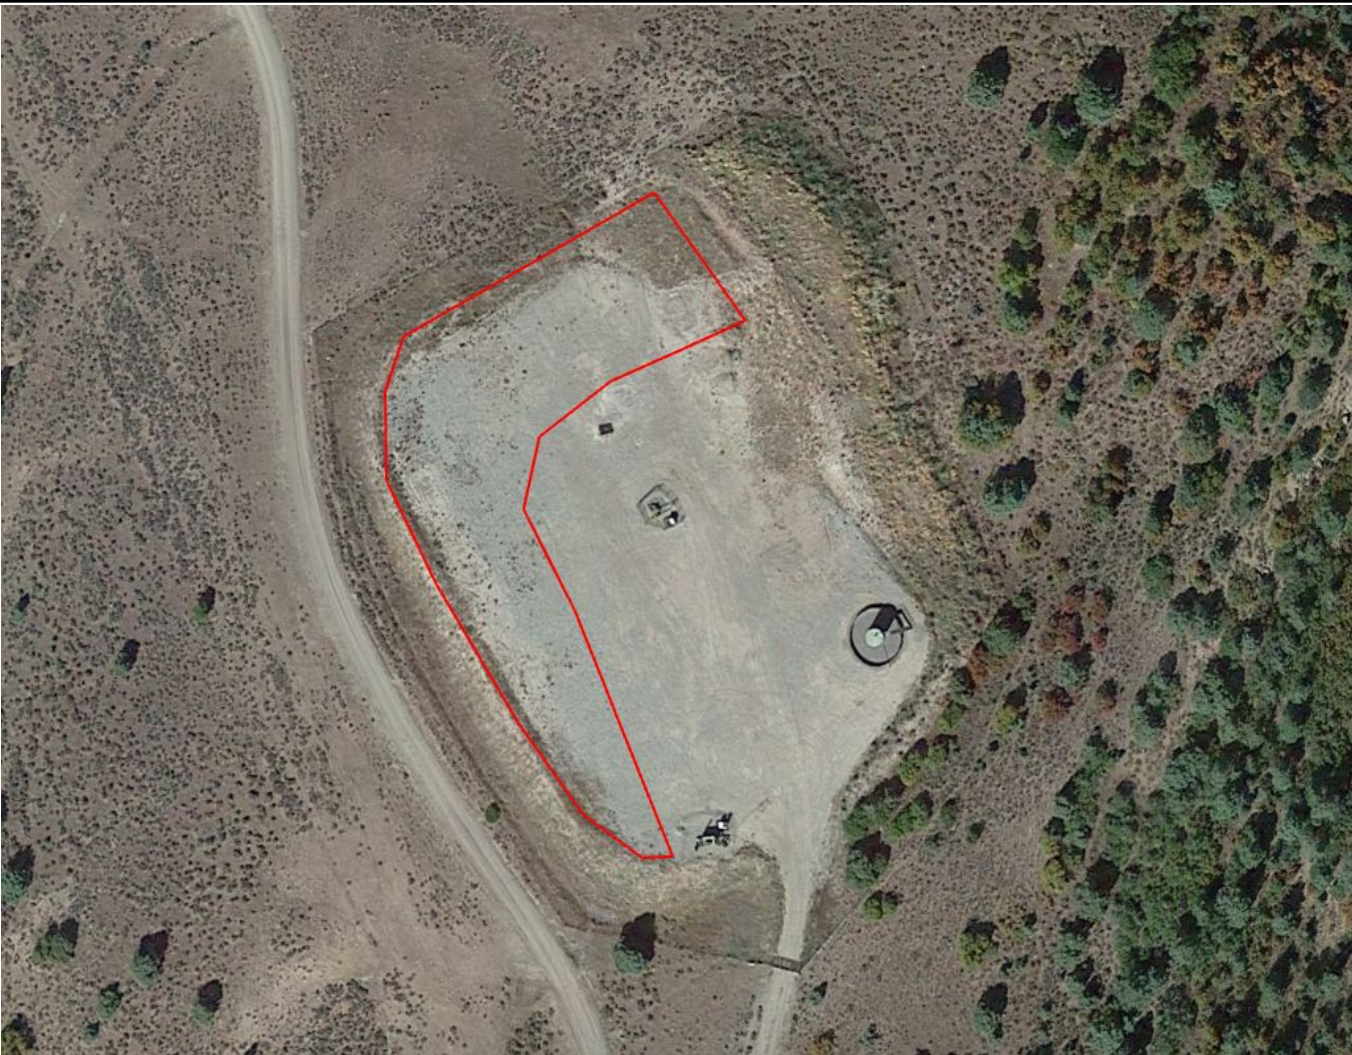
Photo 5: 2019 Google Earth aerial image of the Location. Polygon represents approximate areas of the Location not reasonably needed for production requiring work including, but not limited to, compaction alleviation, recontouring/regrading and reclamation.

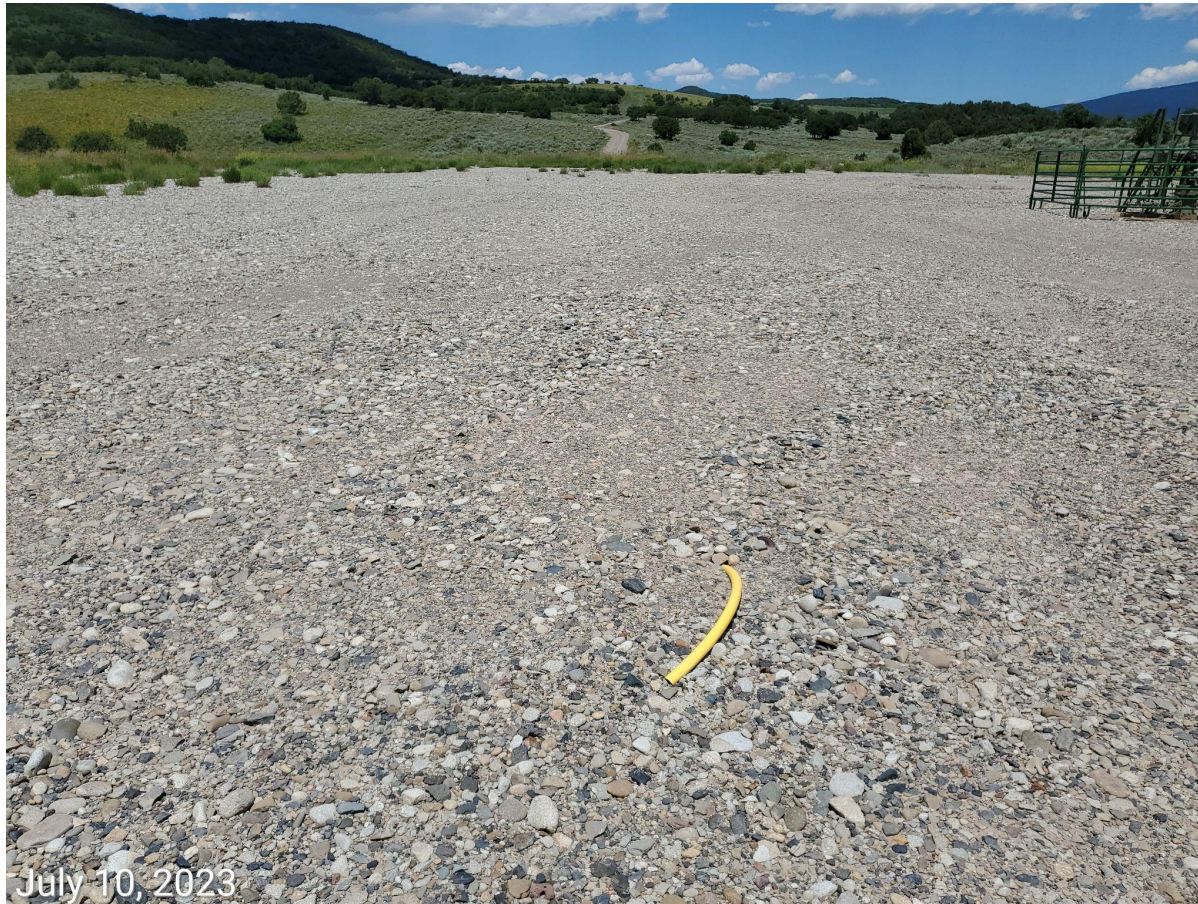
Photo 6: Anchor marker on Location remains in disrepair.
