Interim Reclamation and Stormwater Inspection

Operator: KERR MCGEE OIL & GAS ONSHORE LP - #47120

Location ID: 481939

Location Name: PAUL NELSON/25-29HZ & CHARLENE NELSON 12-34HZ

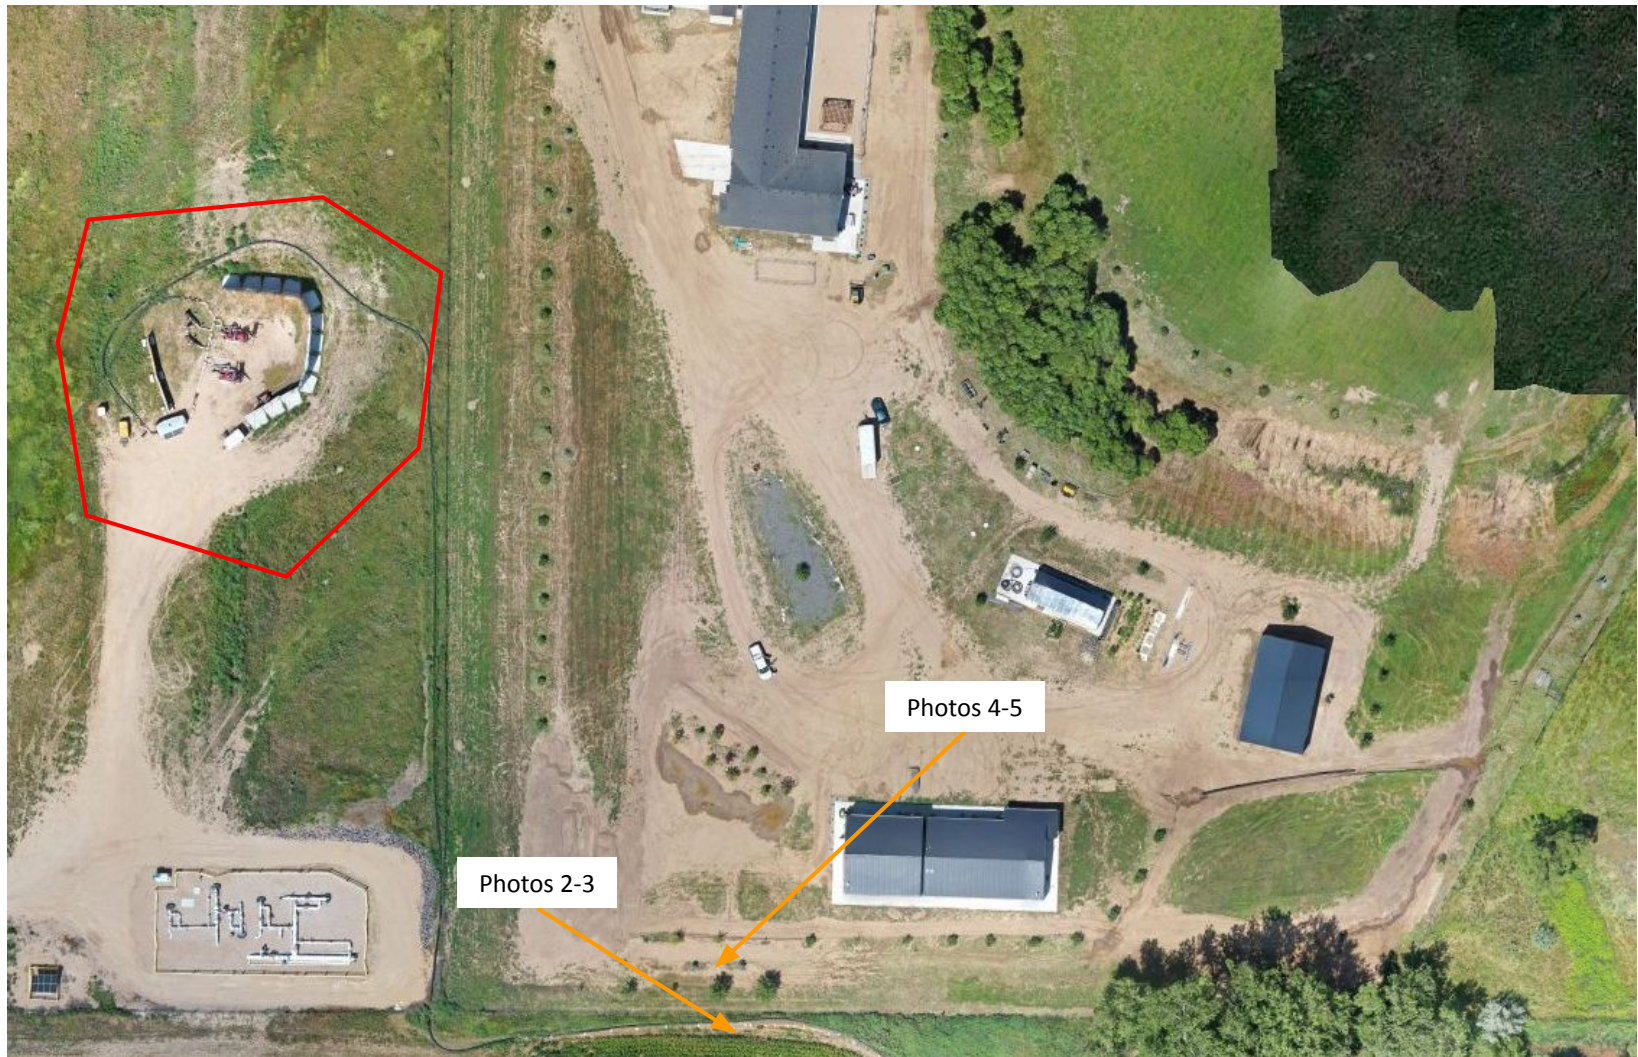
Photo 1. ECMC drone aerial imagery illustrates a water delivery system (red) used for the Paul and Charlene Nelson drilling operations. The water line (orange) travels east to the said locations. Photos 2&3 taken from the orange arrow.

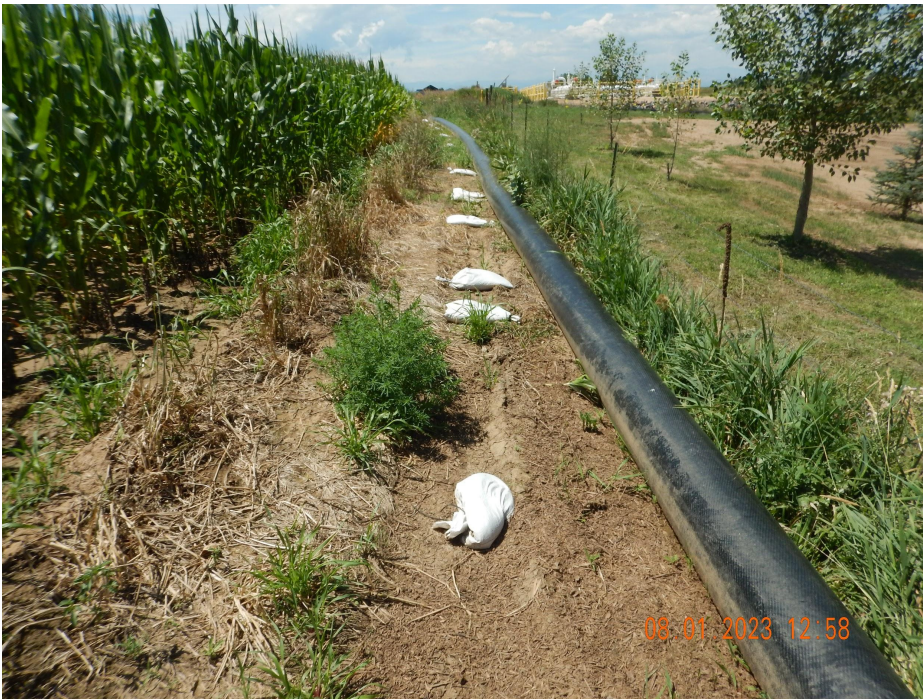
Photo 2. Photo illustrates the water line and sand bags, facing West. Sand bags were deployed by the Operator as a mitigation measure to allow irrigation tailwater to flow under the water line. Water line is no longer on sand bags.

Corn field to the left is the adjacent neighbor and the water line is on the adjacent neighboring property.

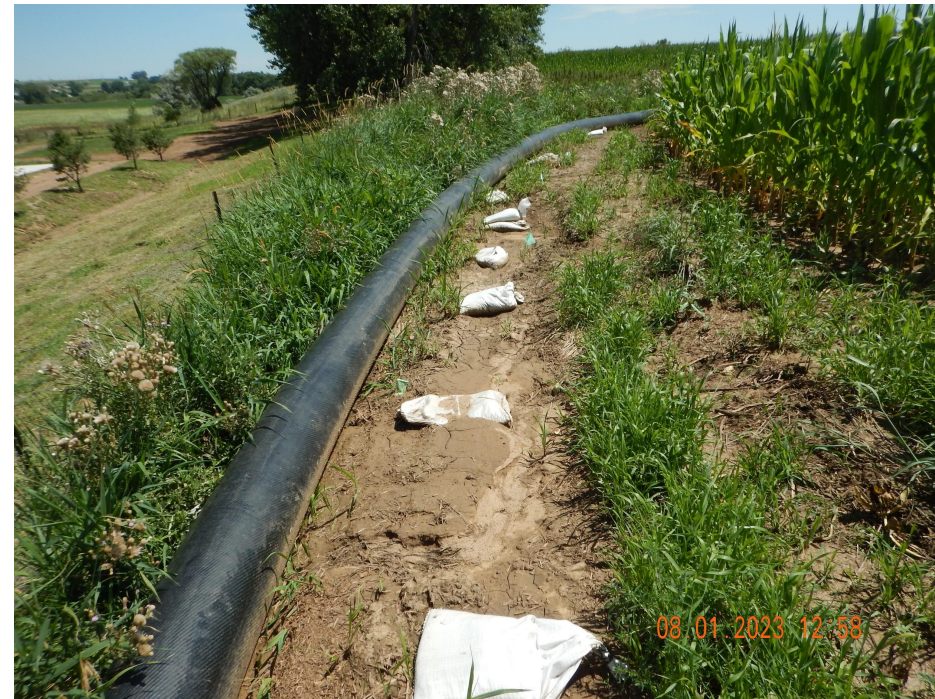
Photo 3. Photo illustrates the water line and sand bags, facing East. See comments under Photo 2.

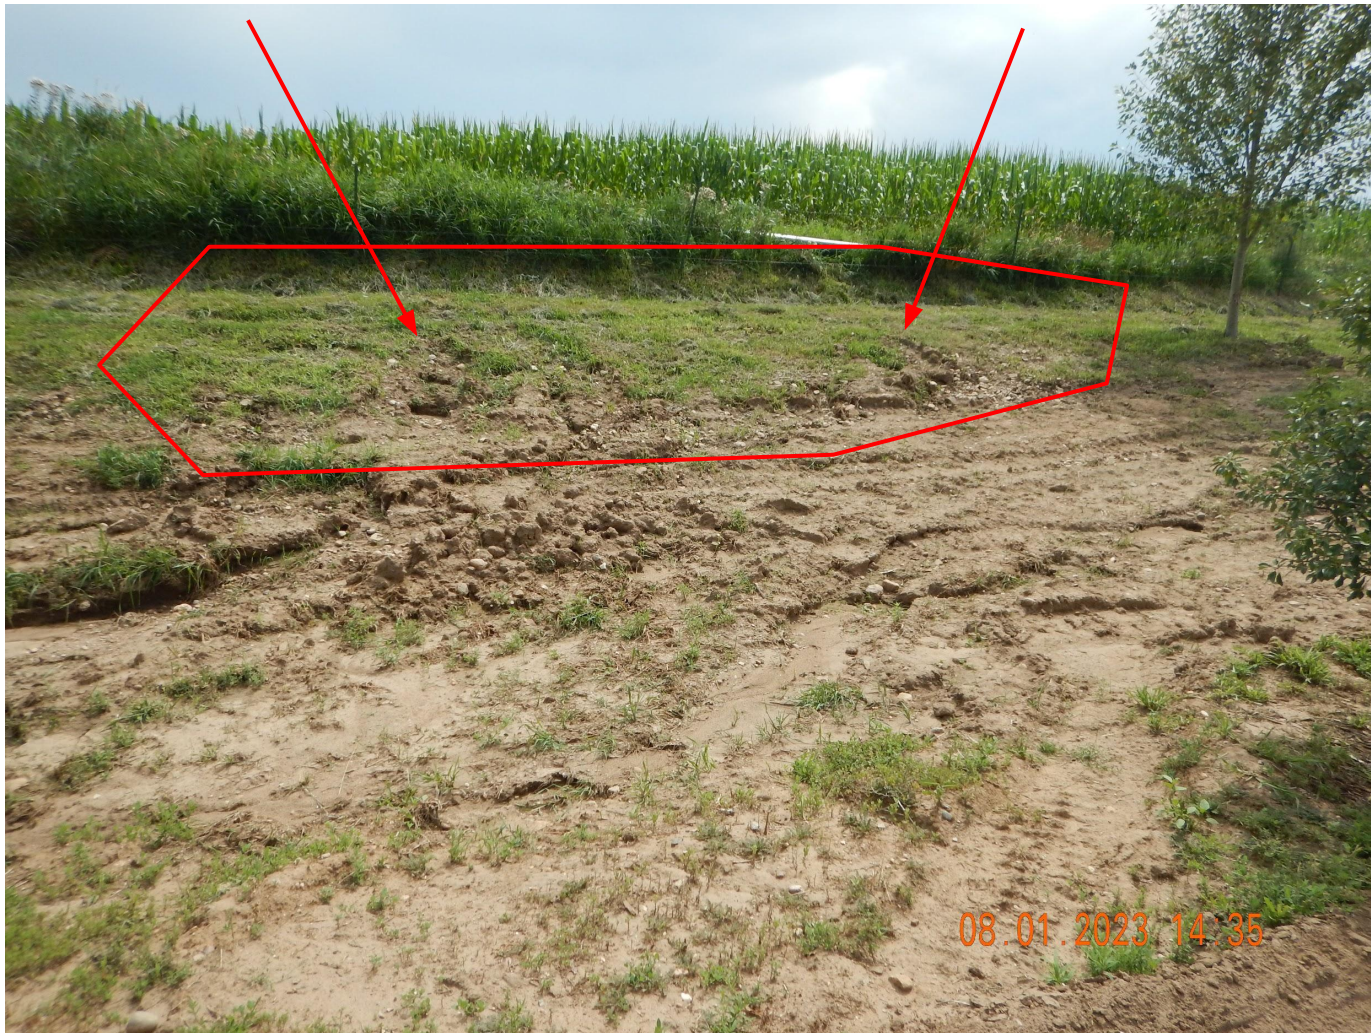
Photo 4. Photo illustrates rill/gully erosion starting within the vegetated area. The bare soil area below is from work to repair erosion.

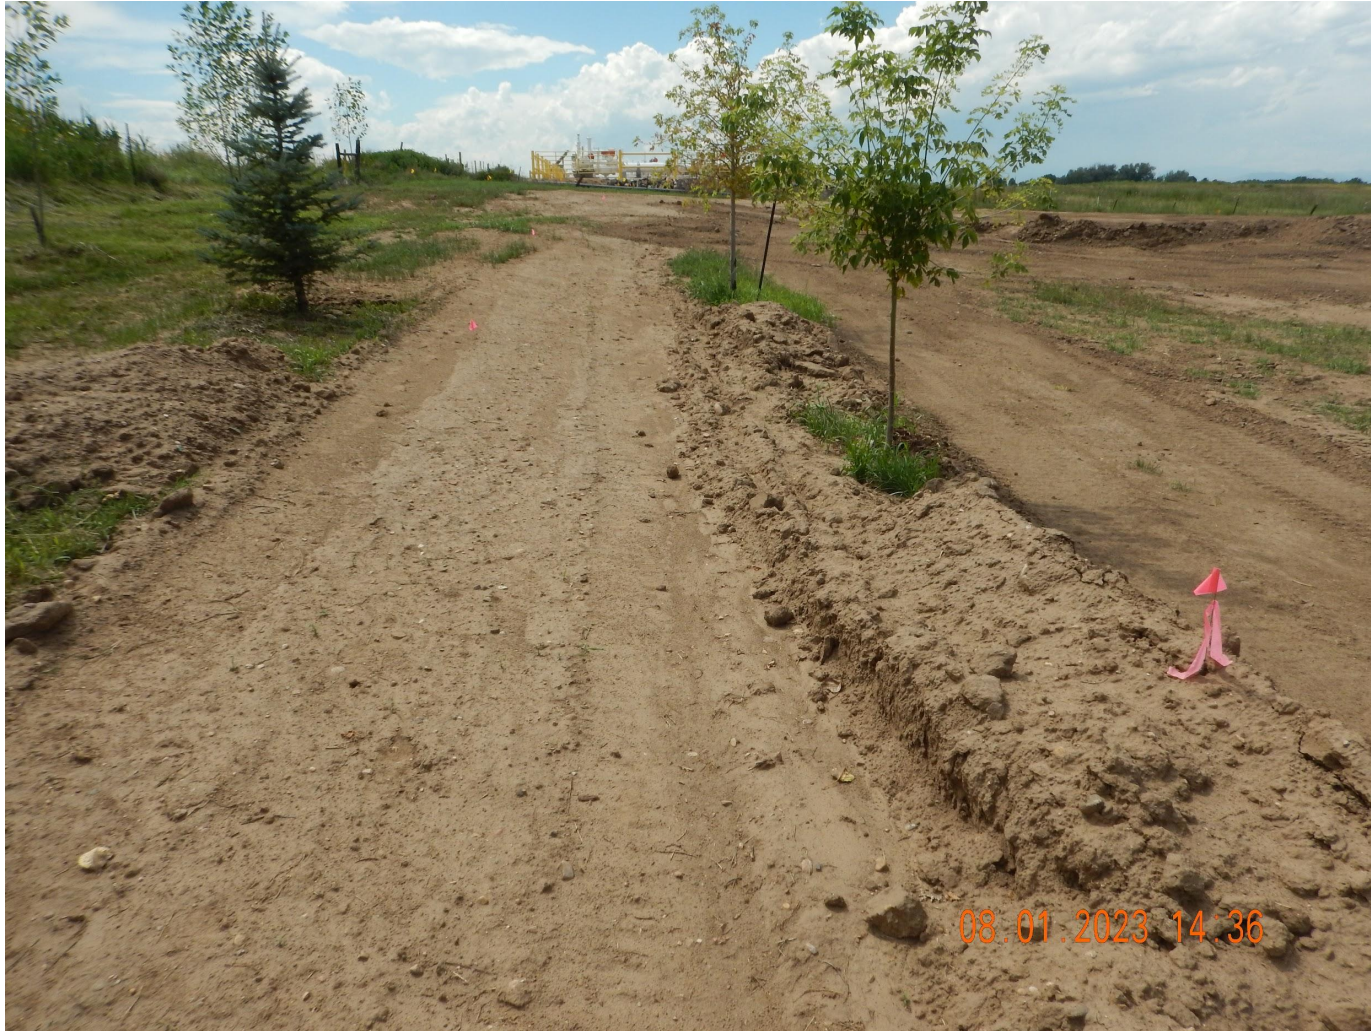
Photo 5. Photo illustrates a disturbed area that was planned for the installation of a BMP to mitigate irrigation tailwater run-on. Pink flags were placed by the Operator and yellow flags in the background were 811 locates. The temporary soil berm was constructed by the surface owner as a mitigation measure to protect their septic system.
