Operator: CRESTONE PEAK RESOURCES OPERATING LLC

Location Name: Florida/3-65 27-26

Loc ID: 454192

Inspection: 709400438

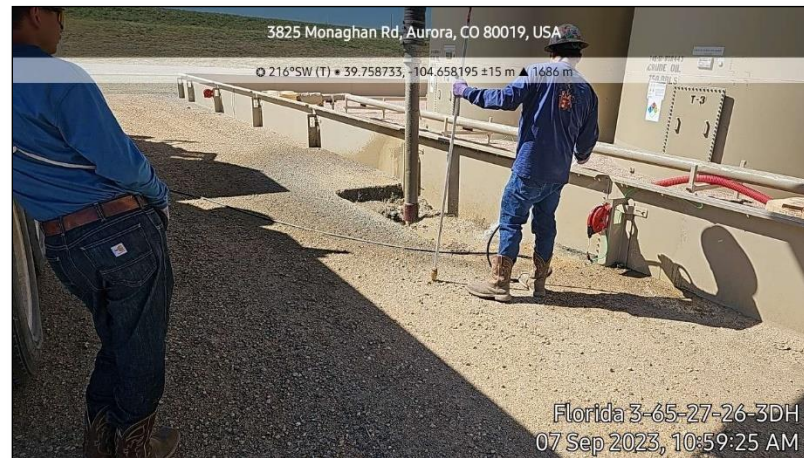
Exhibit G

CA: Stormwater erosion above culvert from access road. Comply with Rule 1002.f.

CA Resolution: Operator has reported and provided photo evidence that the culverts have been repaired as of 9/7/2023 to comply with Rule 1002.f. Additional work has also been completed to address the identified stained soil. Soil has been properly removed and backfilled with clean road base to comply with Rule 905.e.
