Final Reclamation and Stormwater Inspection

Operator: KERR MCGEE OIL & GAS ONSHORE LP -
47120

Location ID: 331755

Inspection Photos
Location Name: Camp Federal 2-19A
Location ID: 331755

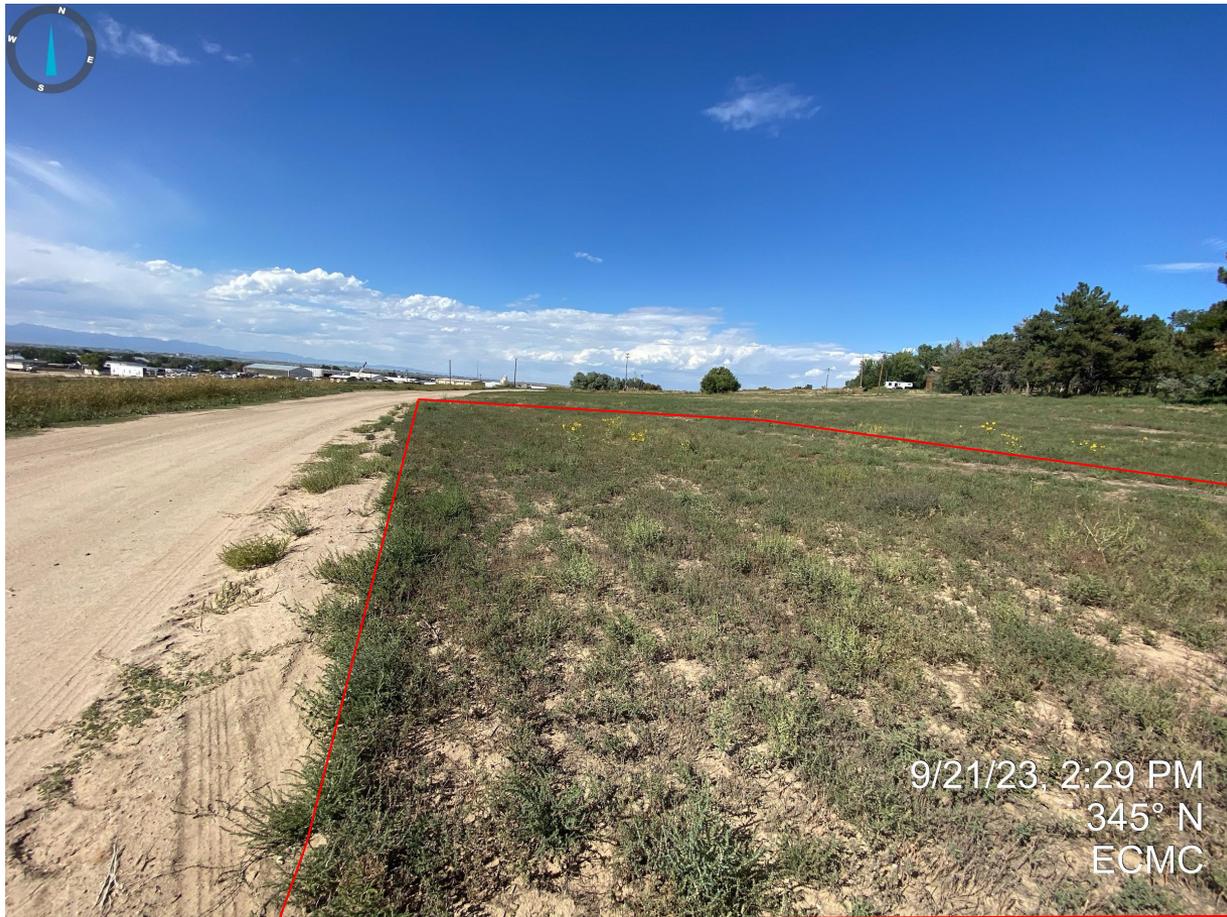
Photo 1. The former production facilities are not progressing towards Rule 1004 regulations and standards as evidenced by undesirable vegetation (e.g. kochia). Additional reclamation activities are required on the former production areas.

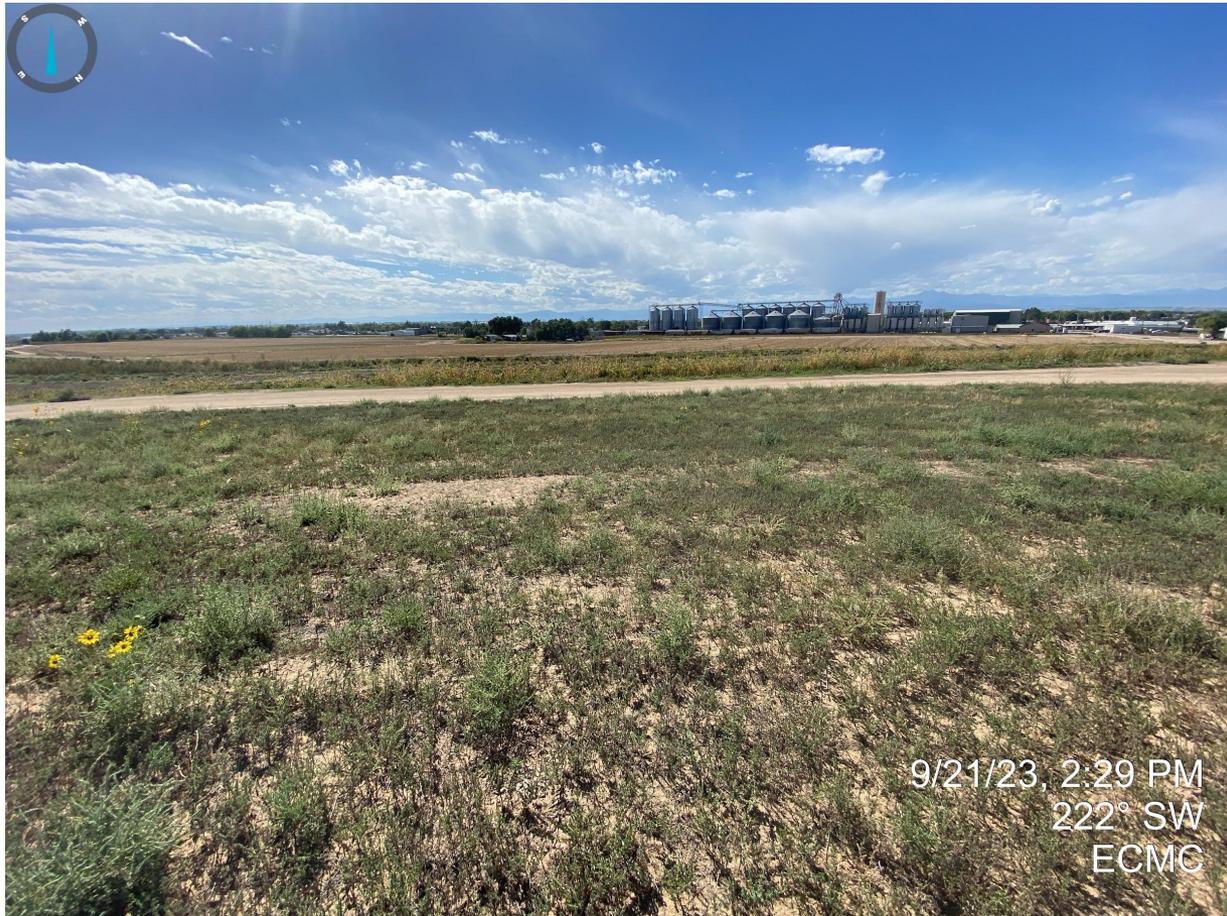
Photo 2. See comments in Photo 1.

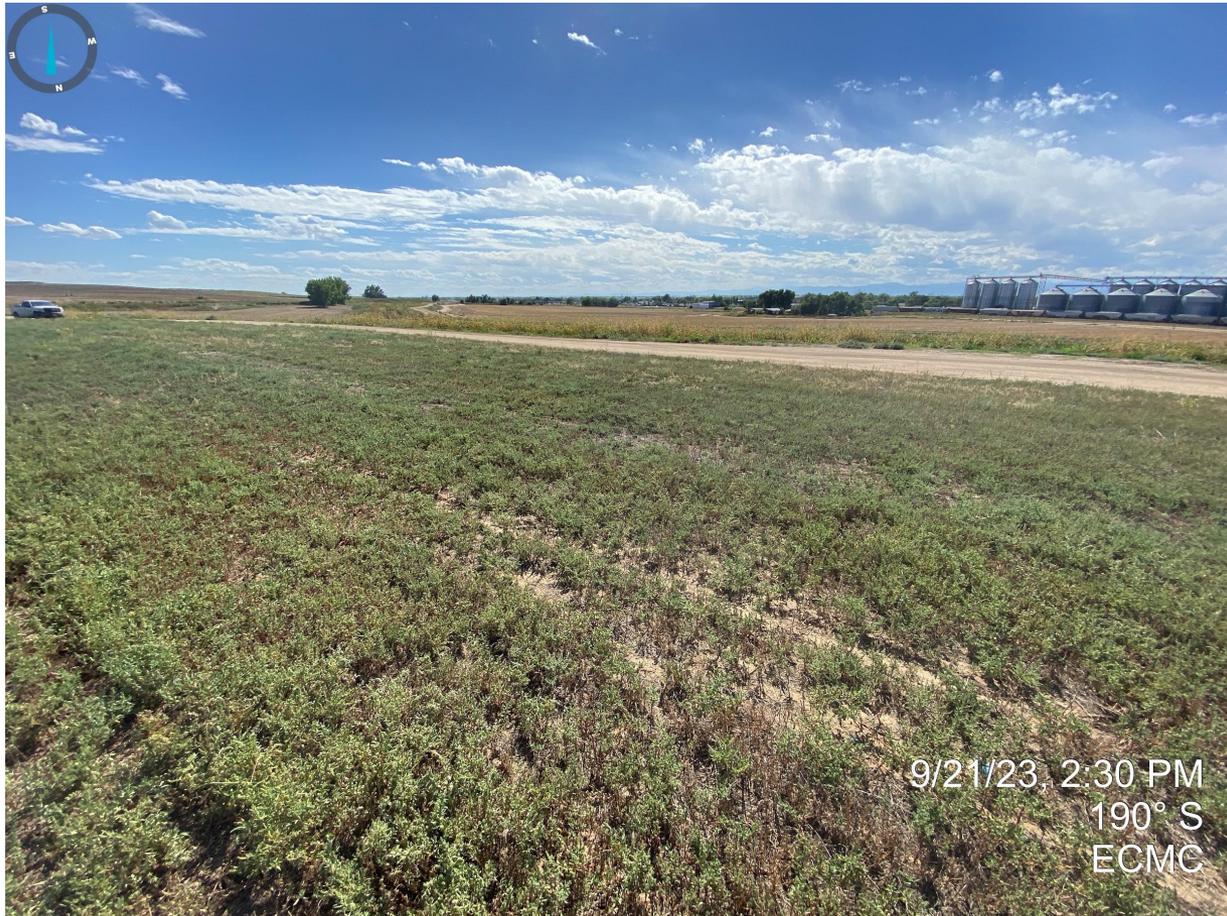
Photo 3. See comments in Photo 1.

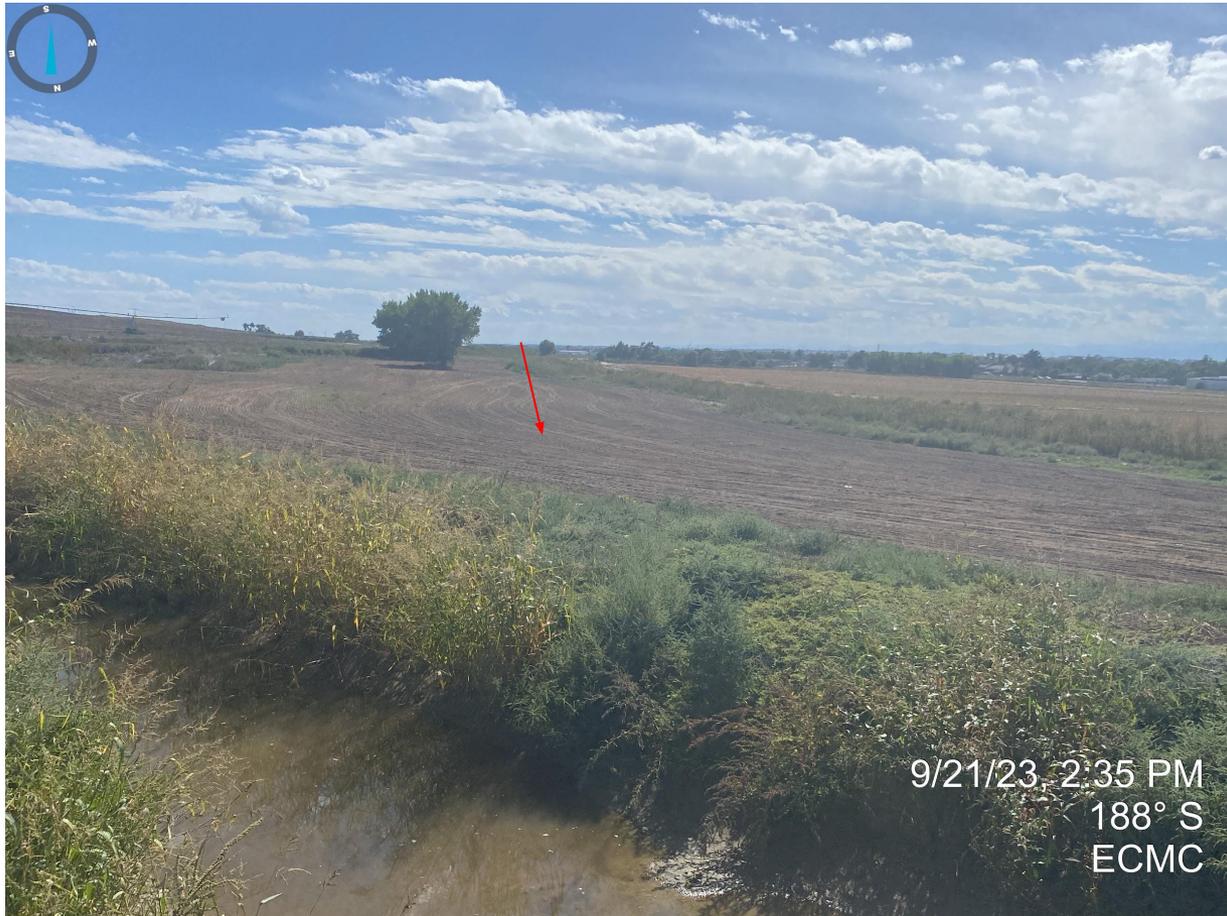
Photo 4. The former wellhead is located in a cropland which was fallow at the time of this inspection and will be inspected at a future date to verify vegetation establishment.
