WELL NAME: HILL RANCH 32-01 & V, API #: 071-06913, INSP. # 695108688

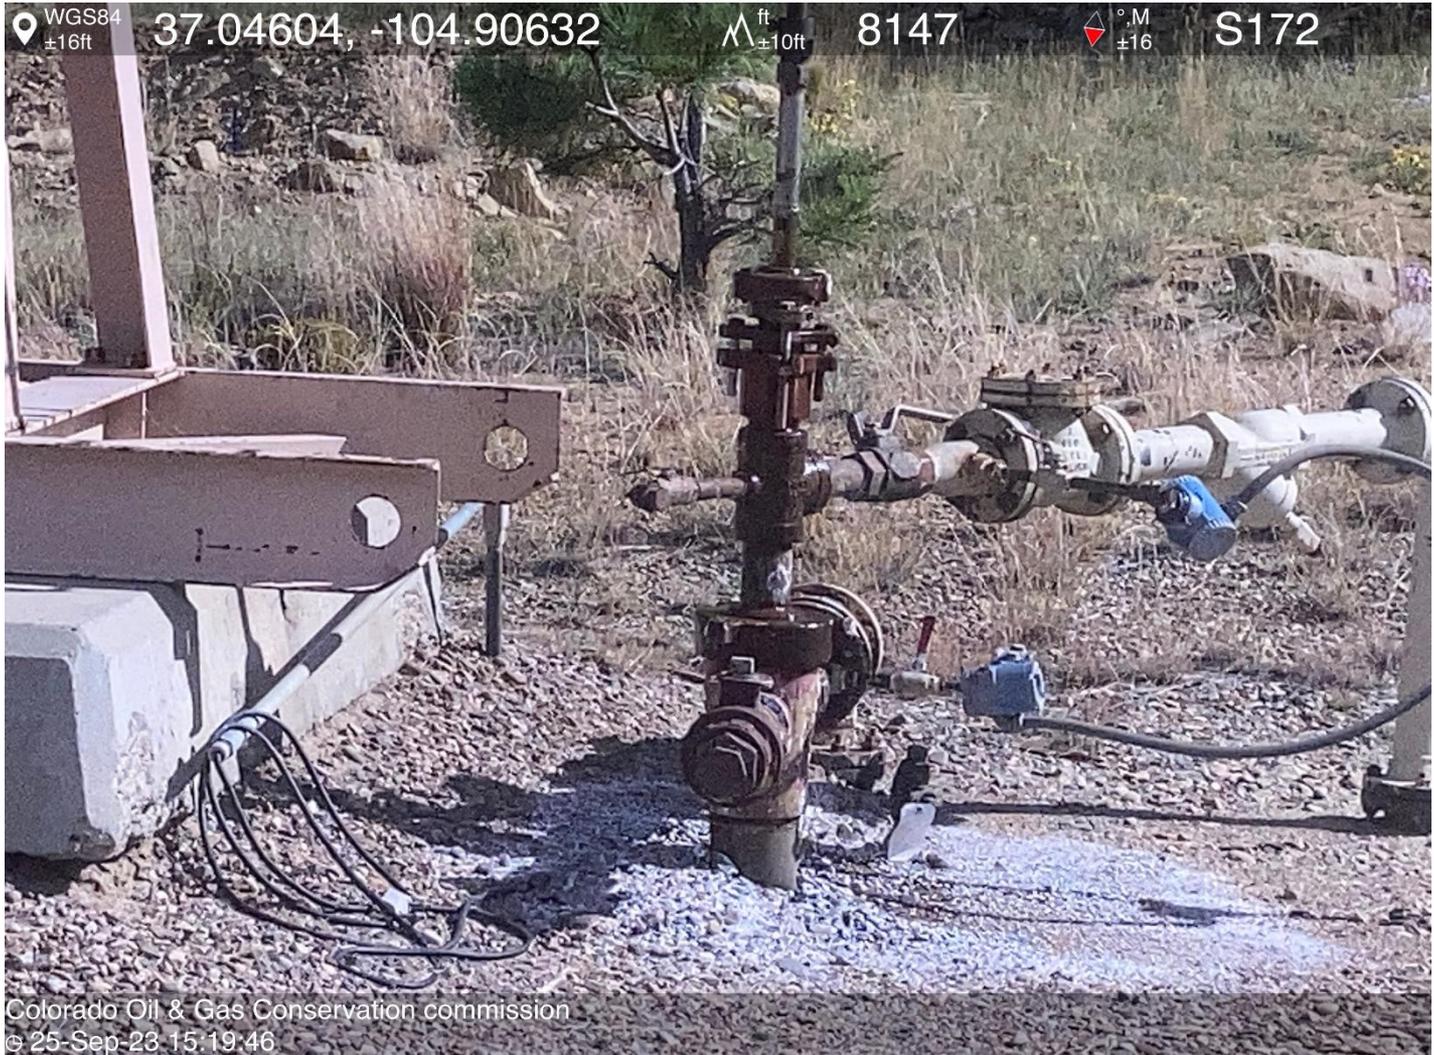
**PHOTO 5: Signs of recent slow leak from wellhead. Salt/mineral buildup is evident on the wellhead ground around wellhead. Securely fasten all valves, pipes, fittings, and Production Facilities to ensure good mechanical condition, inspect at regular intervals, remove salt/mineral buildup, remove and dispose of impacted material and maintain in good mechanical condition per Rule 608.e. ca date 11-20-2023.**
