Summit Midstream Partners
1950 U.S. 6 N 40
Fruita, CO 81521

PN20 Launcher

SB01

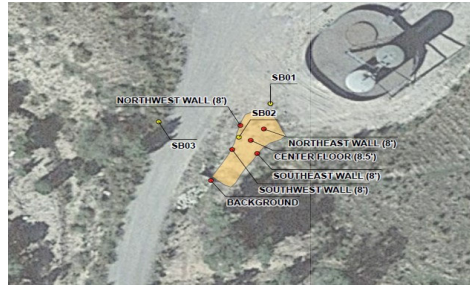
Depth in Feet	USCS	GRAPHIC	DESCRIPTION	Moisture (%)	Structure	PID (ppm)	Staining	Recovery (in)	Sample
0									
5									
10	SC		9-11' light tan to red-brown sandy clay with silty sandstone fragments ending in tan silty friable sandstone	dry	M	0	N	18"	9-11'
15									
20									
25

TD @ 11 ft-bgs

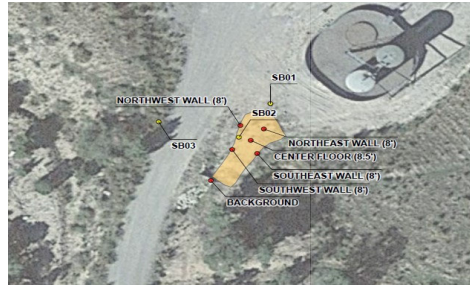
SB02

Depth in Feet	USCS	GRAPHIC	DESCRIPTION	Moisture (%)	Structure	PID (ppm)	Staining	Recovery (in)	Sample
0									
5									
10	GC

9-11' brown gravelly clay	dry	M	0	N	18"	9-11'
15	GC

14-16' as above	dry	M	0	N	18"	14-16'
20	CG

19-21' red and tan sandstone fragments in red and brown silty sandy clay matrix	slm	M	0	N	18"	19-21'
25			TD @ 21 ft-bgs
