Operator: HIGHPOINT OPERATING CORPORATION

Location Name: Pappenheim C-W2 6-62-27_26

Inspection: 696305506

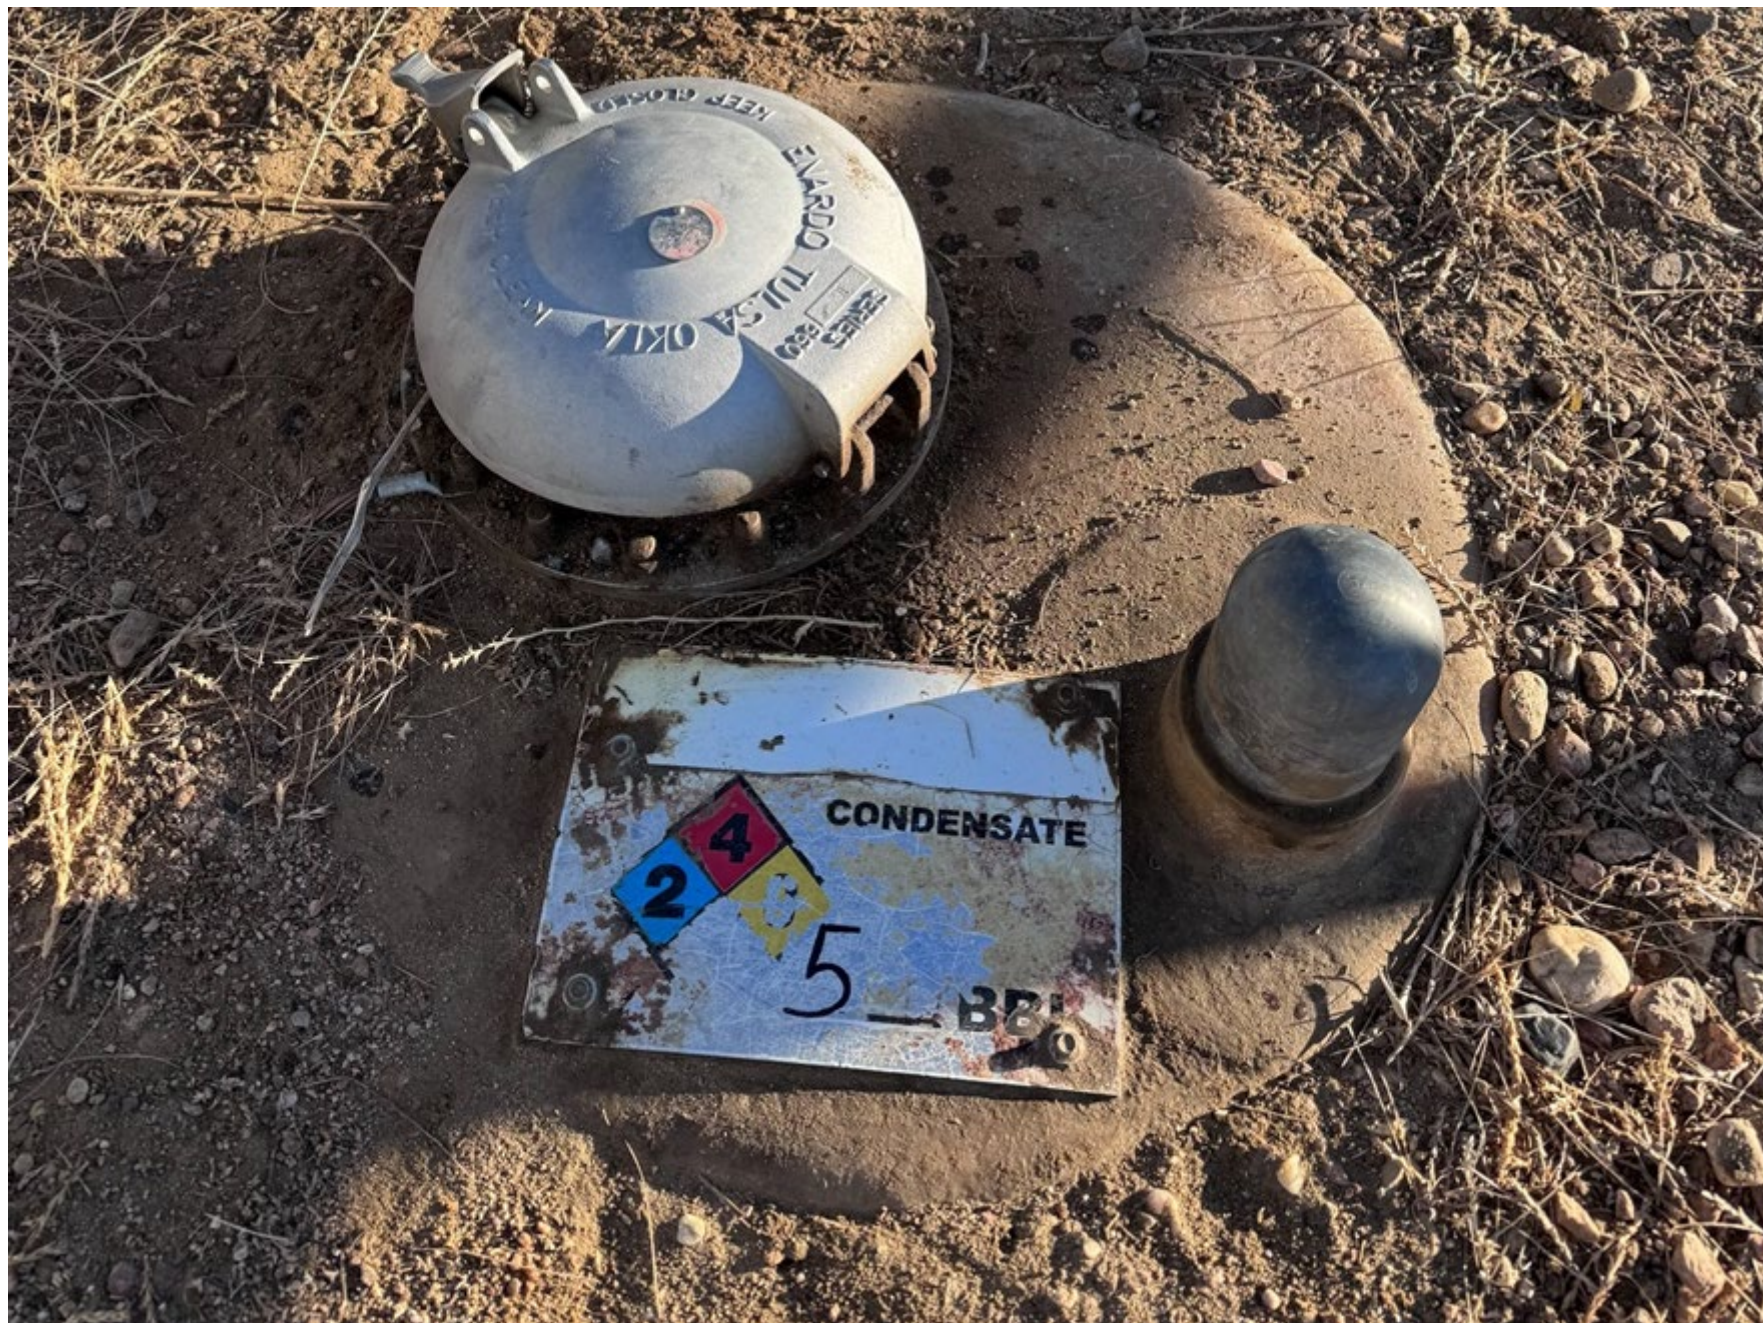
Exhibit A

CA: Condensate Vault missing Capacity Label at VRU. Condensate Vault missing Capacity, Content Labels at Flare. Install sign to comply with Rule 605.h.

CA Resolution: Signs have been installed to comply with Rule 605.h.
