Final Reclamation and Stormwater Inspection

Operator: Kerr McGee Oil & Gas Onshore LP - 47120

Location ID: 330075

Inspection Photos
Location Name: PSC 41-3
Location ID: 330075

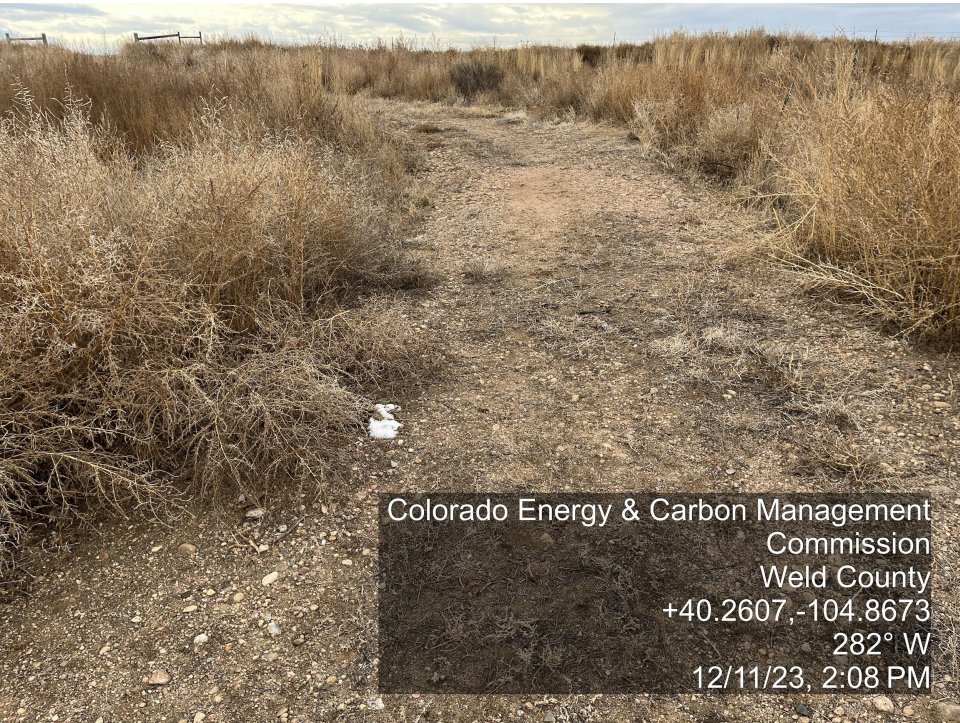
Photo 1. The photo was taken at the well location entrance facing West. The photo illustrates the the access road gravel remains and hasn't been reclaimed.

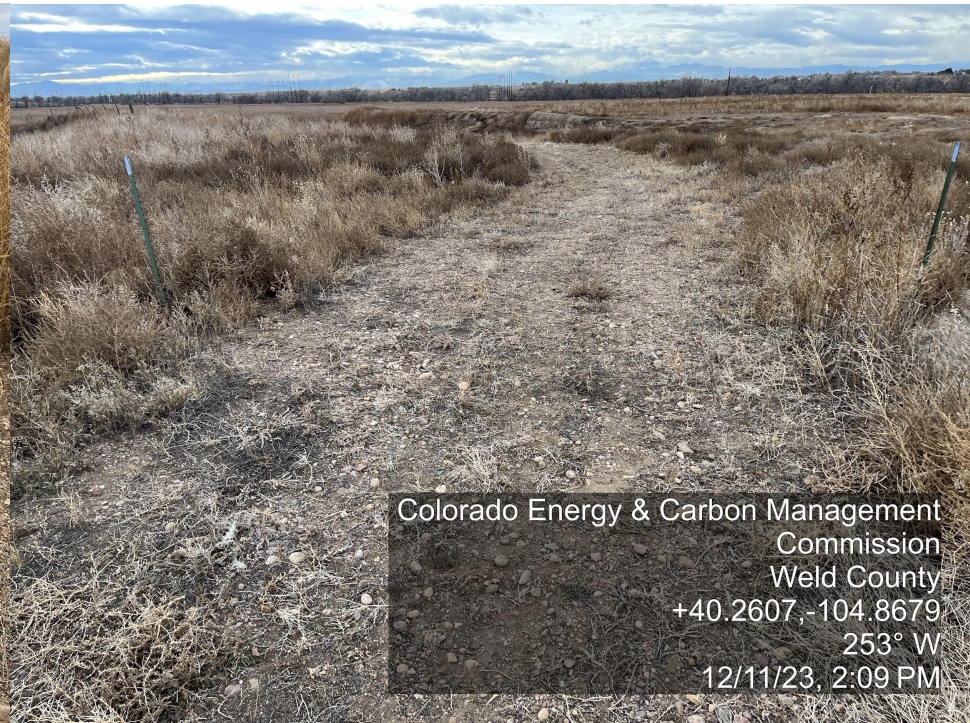
Photo 2. The photo was taken along the access road facing West. Refer to the comment for photo 1.

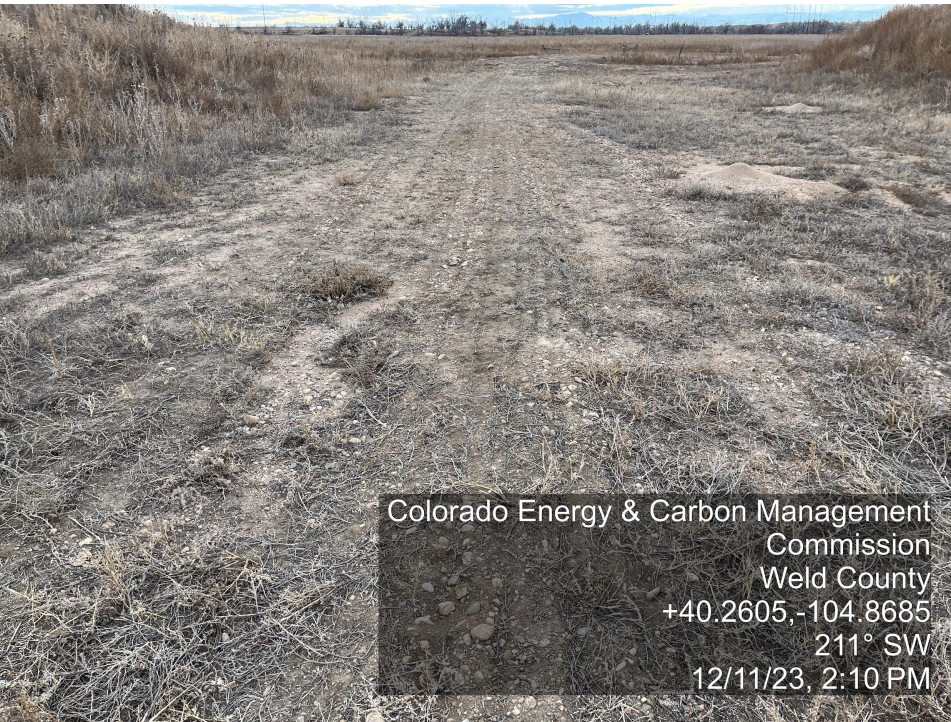
Photo 3. The photo was taken along the access road facing Southwest. Refer to the comment for photo 1.

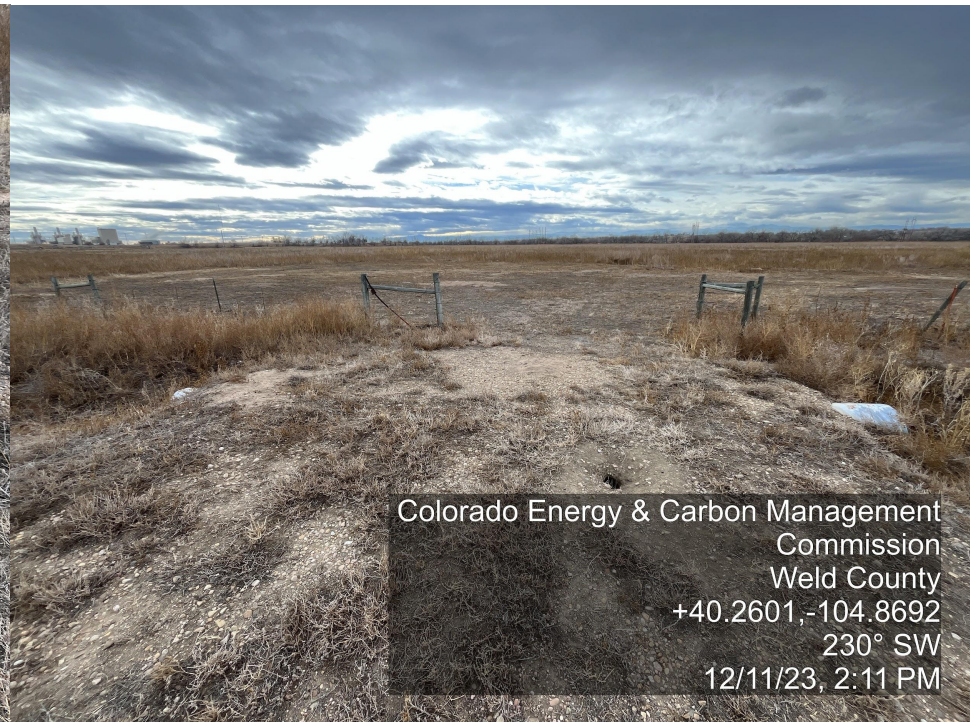
Photo 4. The photo was taken at the well location entrance facing Southwest. The photo illustrates the perimeter fencing and entrance culvert still remain at the well location.

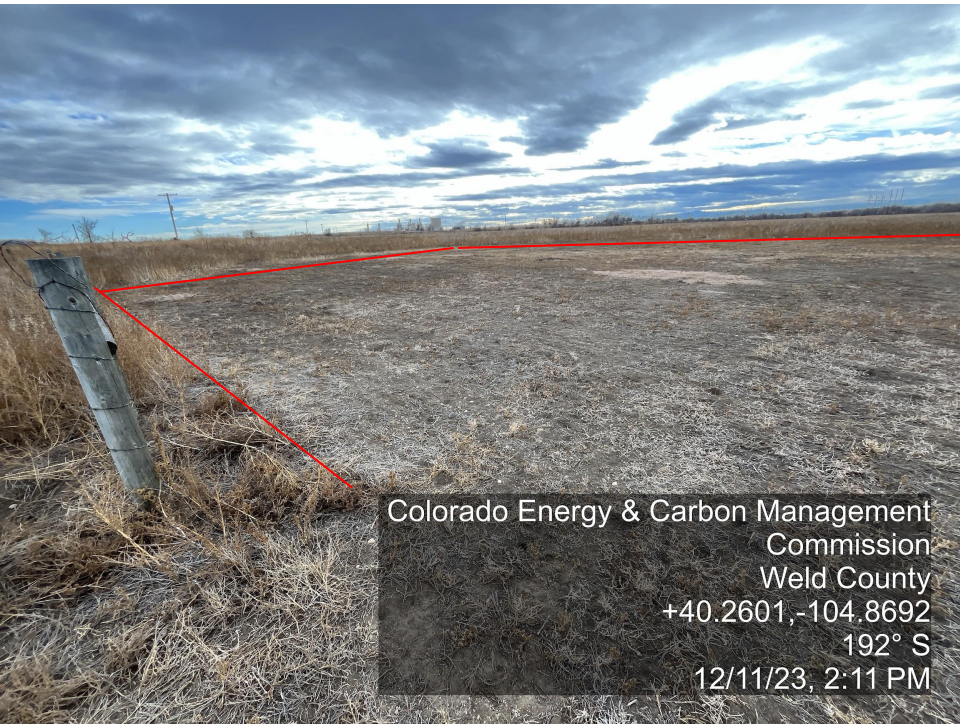
Photo 5. The photo was taken at the entrance to the well location facing South. The photo illustrates the location perimeter fence still remains and has been mowed.

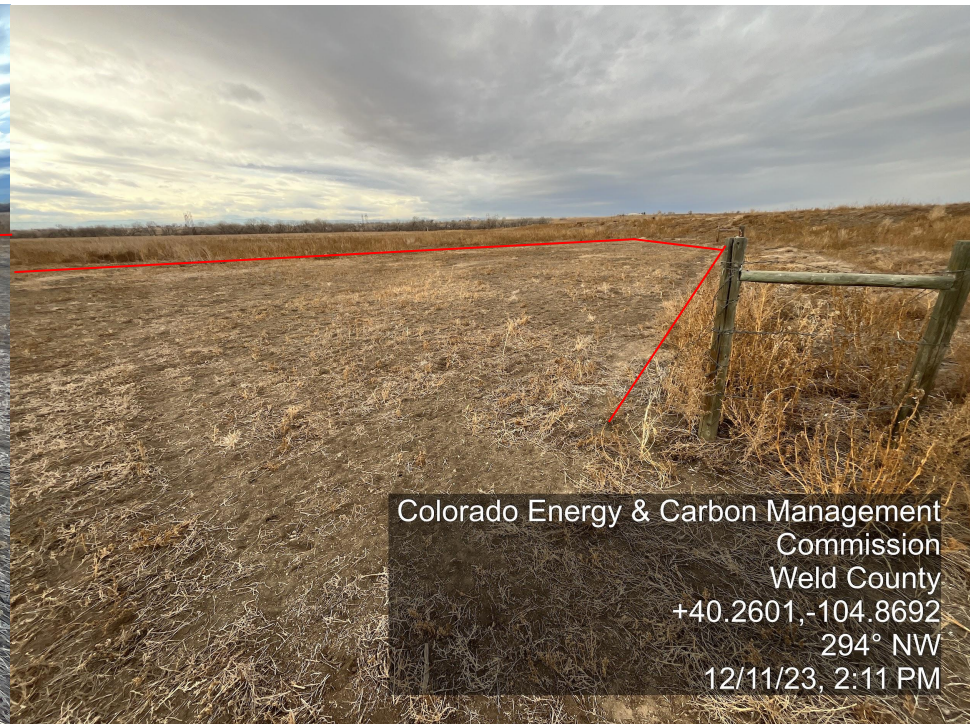
Photo 6. The photo was taken at the entrance to the well location facing Northwest. Refer to the comment for photo 5.
