**Operator: BONANZA CREEK ENERGY OPERATING COMPANY LLC**

**Location Name: ANTELOPE 18I TB**

**Loc ID: 418173**

**Inspection: 696305524**

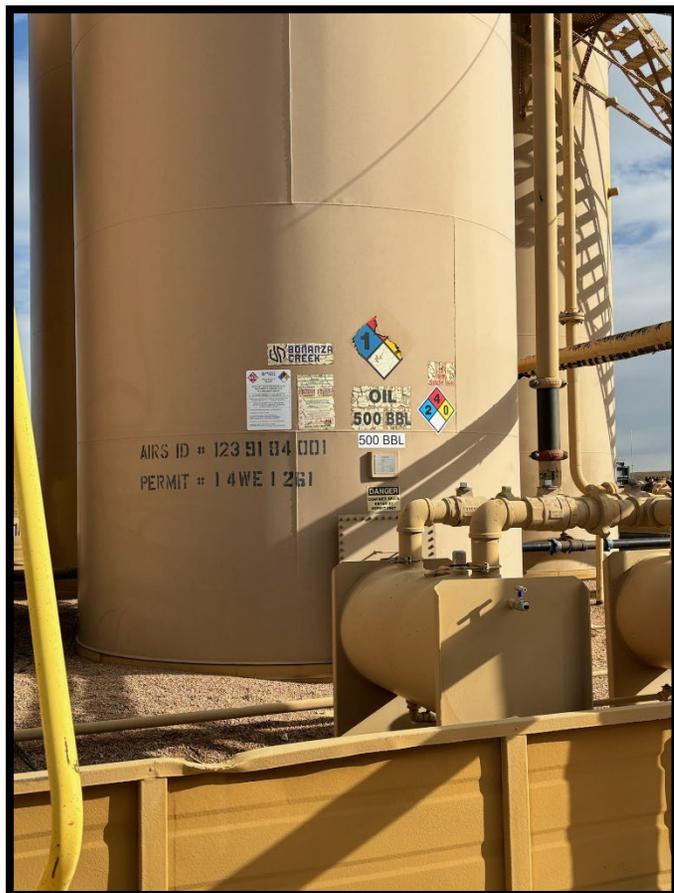
Exhibit A

**CA:** West Side Tanks - NFPA Labels have all faded and peeled; no longer visible. See photos Install sign to comply with Rule 605.h.

**CA Resolution:** Operator has appropriately updated and installed NFPA labels on identified tanks to comply with Rule 605.h.

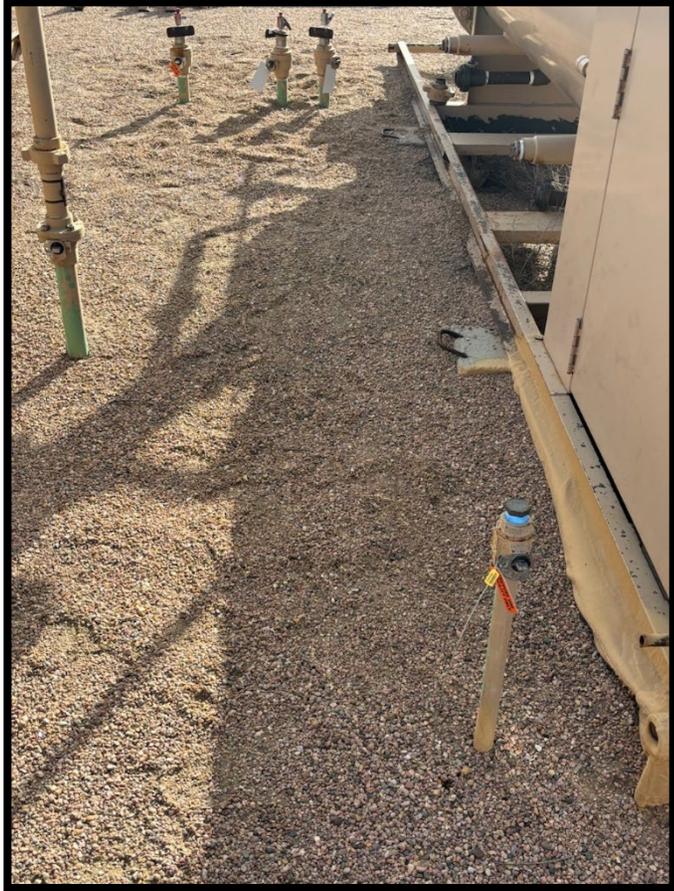
Exhibit A

**CA:** Unmarked 2" and 1" Risers at Separators and 1" Risers at Wellhead. See photos Complete flowline and crude oil transfer line abandonments to comply with Rule 1105.

**CA Resolution:** Operator has appropriately marked all identified Risers at Separators and Wellhead.
