Operator: BONANZA CREEK ENERGY OPERATING COMPANY LLC

Location Name: North Platte I-24 Pad

Loc ID: 429060

Inspection: 713900195

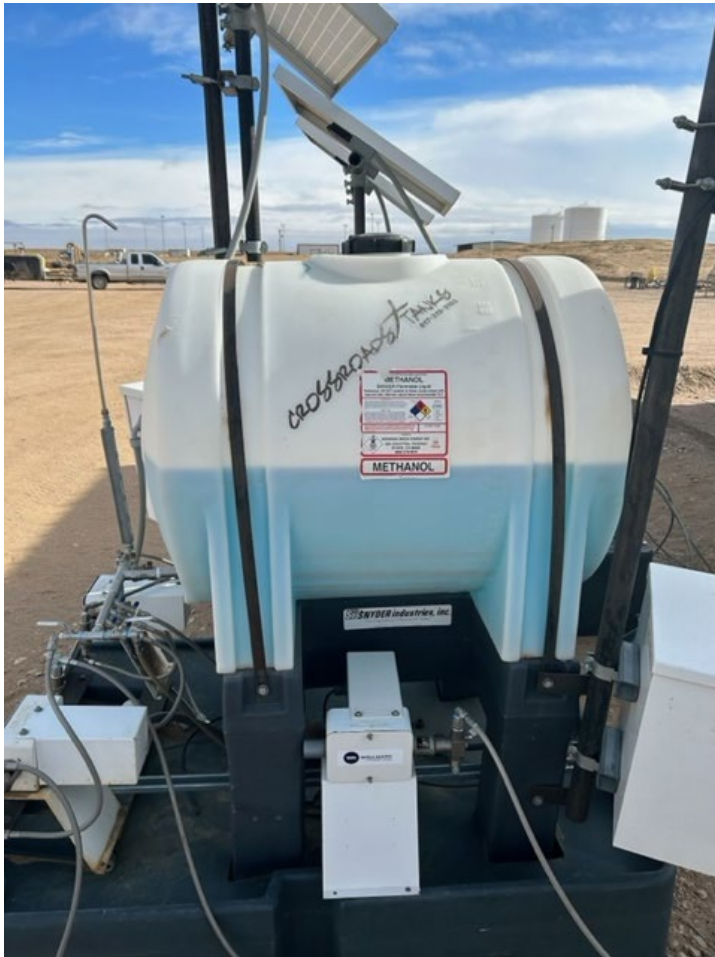
Exhibit A

CA: Tank labels illegible or missing. See inspection photos for details. Replace tank labels per Rule 605.

CA Resolution: Operator appropriately updated the tank labels to comply with Rule 605.
