Operator: BONANZA CREEK ENERGY OPERATING COMPANY LLC

Location Name: North Platte T-23 Pad

Loc ID: 470863

Inspection: 713900191

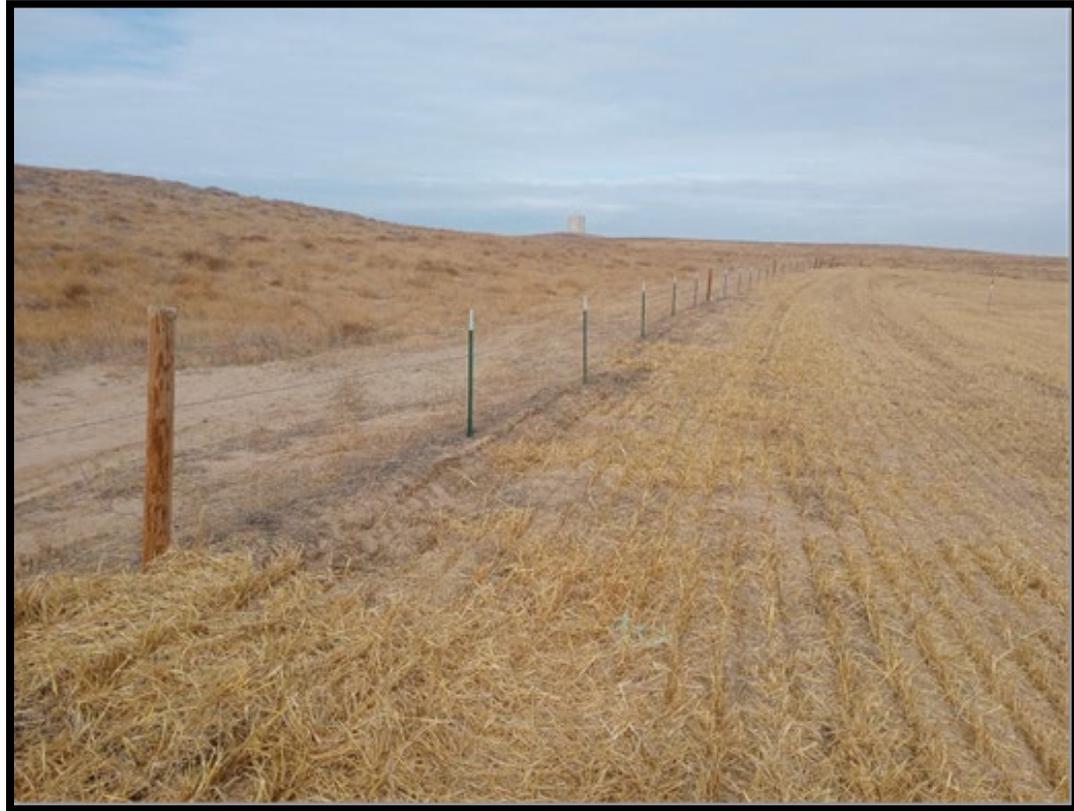
Exhibit A

CA: Weed debris in the form of tumbleweeds were observed across the well location. Tumbleweeds are a troublesome annual non-native weed that easily breaks off at the stem. Operator failed to control and manage weeds to prevent weed waste and prevent the spread of seeds onto adjacent lands. Comply with Rule 606 to remove weed debris.

CA Resolution: Operator has addressed the identified weed debris to assist with preventing the spread of weeds on location and comply with Rule 606. Location has also been reseeded and straw crimped to assist with promoting vegetation.
