Operator: Civitas North
Location Name: Wade 8-59 17 Pad
Loc ID: 484554
Inspection: 708200892

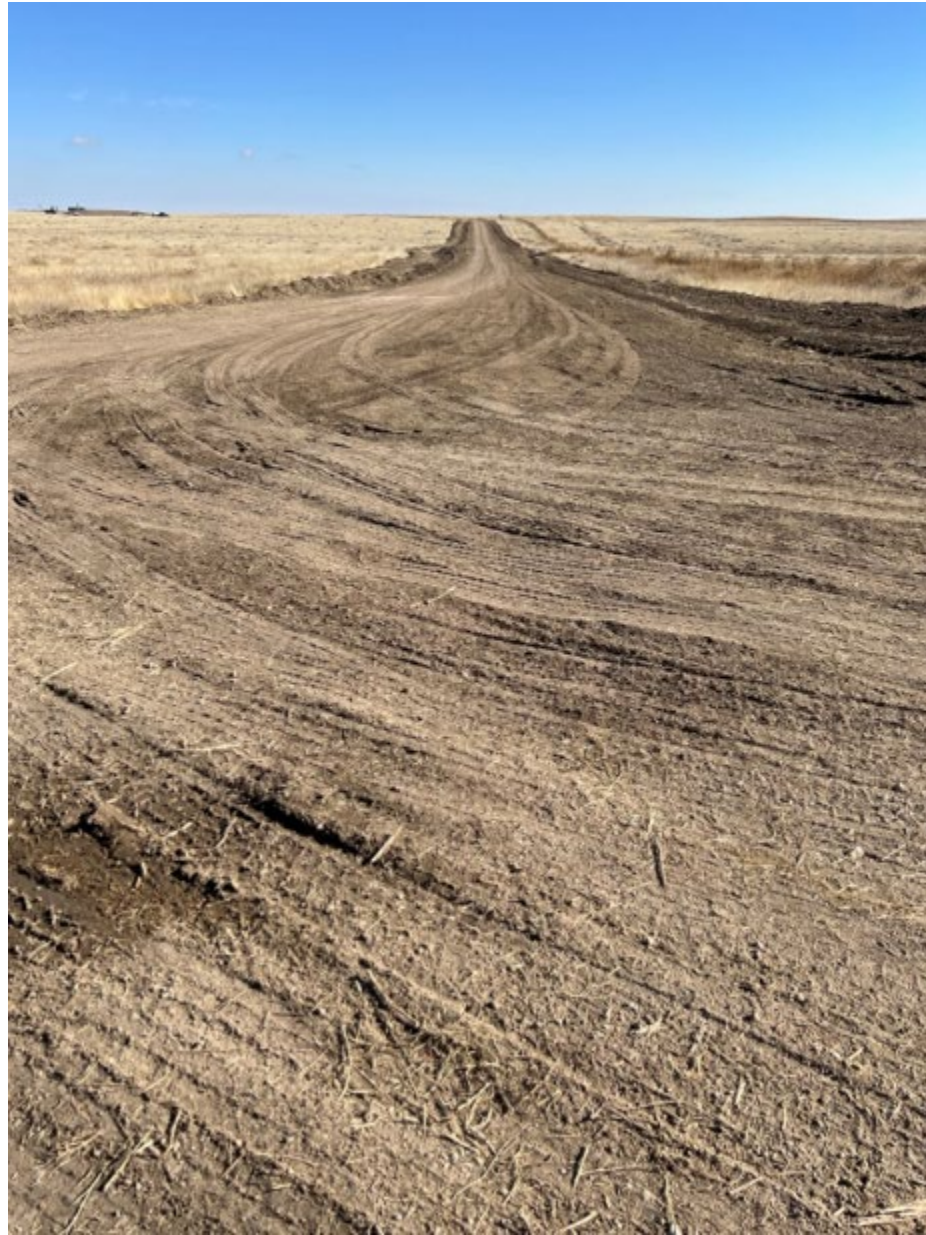
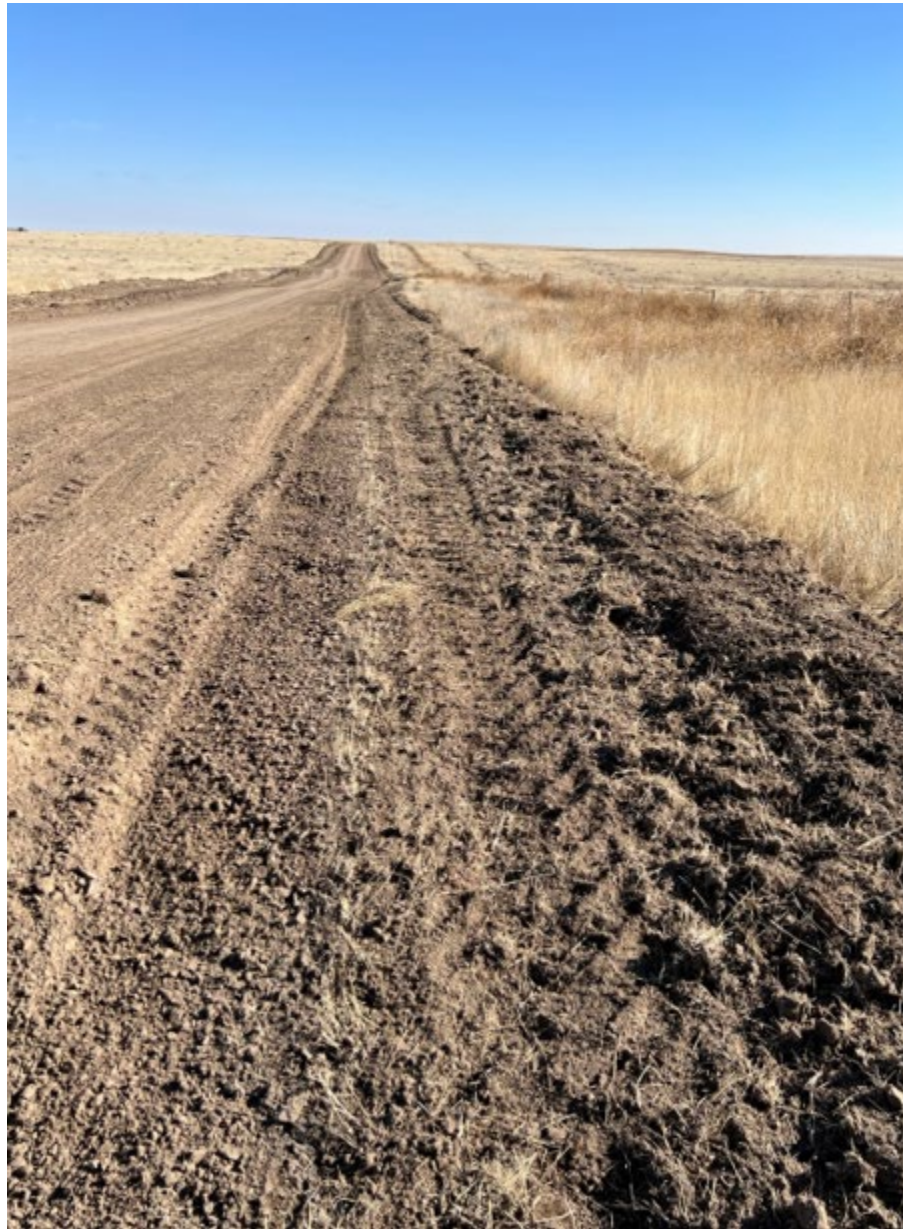
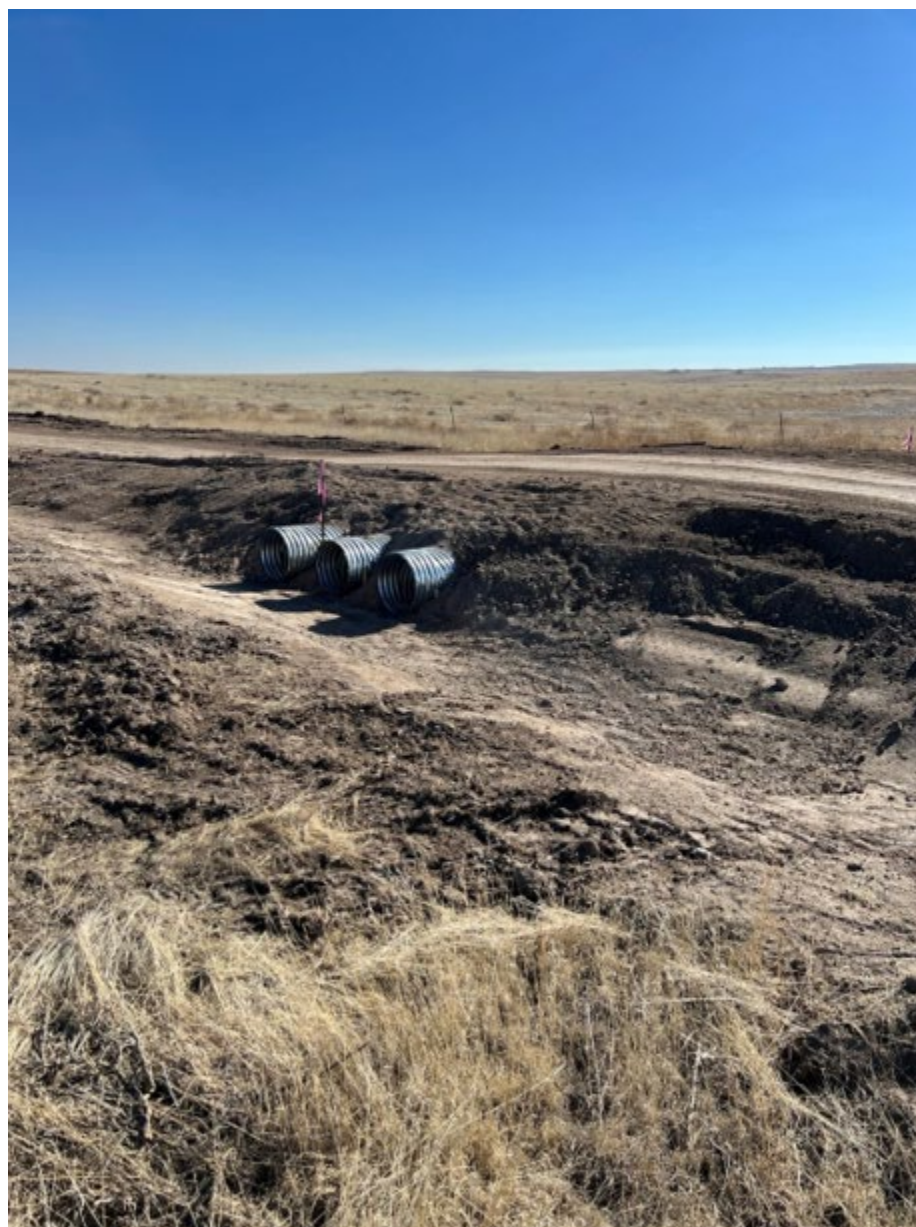
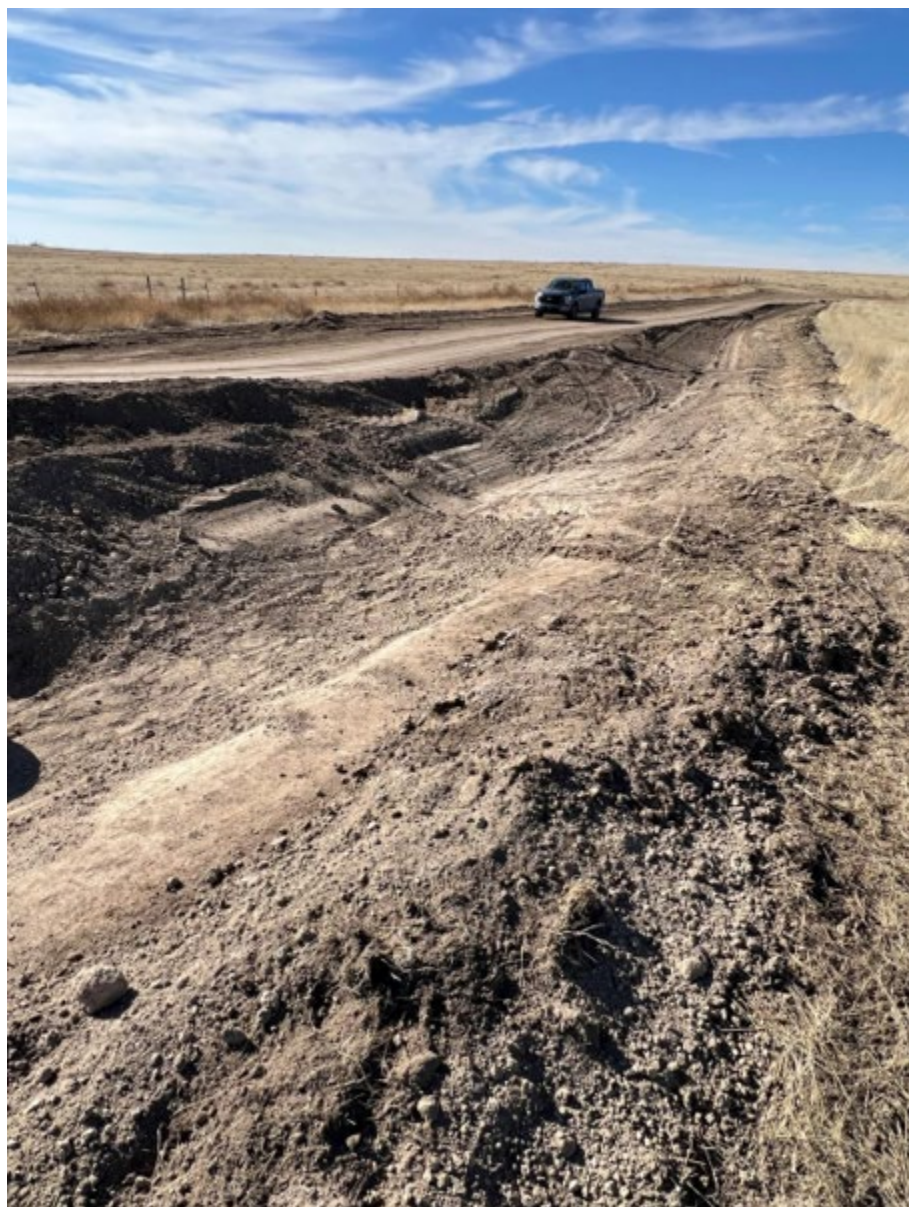
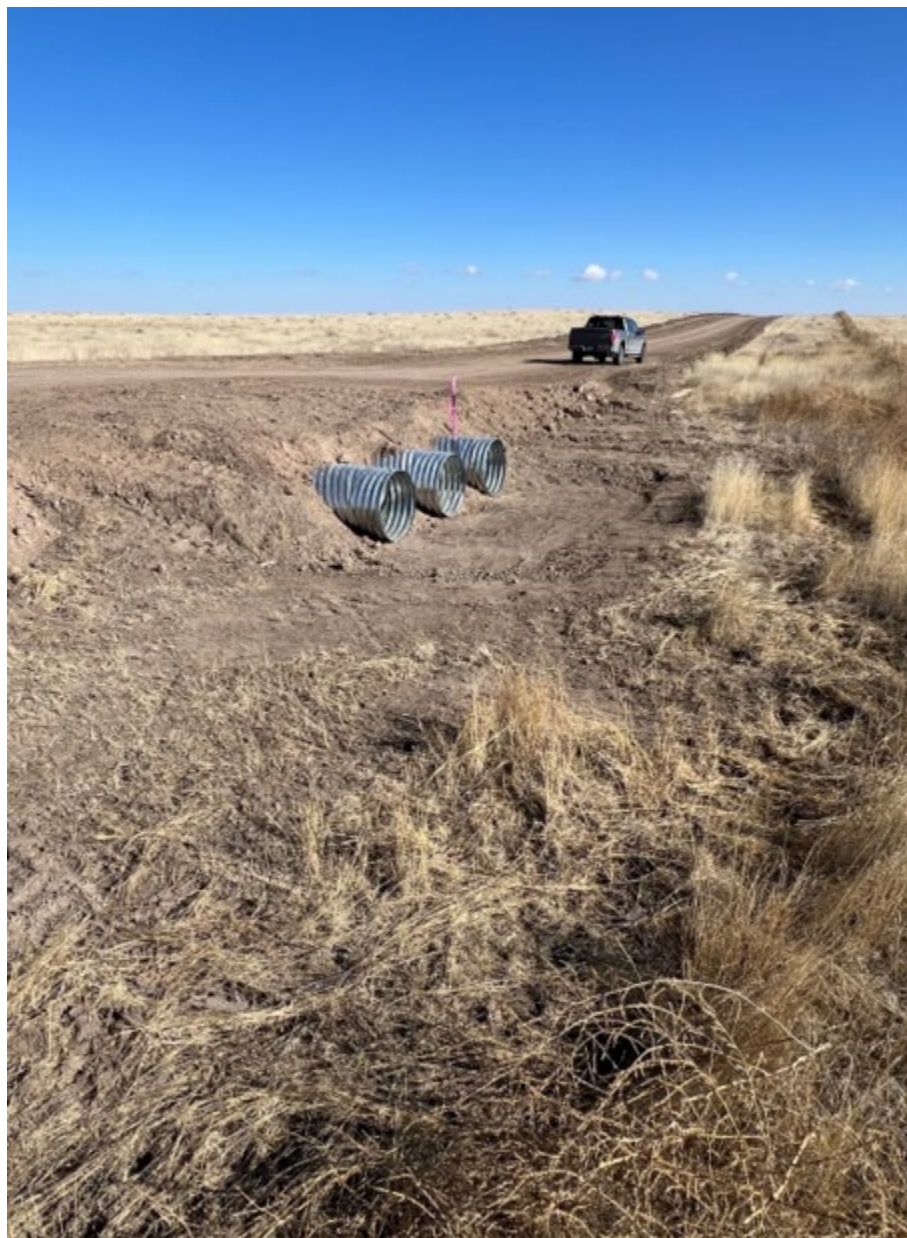
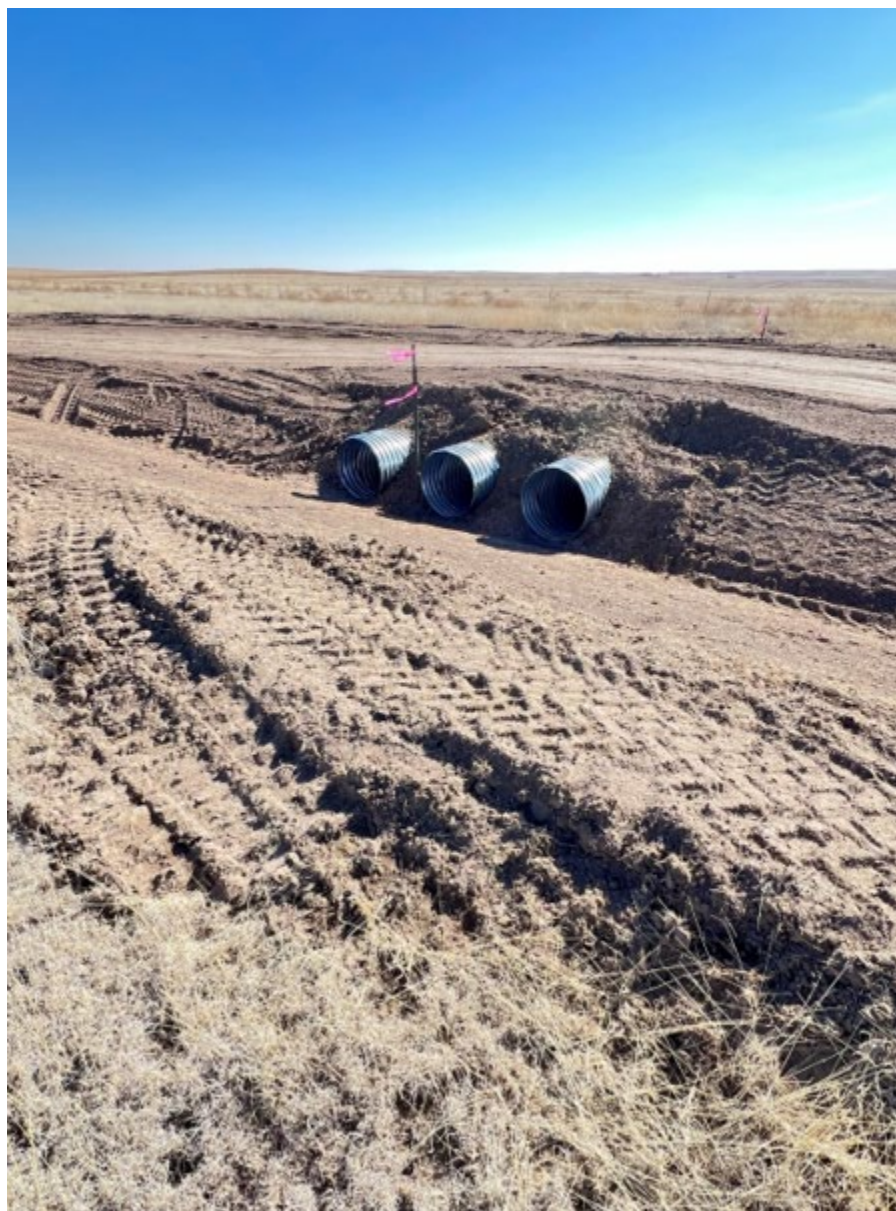
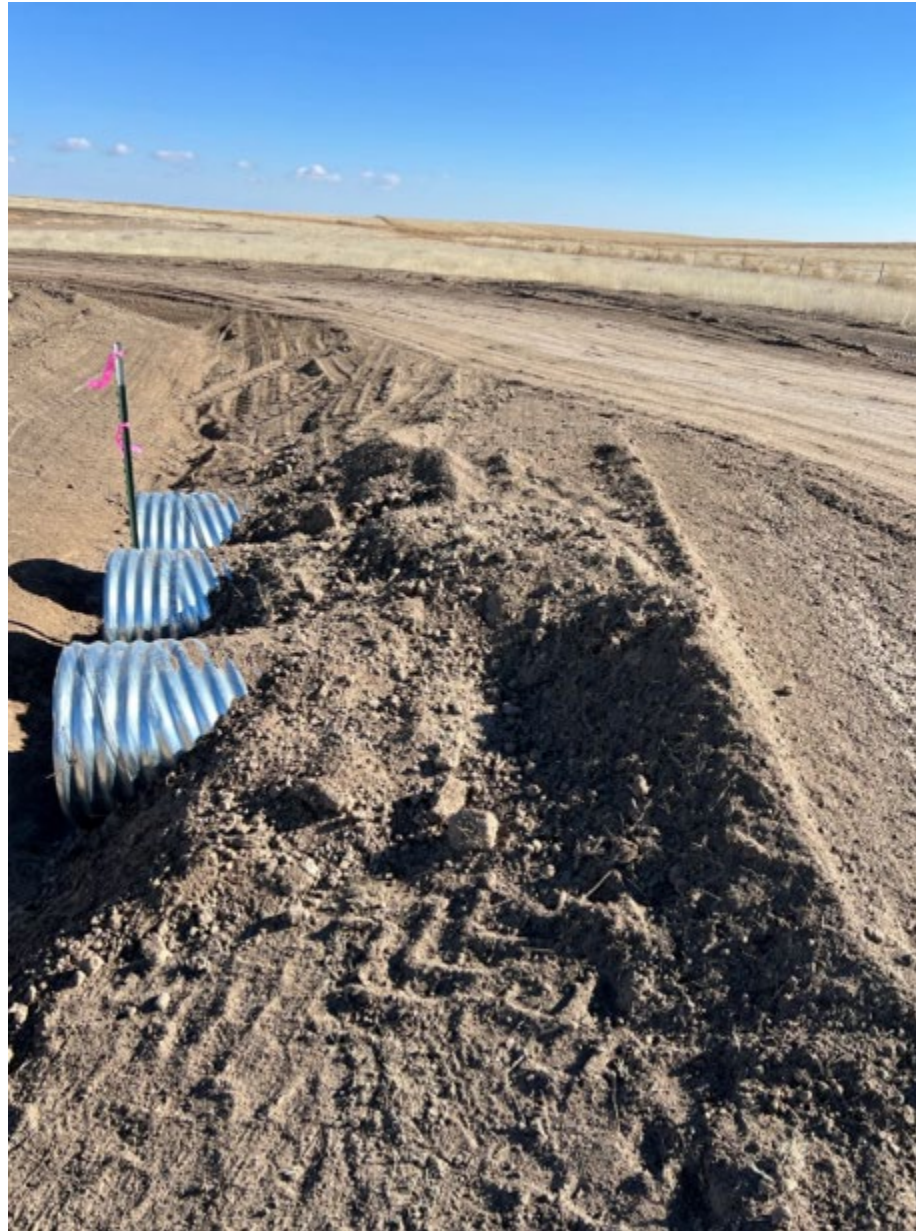
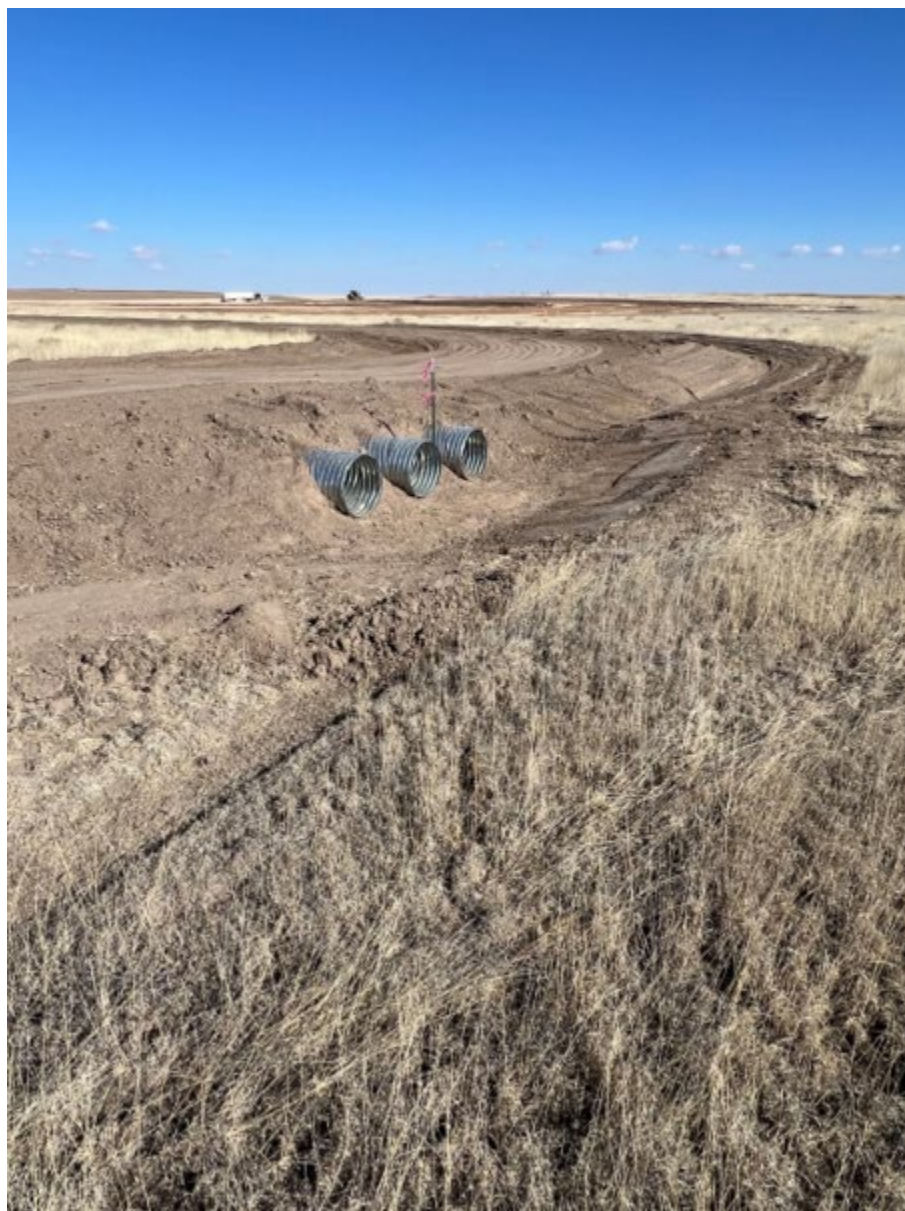
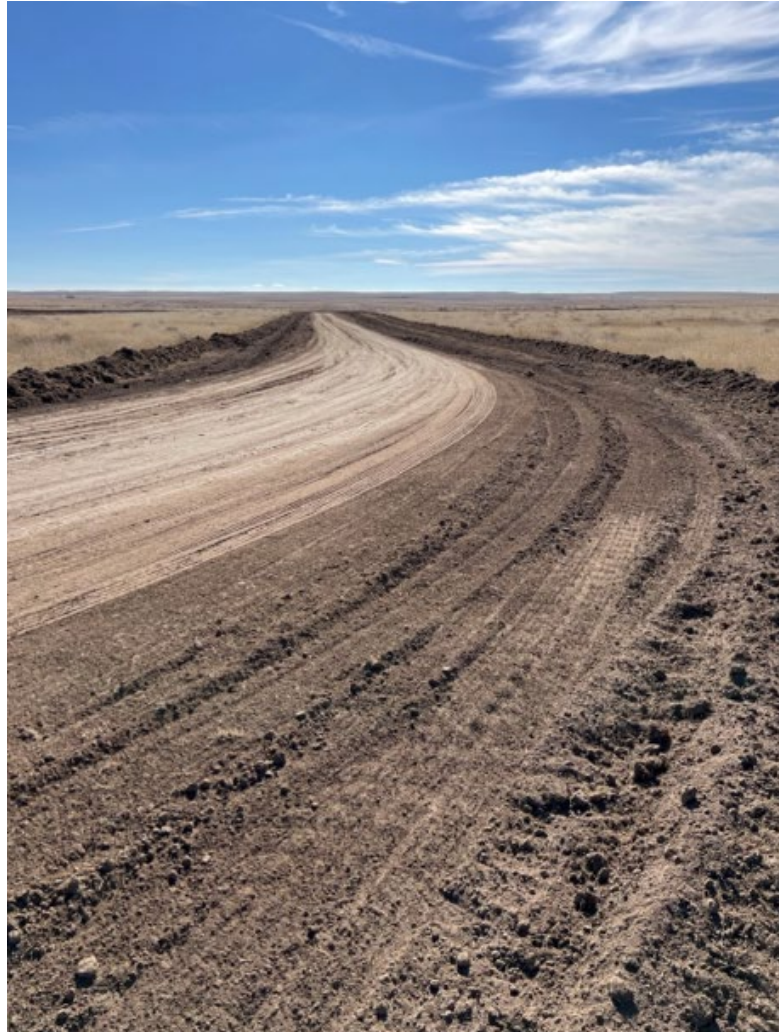
CA: This location does not comply with Rule 1002.b. During this inspection, it was observed that the access road did not appear to have the topsoil salvaged. Additionally, it appears that topsoil was used as fill material at culvert crossings. Refer to attached inspection photos. Comply with Rule 1002.b. Operator shall ensure all topsoil has been salvaged from the Date access road, including any topsoil used as fill material. The location will remain out of compliance until the corrective action has been resolved.

CA Resolution: Topsoil has been salvaged to comply with Rule 1002.b.
