Operator: CIVITAS NORTH LLC
Location Name: Hunt 8-60 17B
Loc ID: 457475
Inspection: 696305980

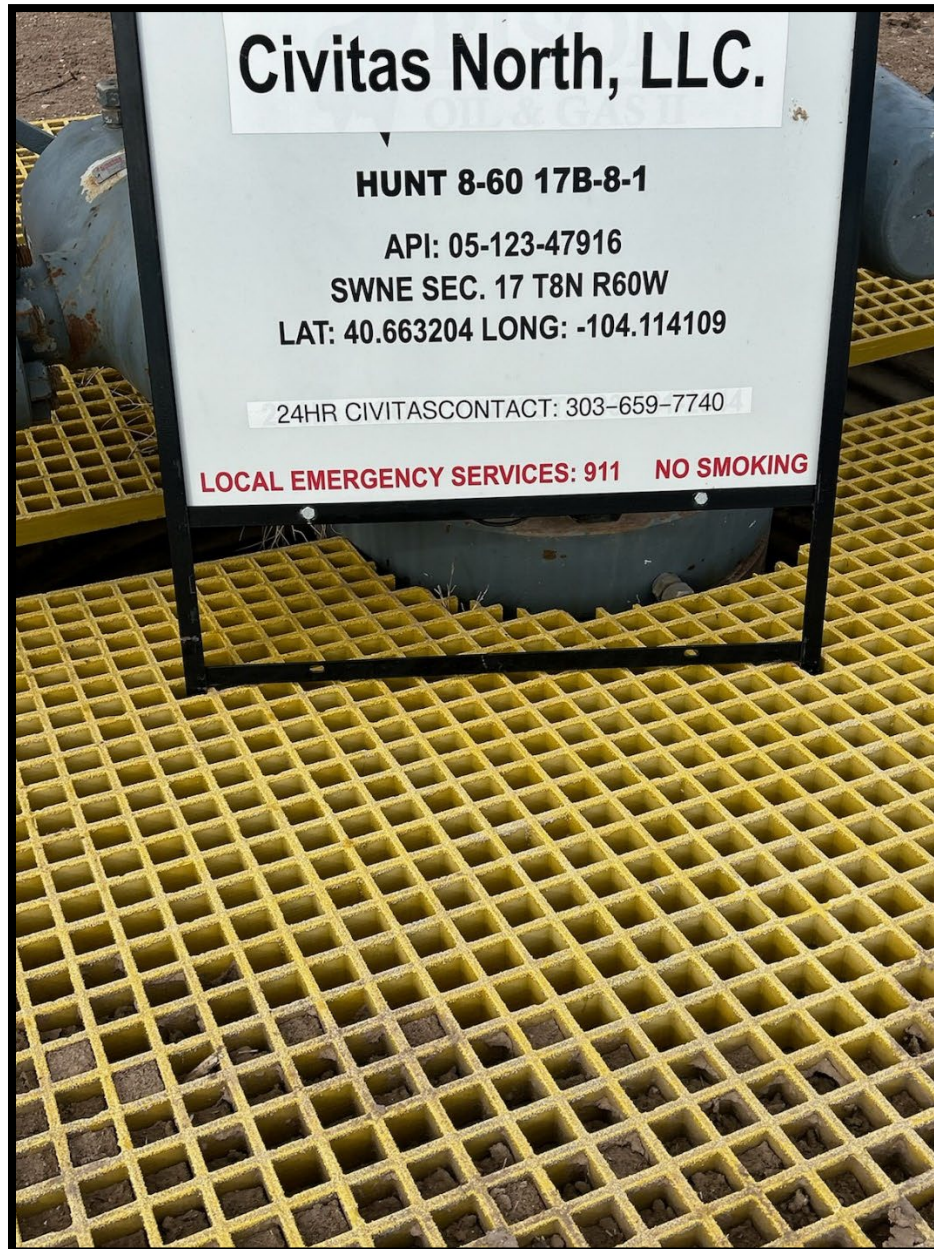
Exhibit A

CA: 24 Hour Emergency Number on Wellhead Sign does not reflect Current Operator. Install sign to comply with Rule 605.d.

CA Resolution: Operator has made the appropriate updates to the Wellhead sign to comply with Rule 605.d.

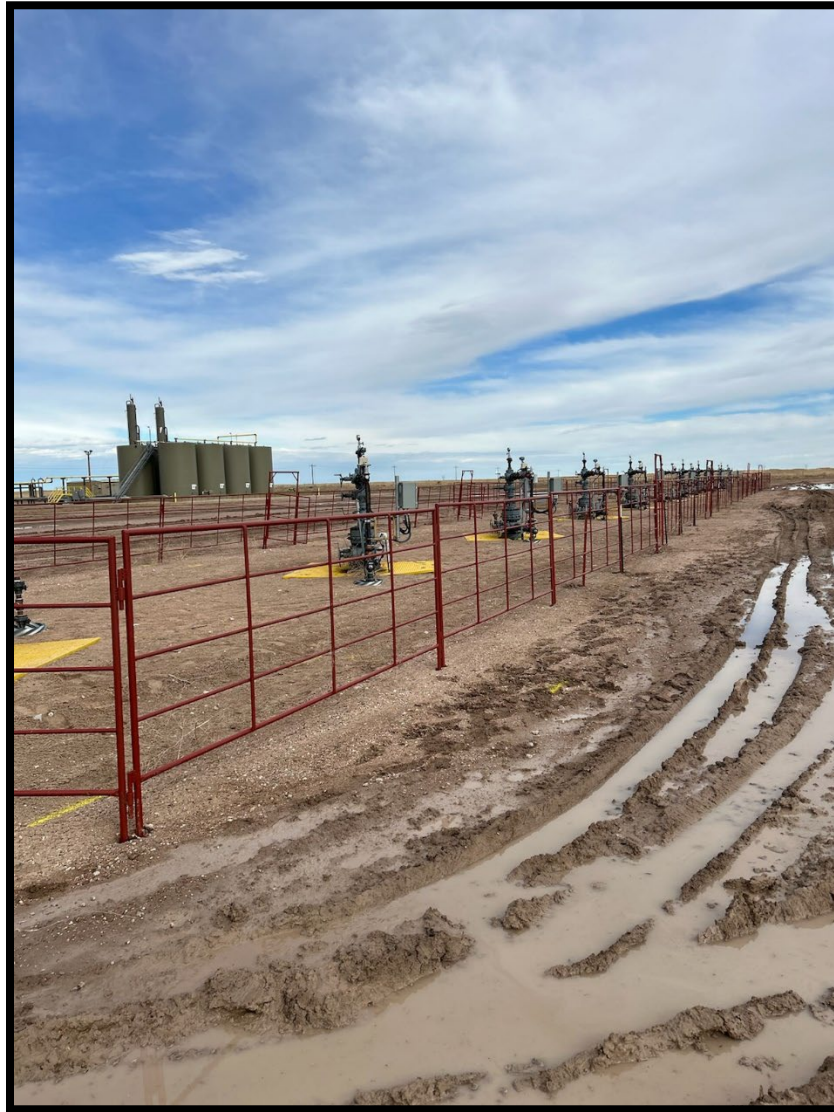
Exhibit A

CA: Panels - Fencing is in disrepair - see photos. Comply with Rule 606.

CA Resolution: Operator has repaired/properly installed fencing to comply with Rules 606 and 603.h.
