Operator: CIVITAS NORTH LLC
Location Name: Hunt 8-60 17A
Loc ID: 457131
Inspection: 696305979

Exhibit A

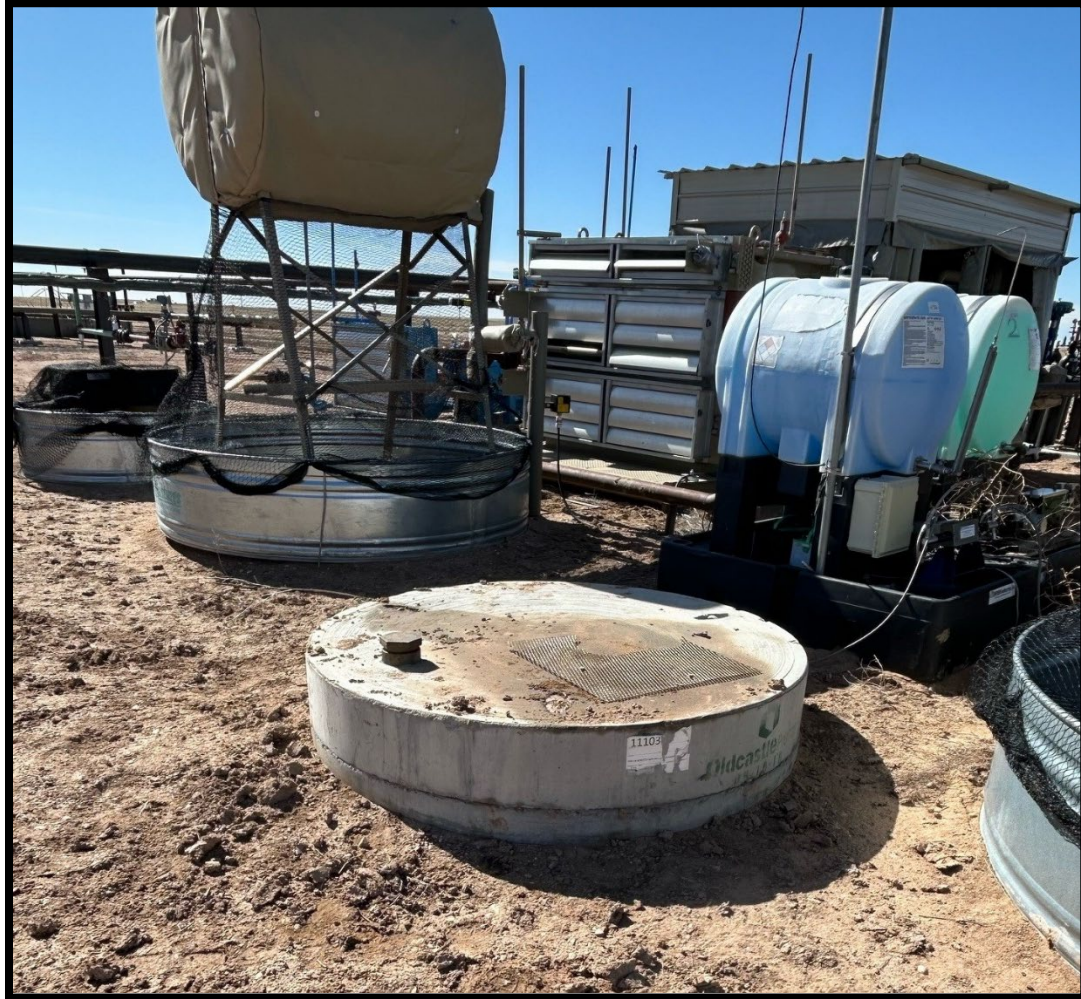
CA: Day Tanks - Wildlife Netting is in disrepair. Deceased birds and Debris is present; See Photos. Secondary Containment with Chemical Drums inside - Wildlife Netting is MISSING; See Photos. Comply with Rule 606. Install or repair wildlife protection equipment. Prevent any unauthorized discharge (specify condition if it is E&P waste, improper disposal, trash, etc.) Per Rule 902.b

CA Resolution: Operator has appropriately repaired/installed Wildlife Netting at identified areas of location to comply with Rule 902.b. Covering and appropriate cap have also been installed on vault.
